## Annual Inspection

Knaptton Parish Council

Mundesley & District Recreation Association

## Mundesley & District Recreation Association

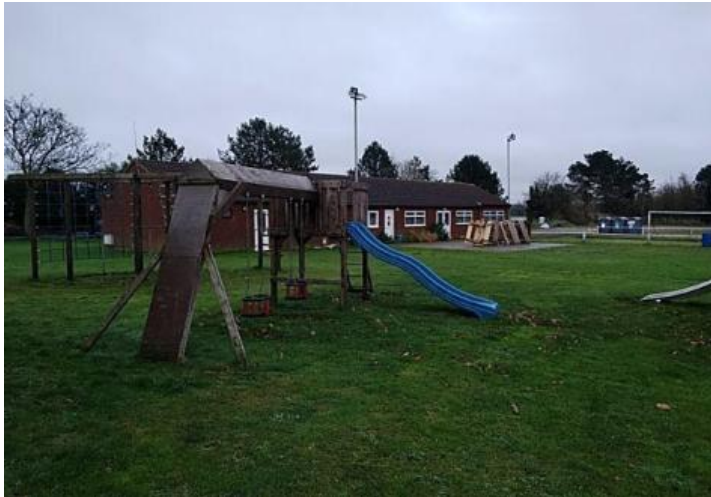
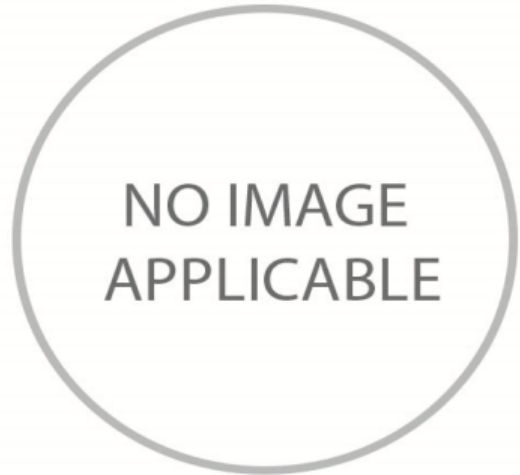
**Finding:** It is recommended that signage, with information including the site address, contact information for maintenance issues and emergency contact details are provided for the facility

**Action:** Provide in accordance with the recommendations

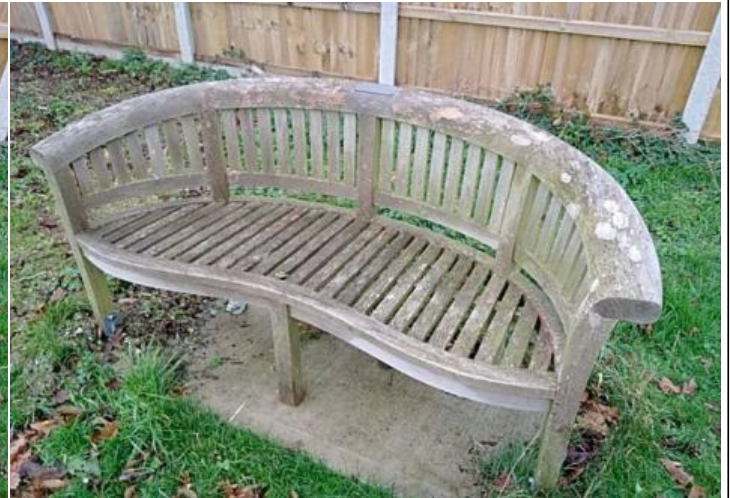
**Finding:** There is algae or moss on the surface of the equipment

**Action:** Clean and treat appropriately

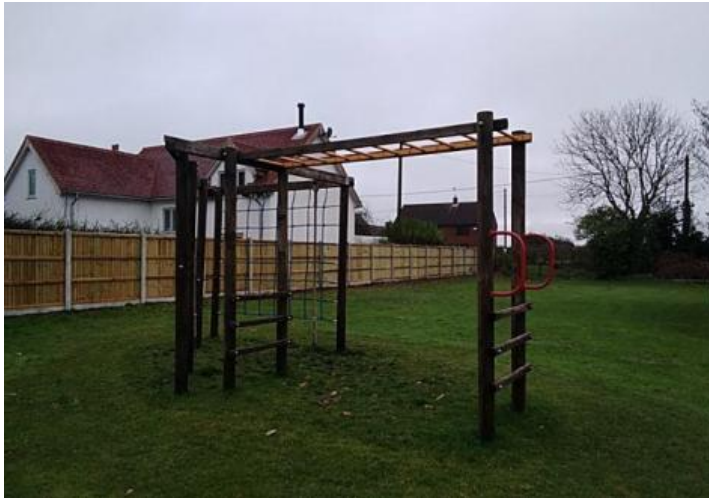
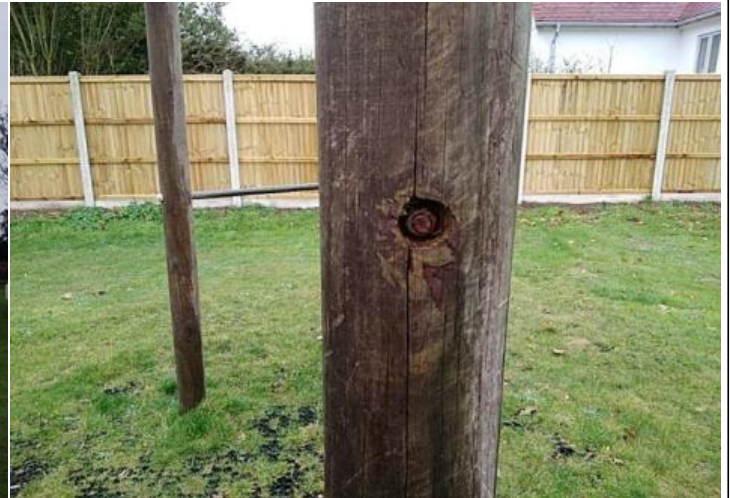
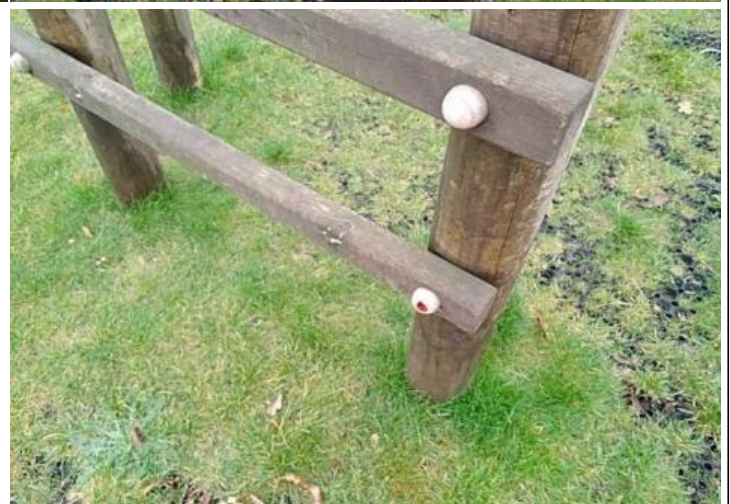
**Finding:** There is/are bolt cap covers missing or damaged on the item

**Action:** Replace missing or damaged bolt cap covers

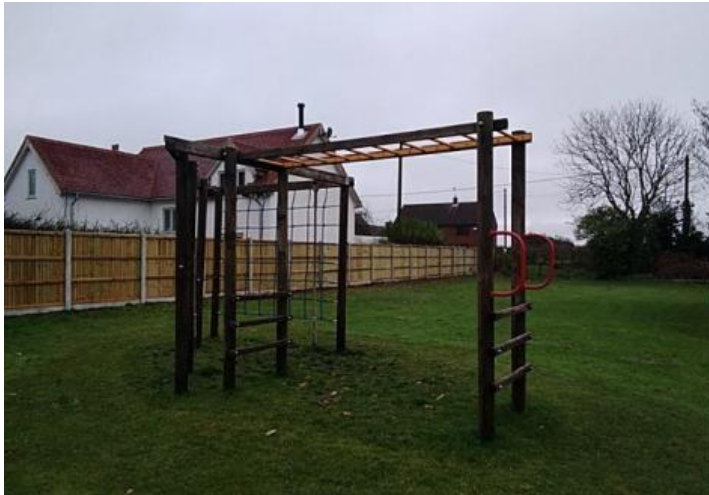
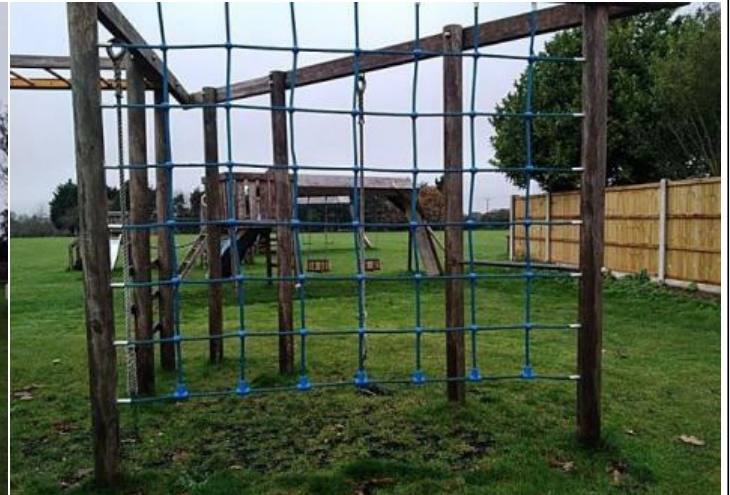
**Finding:** The item is slightly loose in its foundations

**Action:** Monitor for any further deterioration and repair as required

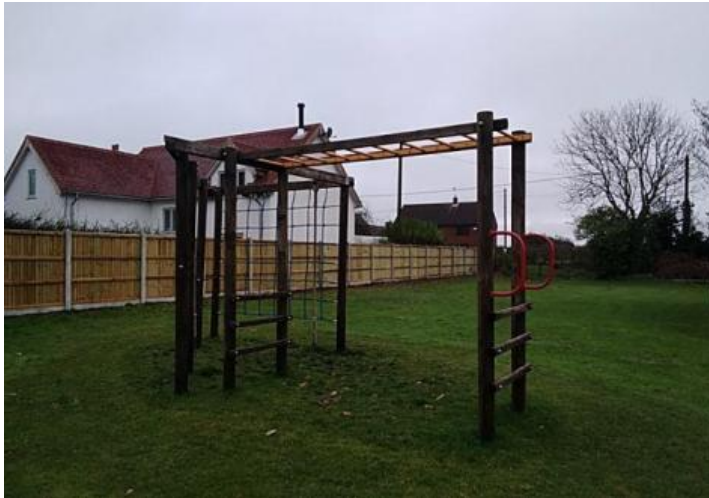
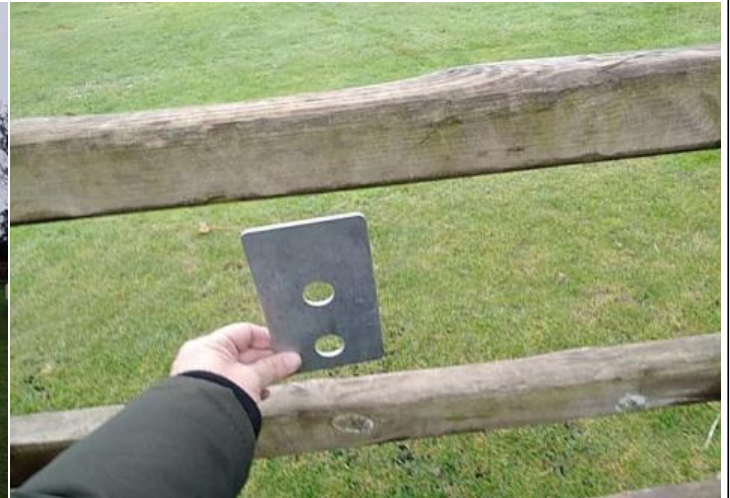
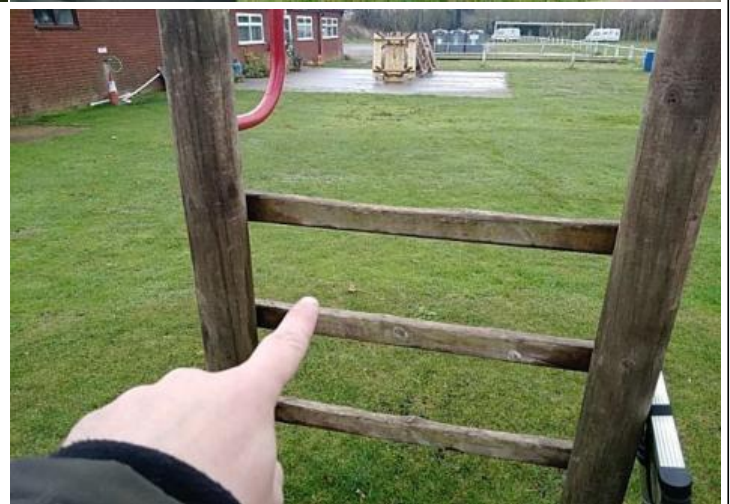
**Finding:** The item fails to meet the requirements of BS EN 1176 Part 1 4.2.7.2 for head and neck entrapment in the framework

**Action:** Monitor - No remedial work recommended

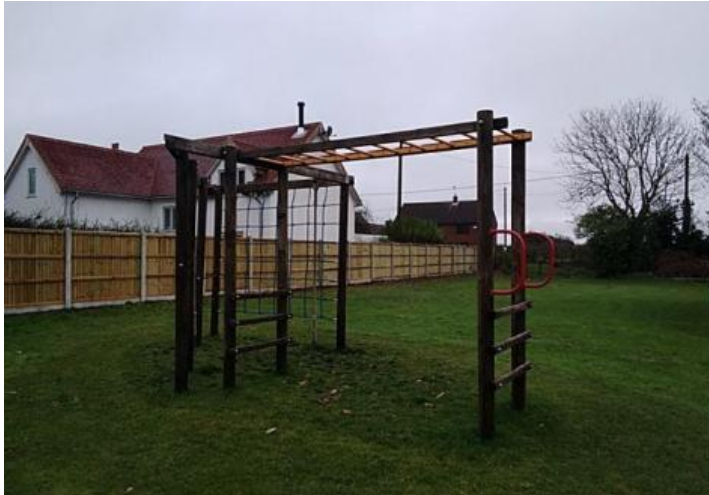
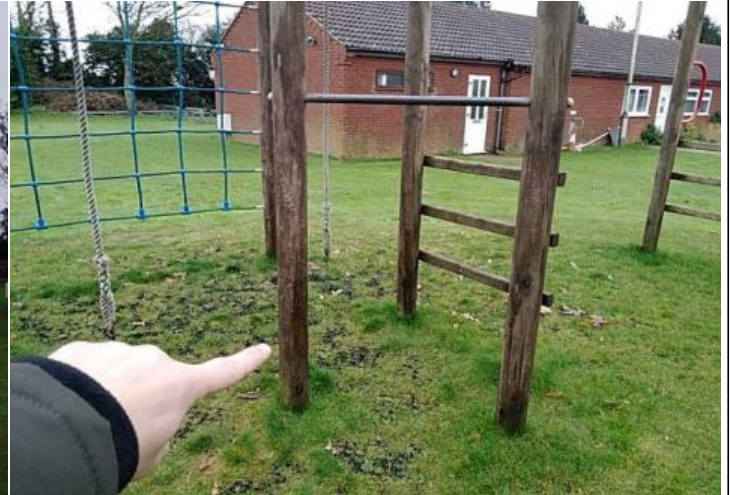
**Finding:** There are areas or parts of the timber on the structure that have rotted

**Action:** Replace all affected timbers

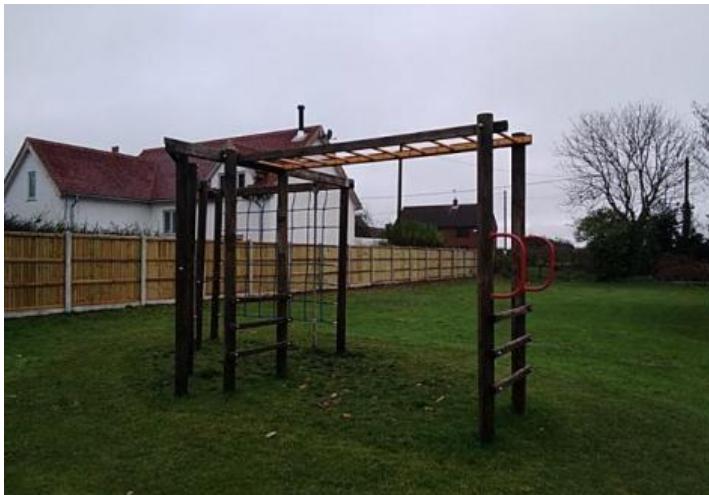
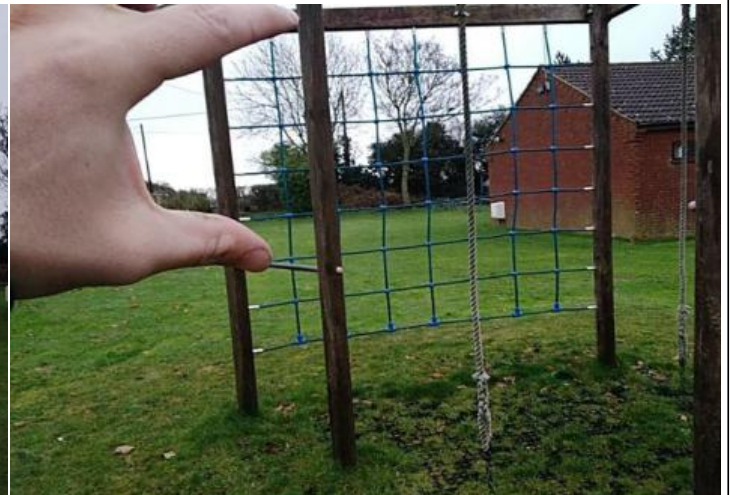
**Finding:** There are falls in excess of 600mm between adjacent components on the structure, in contravention of the recommendations set out in BS EN 1176 Part 1; 4.2.8.4

**Action:** Monitor - No remedial work recommended

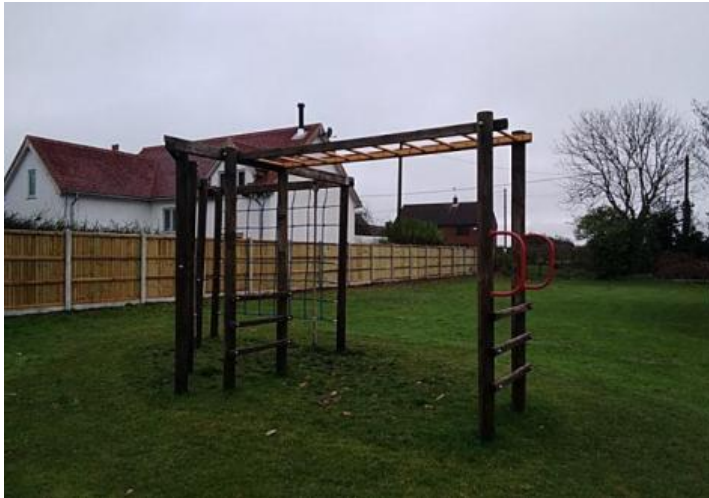
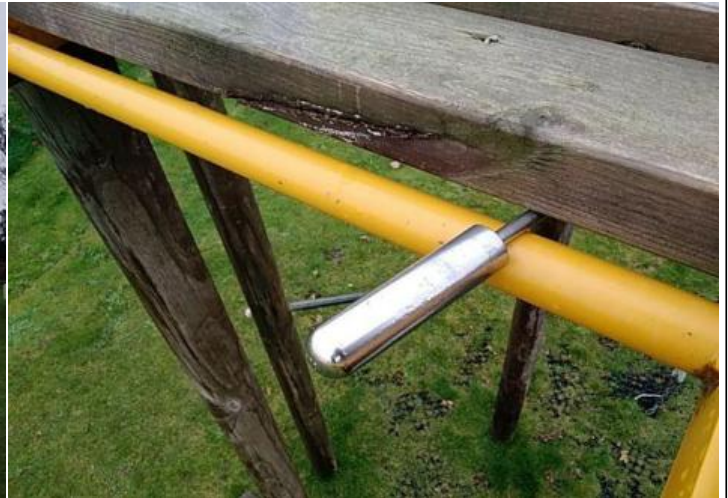
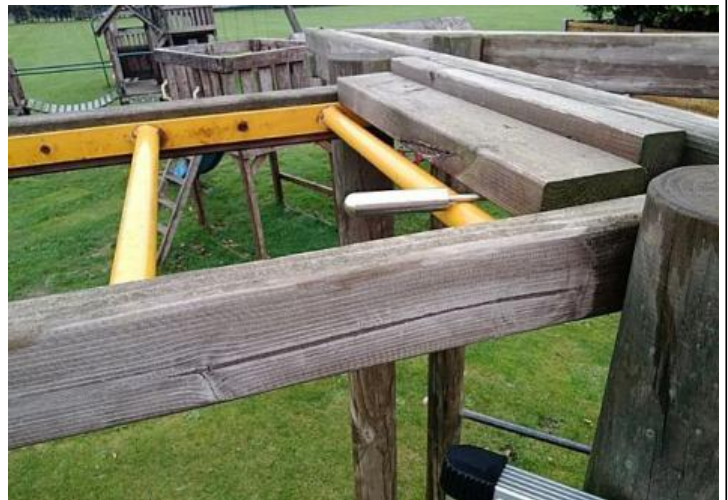
**Finding:** There is/are finger entrapment/s in the framework by the monkey bars and the item fails to meet the requirements of BS EN 1176 Part 1 4.2.7.6 Entrapment of fingers

**Action:** Monitor - No remedial work recommended

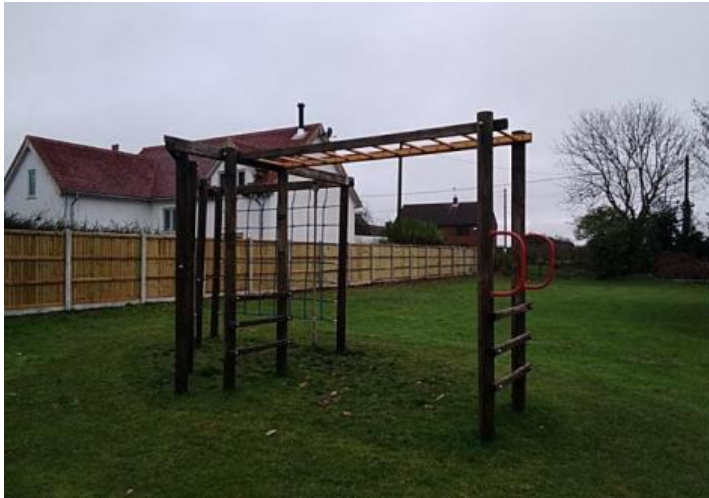
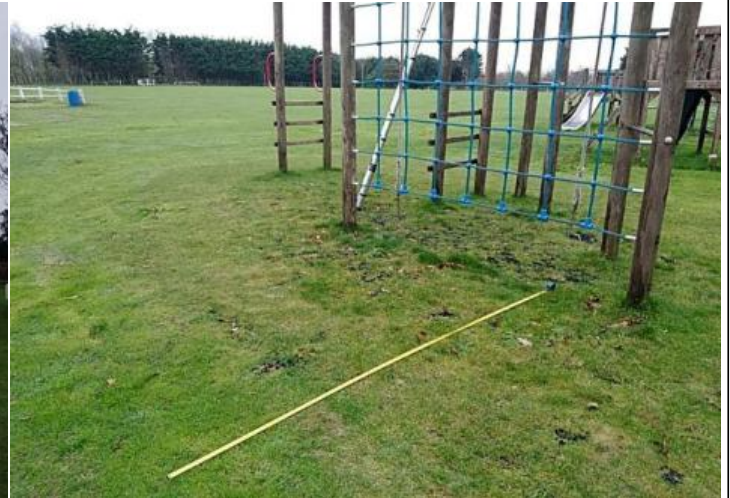
**Finding:** The surfacing dimensions are short and do not meet with the requirements of the current applicable standard

**Action:** Monitor - no remedial action recommended

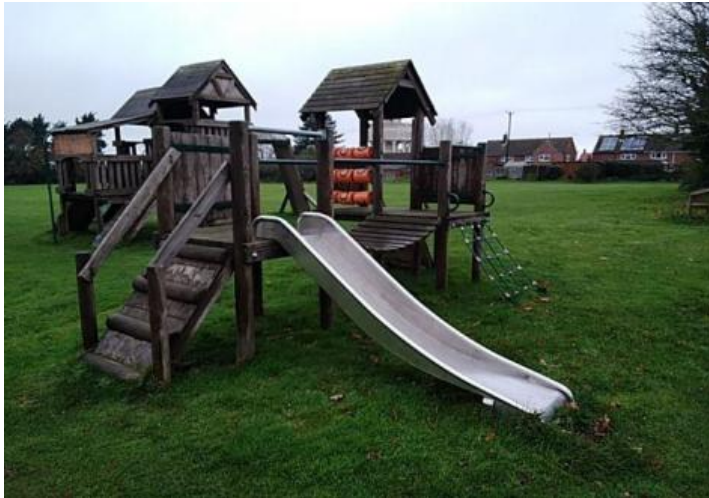
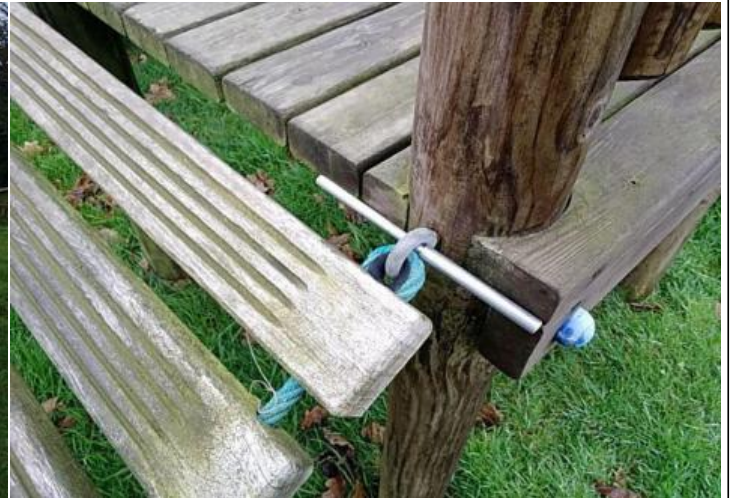
**Finding:** The chain openings are in excess of 8.6mm and do not meet the recommendations of BS EN 1176 Part 1

**Action:** Monitor - No remedial work recommended

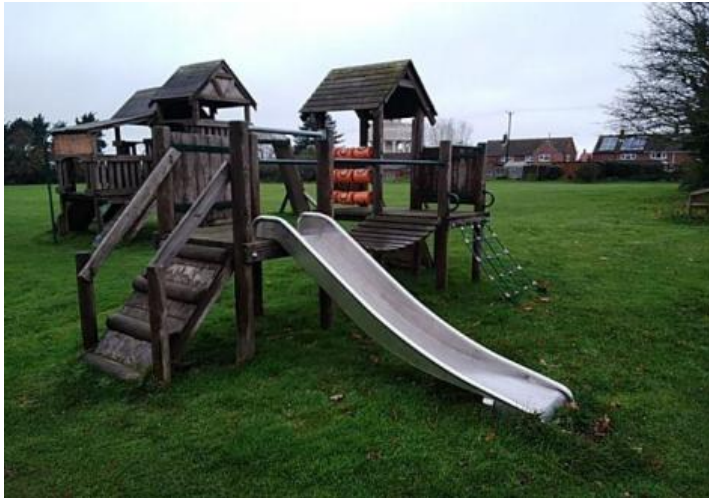
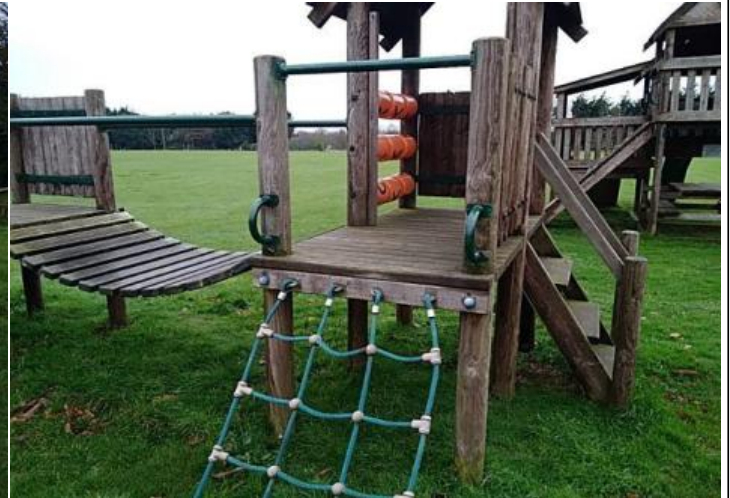
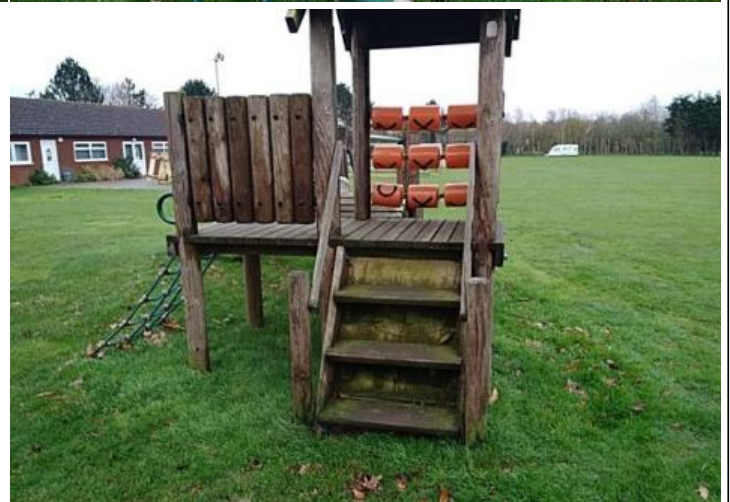
**Finding:** There is an opening in the barriers exceeding the width allowed (500mm) in BS EN 1176, this is a low risk failure and no remedial action is required

**Action:** Monitor - No remedial work recommended

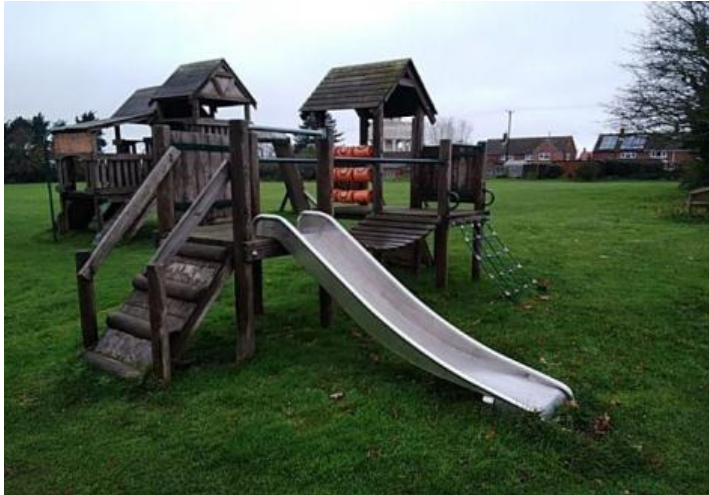
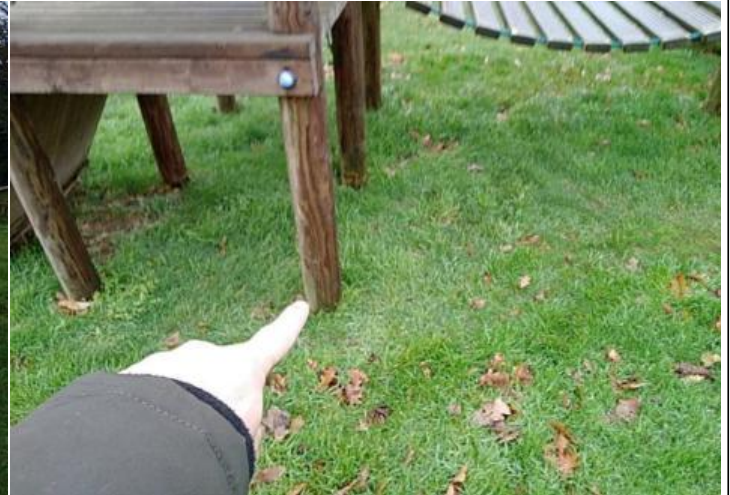
**Finding:** There are areas or parts of the timber on the structure that have rotted

**Action:** Replace all affected timbers

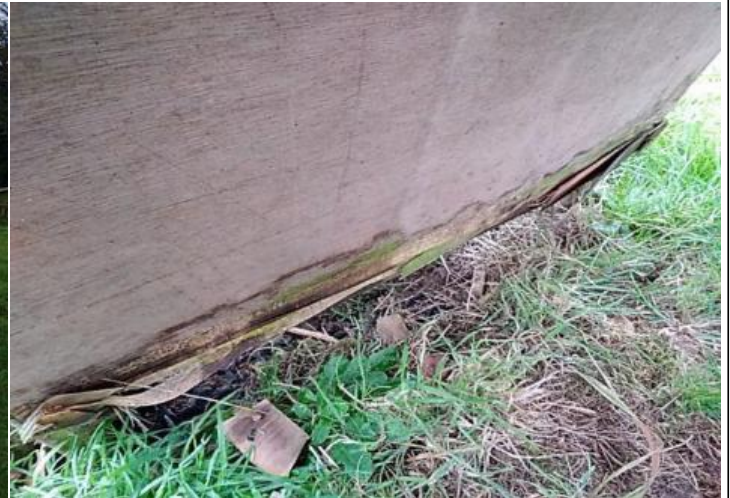
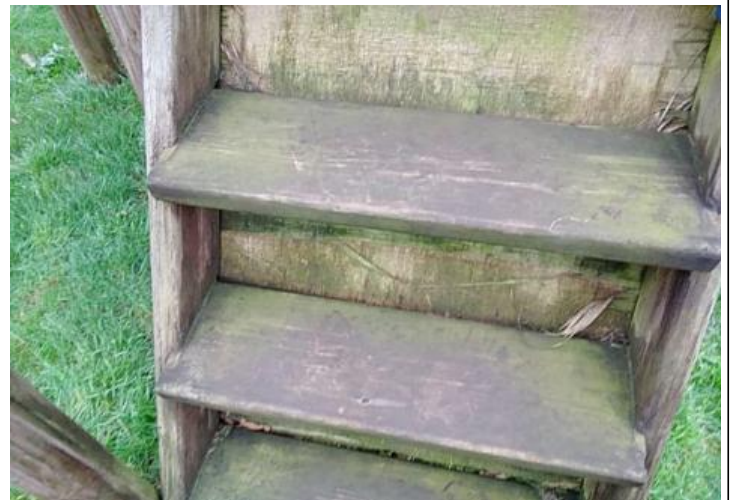
**Finding:** The plywood has delaminated in some places

**Action:** Remove all rough or splintered edges.

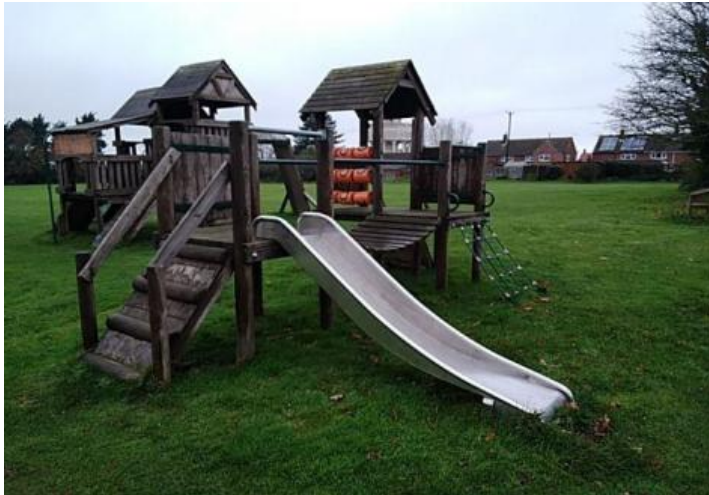
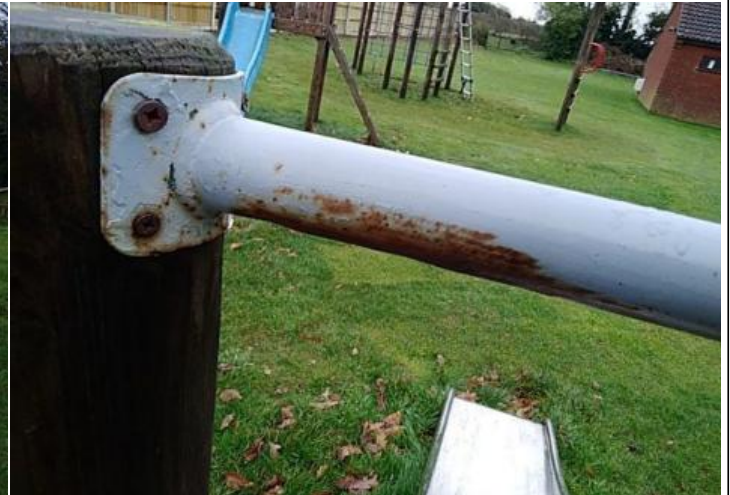
**Finding:** The paintwork on this item has been damaged or worn exposing the metal underneath which is rusting

**Action:** Treat any rusting components and repaint

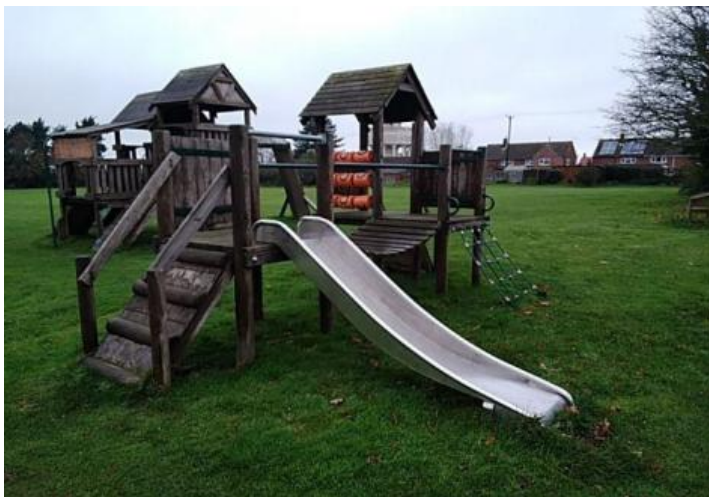
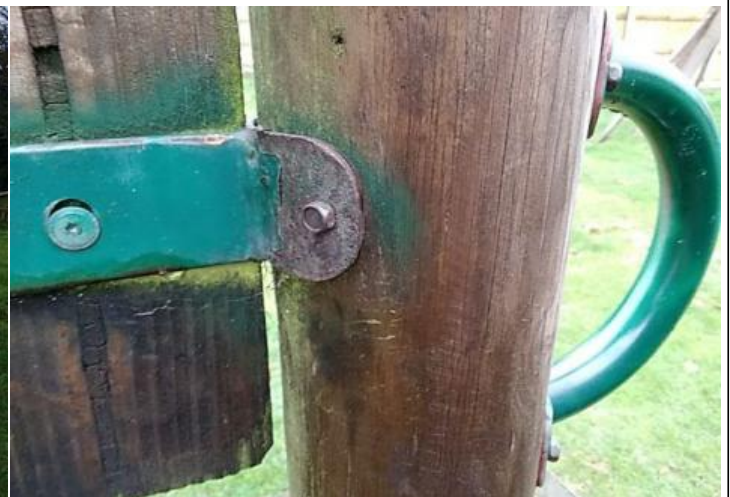
**Finding:** There is surface corrosion present on the item

**Action:** Consider treating the item

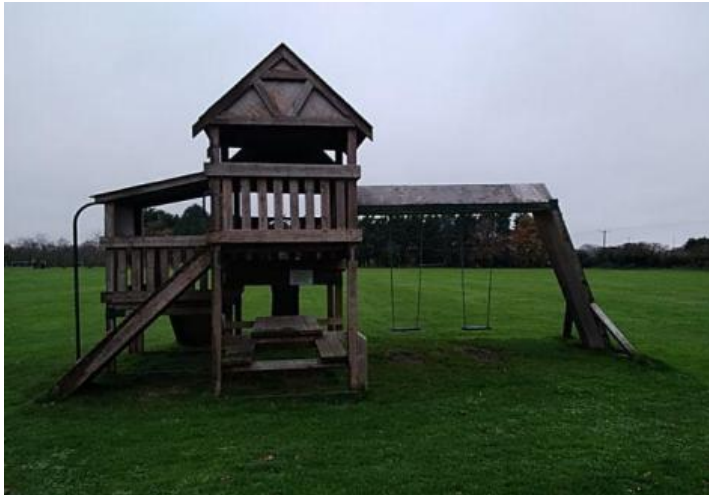
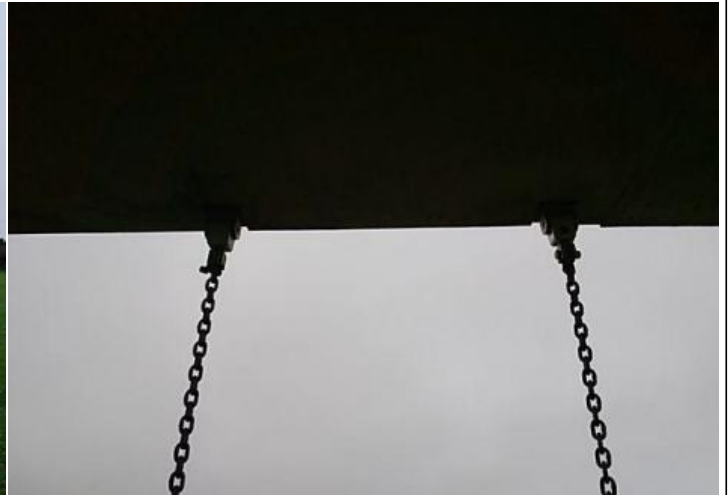
**Finding:** This design of swing joint has been known to fail on the weld connecting the joint to the threaded stud

**Action:** We would recommend that the joint be dismantled and checked on a regular basis or a Secondary Safety Device be fitted

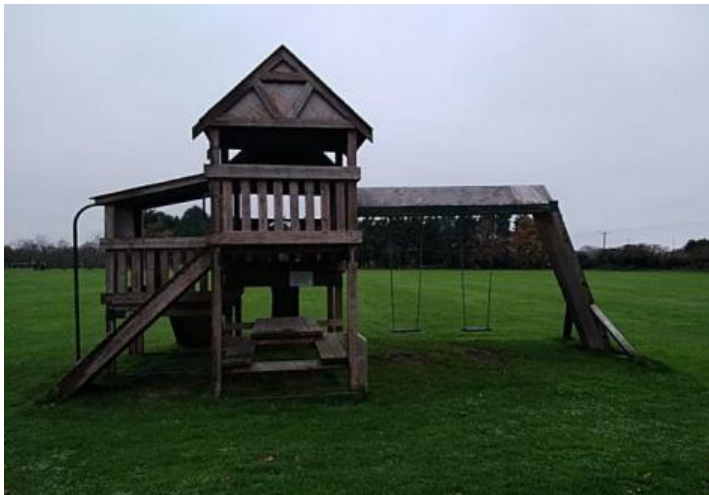
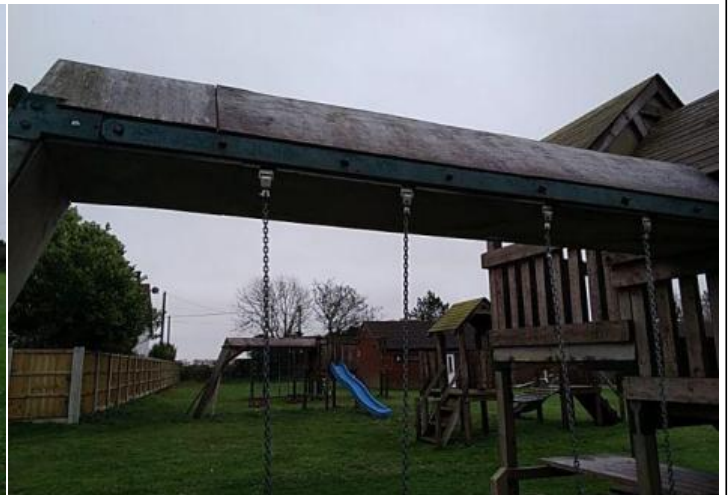
**Finding:** Swing frames or their top bar should only be attached to other equipment where specific measures are undertaken to segregate them from other activities, eg. additional 1.50m circulation area, barrier, or enclosures - BS EN 1176 Part 2 - 4.9

**Action:** Monitor - No remedial work recommended

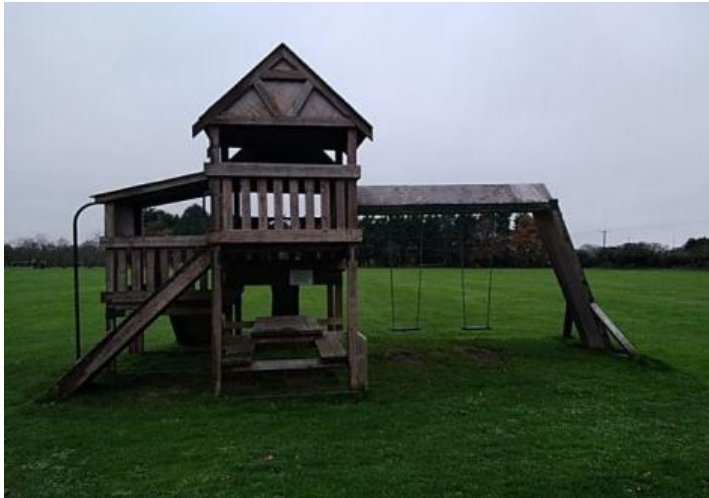
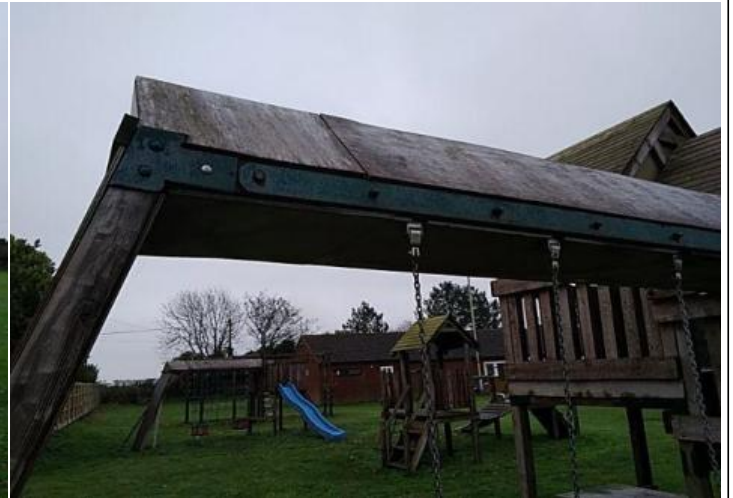
**Finding:** Sections of the unit have been encased and it is not possible to determine the condition of the timber within

**Action:** Create an inspection regime to inspect the internal components condition regularly

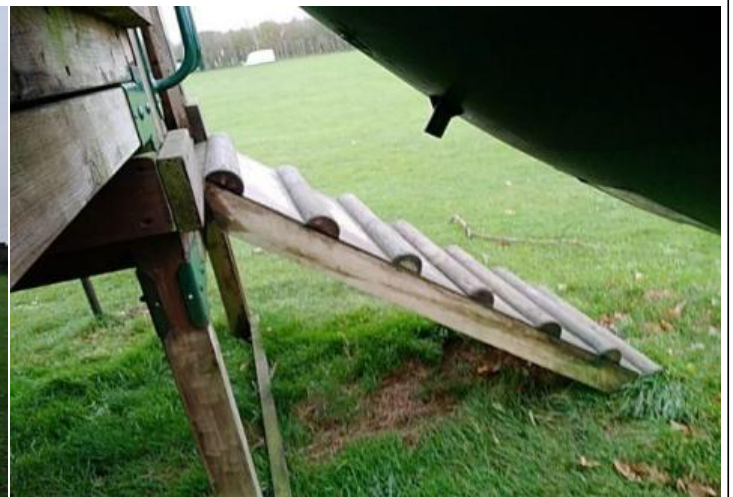
**Finding:** There are projecting bolt thread(s) present

**Action:** Remove excess thread length and deburr or provide cap

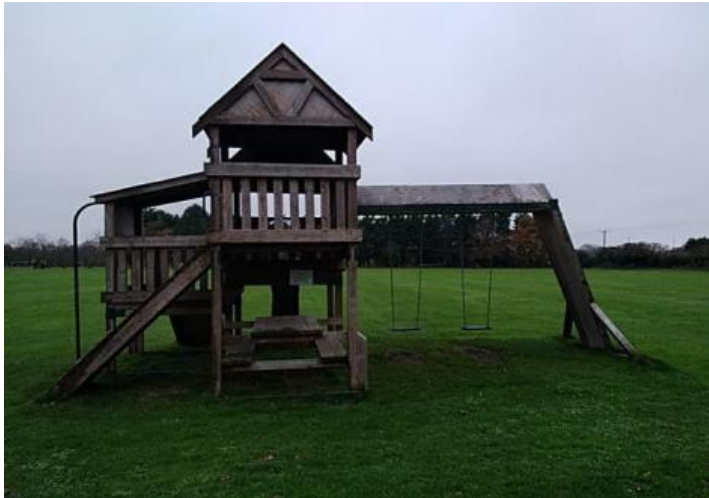
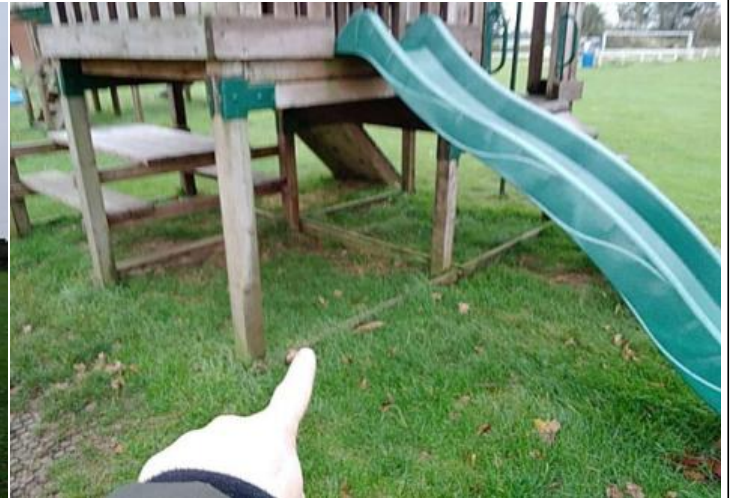
**Finding:** The lower framework forms a hard object within the impact area of the equipment in contravention of the requirements of BS EN 1176 Part 1

**Action:** Monitor - No remedial work recommended

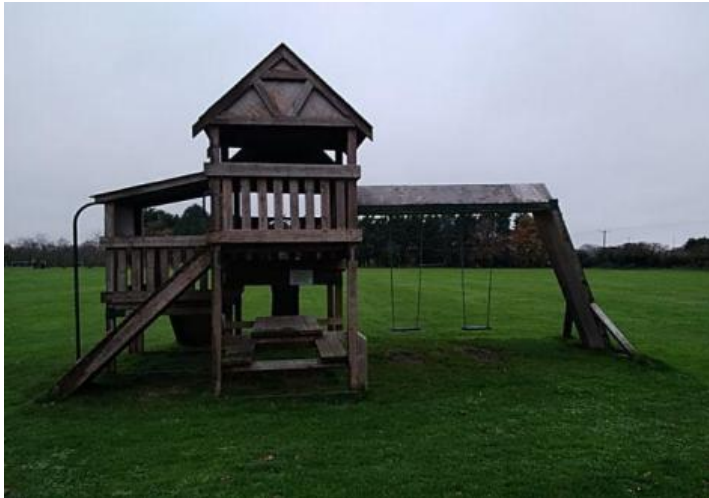
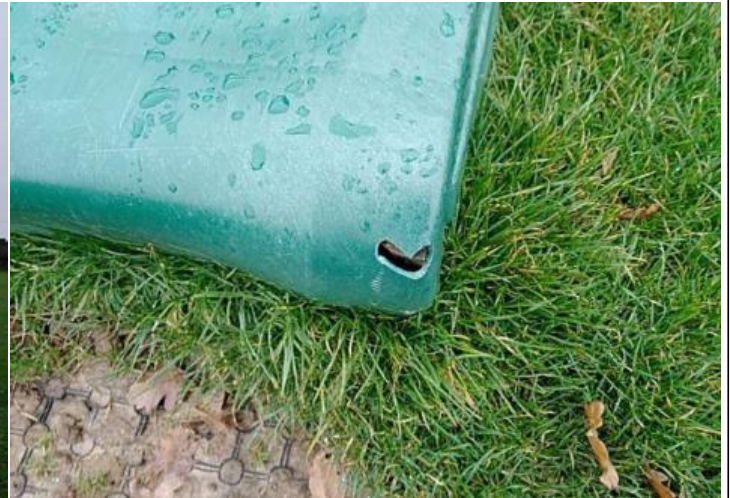
**Finding:** The run out section of the slide has been damaged **Action:** Repair or replace the item

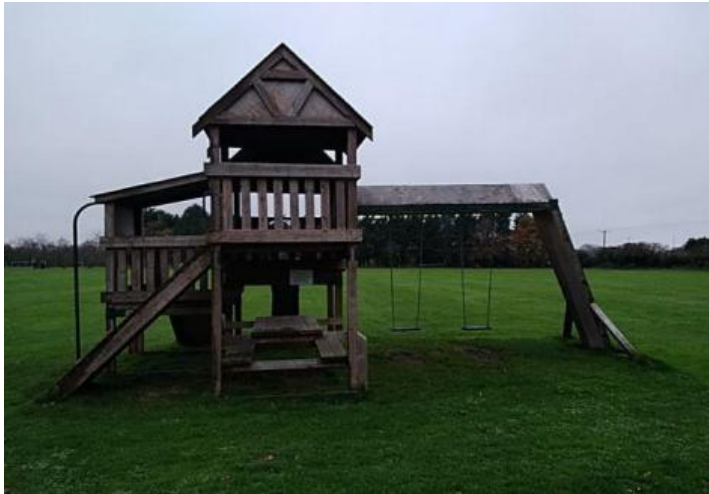
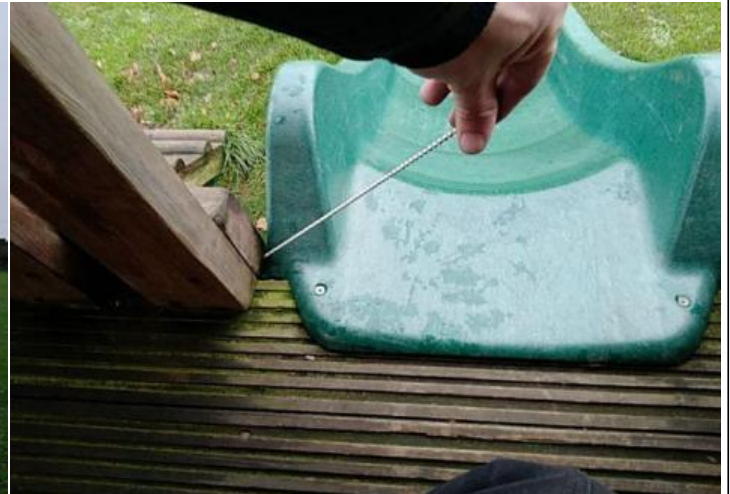
**Finding:** There is / are toggle entrapment/s present in contravention of the recommendations set out in BS EN 1176 Part 3

**Action:** Monitor - no remedial work recommended

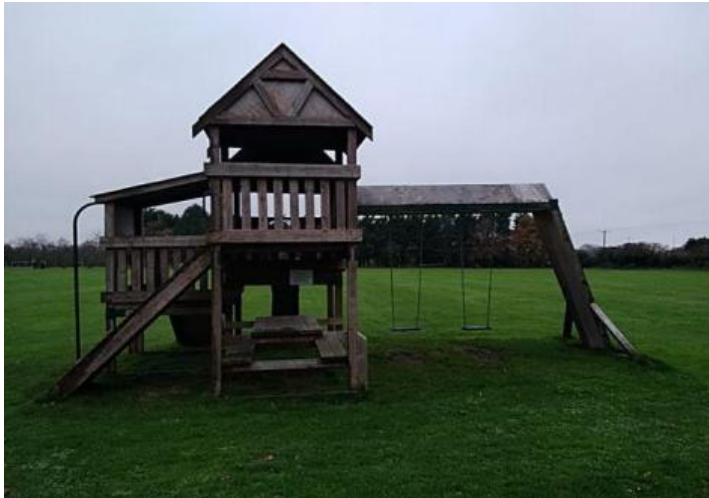
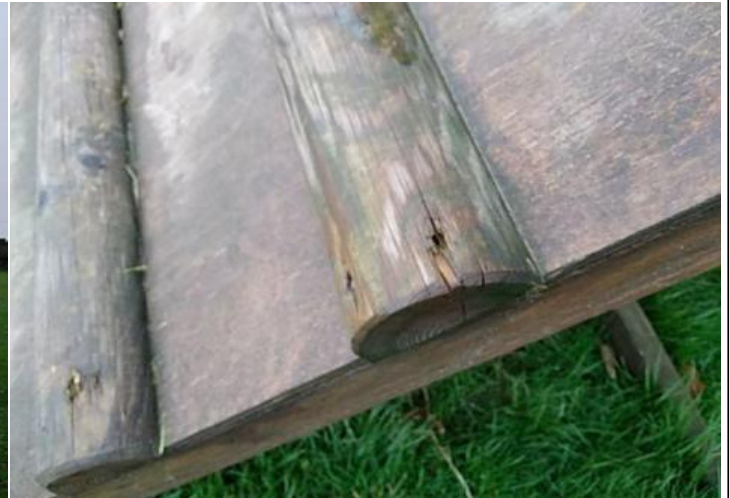
**Finding:** There is some evidence of rot in the timber

**Action:** Monitor for any further deterioration and replace as required

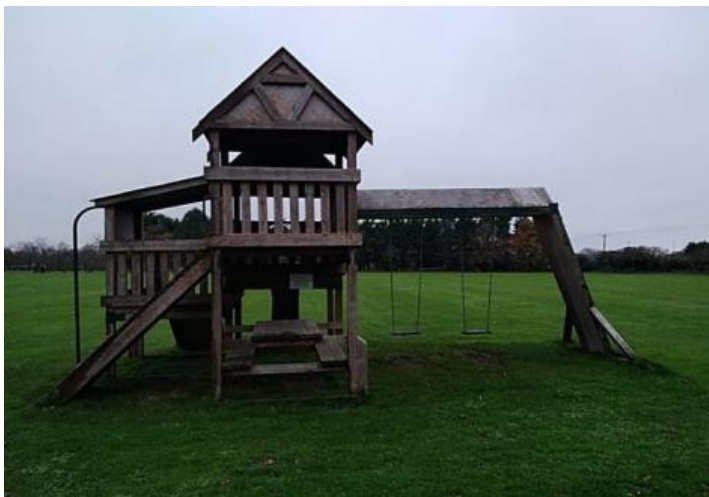
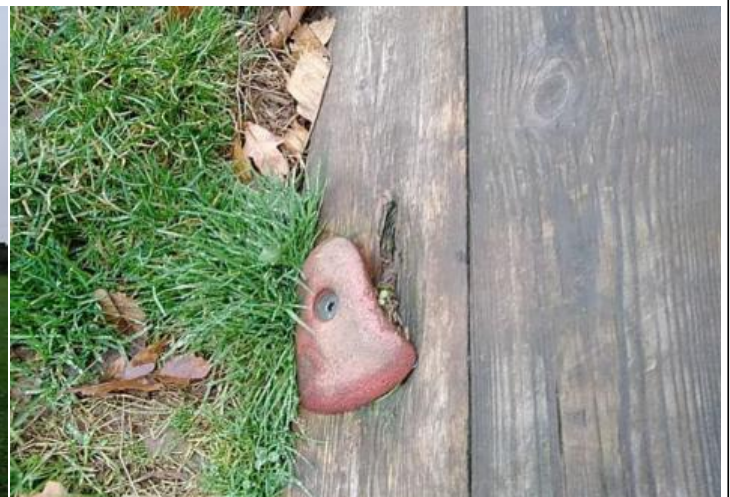
**Finding:** There is some evidence of rot in the timber

**Action:** Monitor for any further deterioration and replace as required

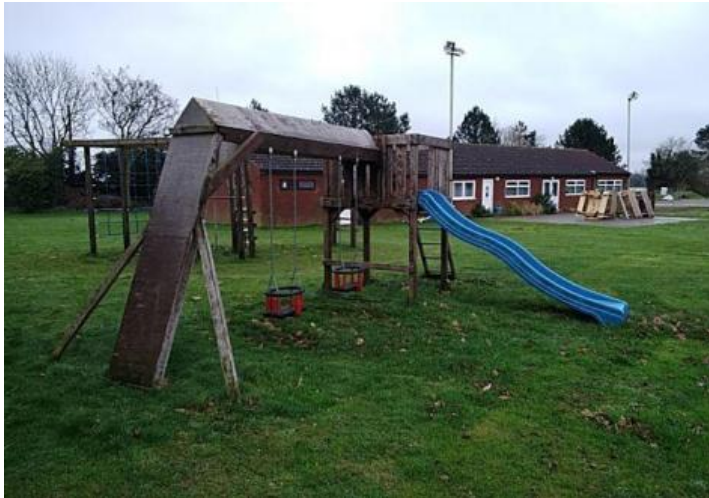
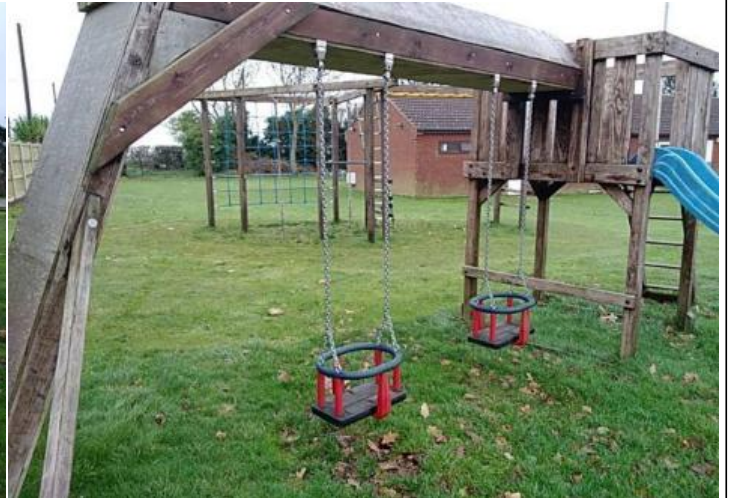
**Finding:** Swing frames or their top bar should only be attached to other equipment where specific measures are undertaken to segregate them from other activities, eg. additional 1.50m circulation area, barrier, or enclosures - BS EN 1176 Part 2 - 4.9

**Action:** Monitor - No remedial work recommended

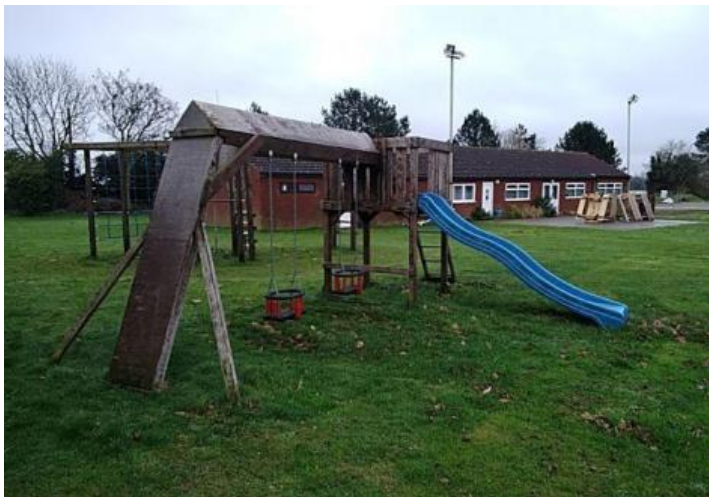
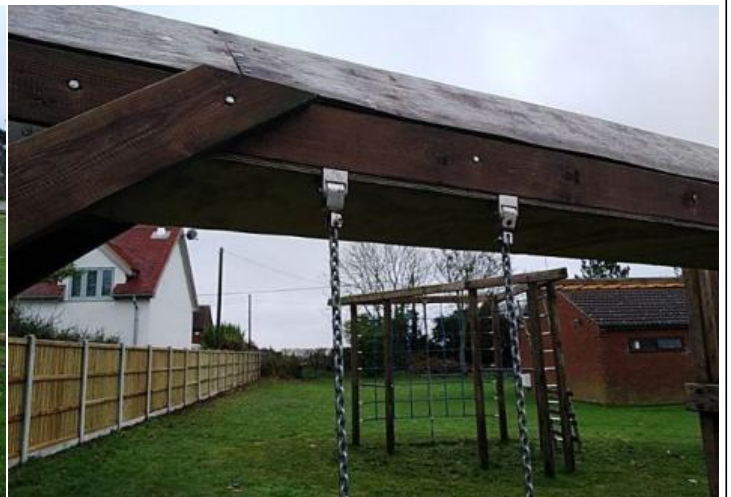
**Finding:** This design of swing joint has been known to fail on the weld connecting the joint to the threaded stud

**Action:** We would recommend that the joint be dismantled and checked on a regular basis or a Secondary Safety Device be fitted

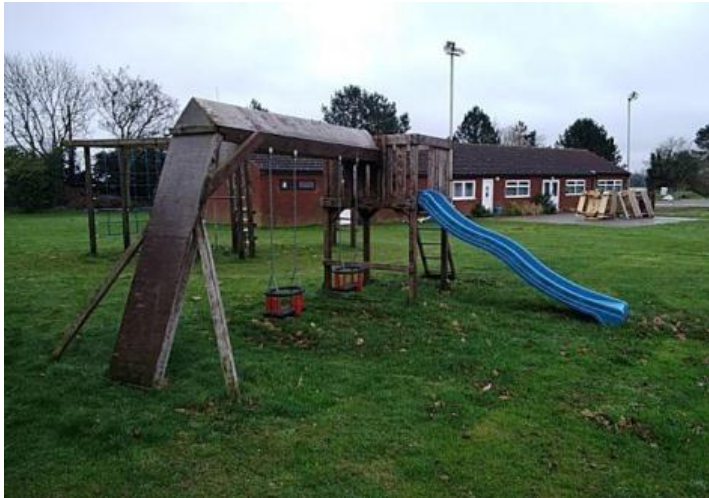
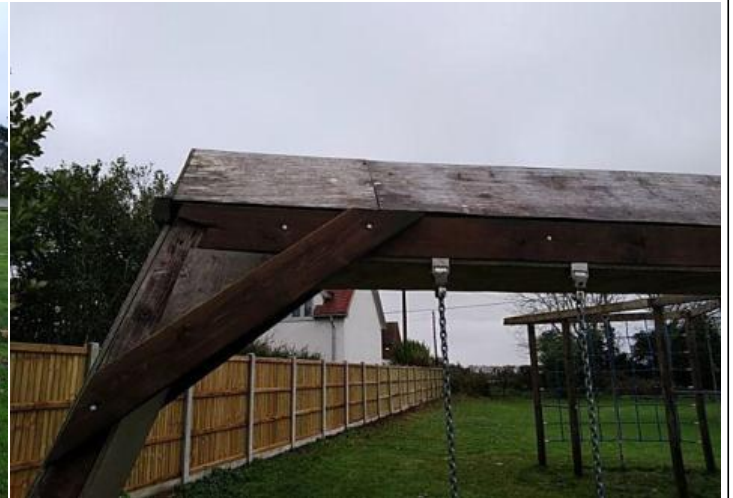
**Finding:** Sections of the unit have been encased and it is not possible to determine the condition of the timber within

**Action:** Create an inspection regime to inspect the internal components condition regularly

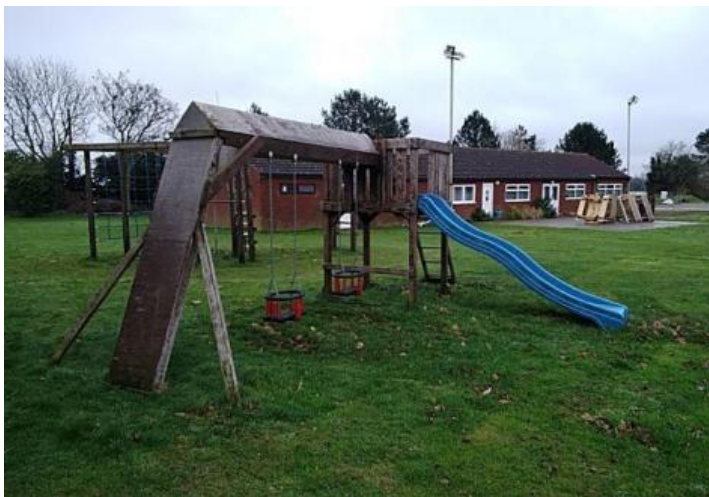
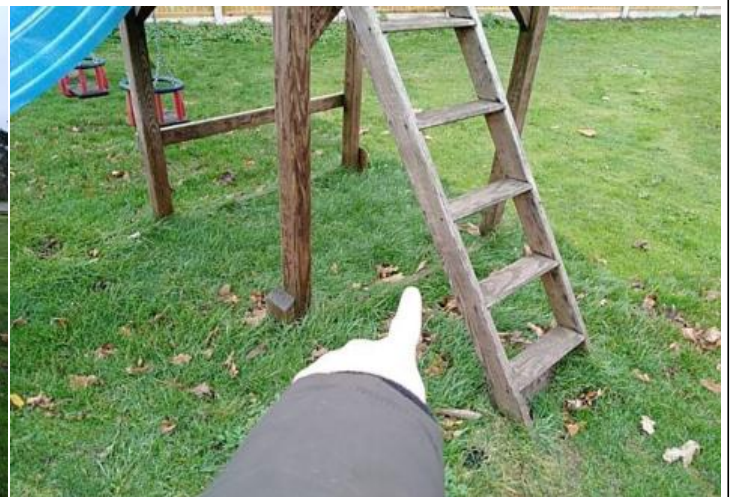
**Finding:** The lower framework forms a hard object within the falling space of the equipment in contravention of the requirements of BS EN 1176 Part 1

**Action:** Monitor - No remedial work recommended

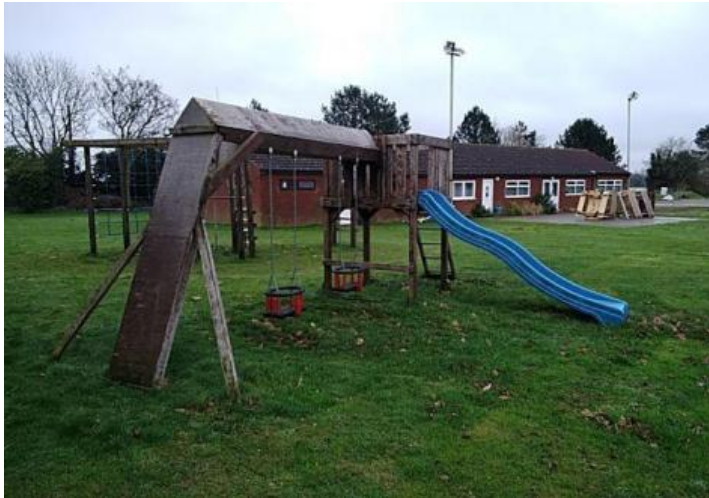
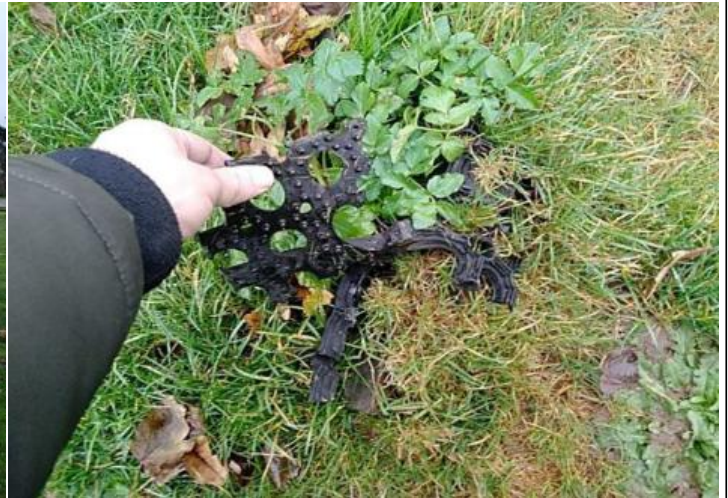
**Finding:** There are damaged sections of grass mass and there are trip hazards present

**Action:** Repair perimeter of surfacing to remove trip points

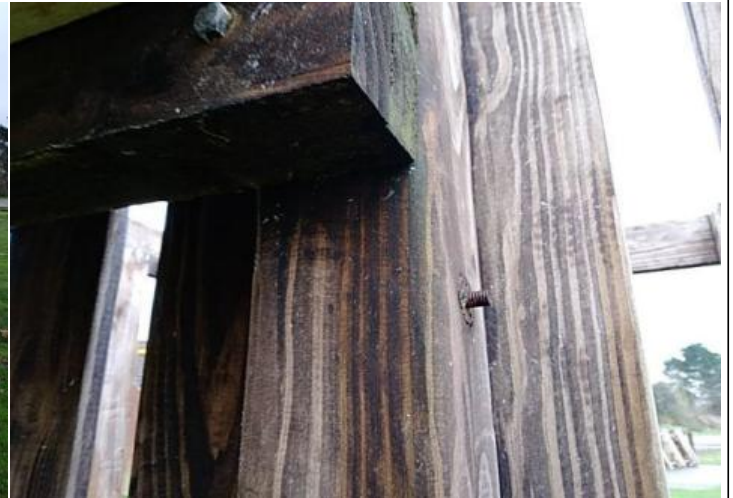
**Finding:** There are projecting bolt thread(s) present

**Action:** Remove excess thread length and deburr or provide cap
