## Annual Inspection

Knaptton Parish Council

Mundesley & District Recreation Association

## Mundesley & District Recreation Association

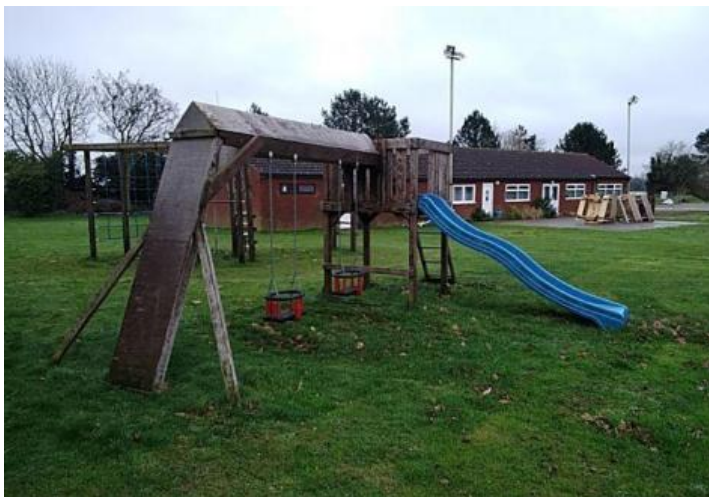
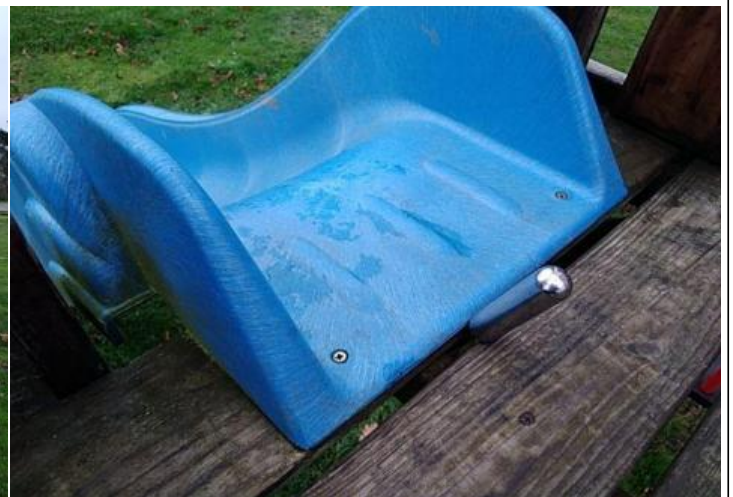
**Finding:** There is/are finger entrapment/s in the platform by the starting section of the slide and the item fails to meet the requirements of BS EN 1176 Part 1 4.2.7.6 Entrapment of fingers

**Action:** Monitor - No remedial work recommended

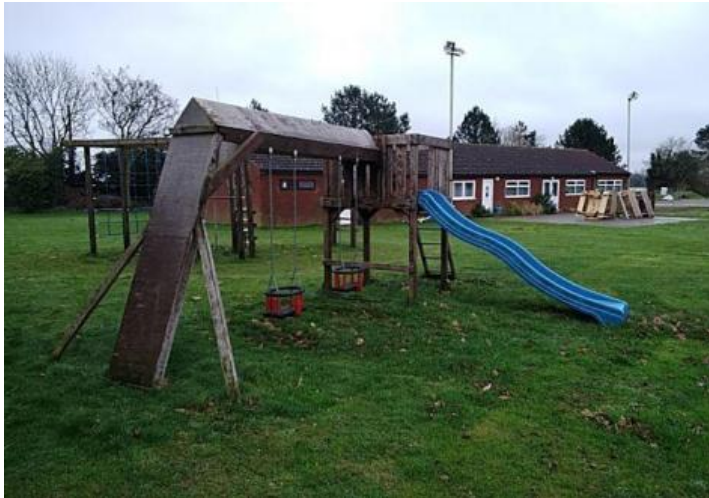
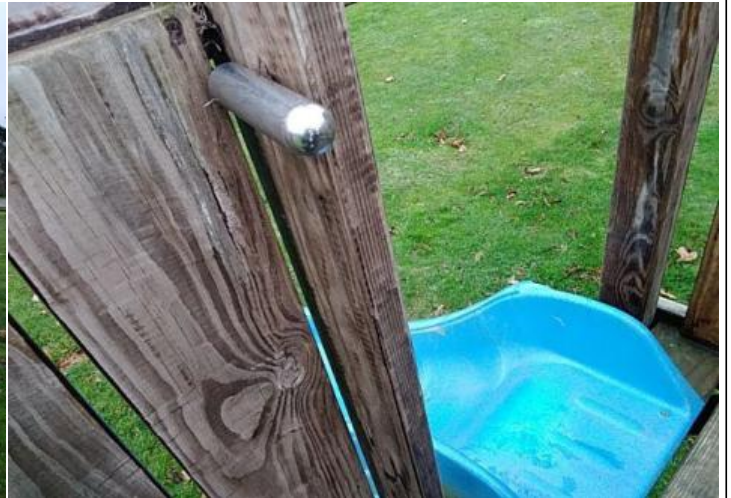
**Finding:** There is/are finger entrapment/s in the barrier by the starting section of the slide and the item fails to meet the requirements of BS EN 1176 Part 1 4.2.7.6 Entrapment of fingers

**Action:** Monitor - No remedial work recommended

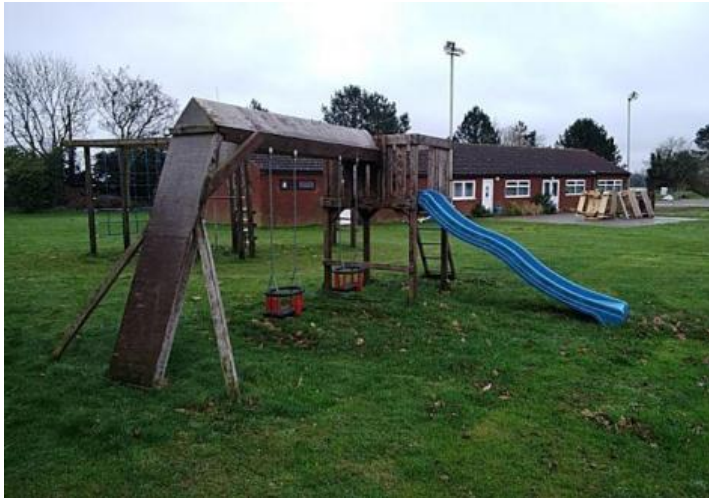
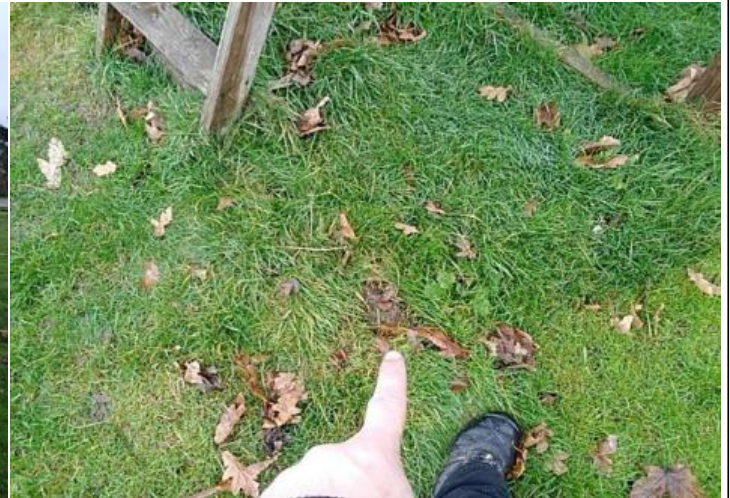
**Finding:** There is parts of the framework that is hidden by the surface and there are trip hazards present

**Action:** Reinstate surrounding surface levels to remove the trip points
