Post Installation Report

Knaption Parish Council

Mundesley & District Recreation Association

Hall Lane , Knaption, Walsham, NR28 0RZ

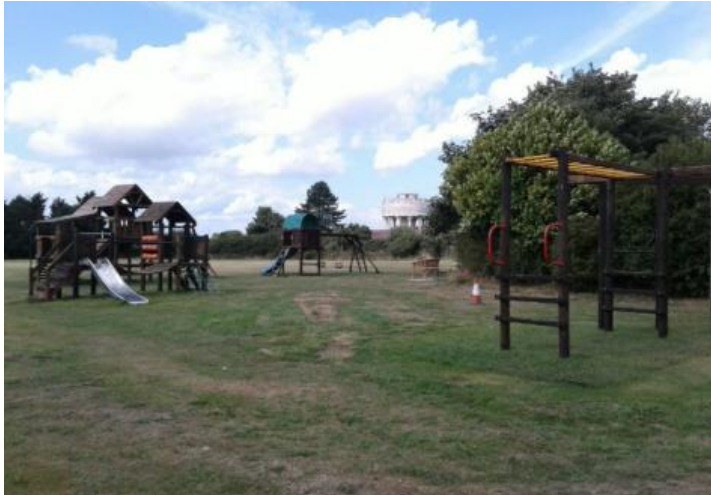
Item: Ancillary Items - Site General
Manufacturer: Owner/Operator

Finding: It is recommended that information signs with emergency contact details are installed at each entrance/exit set out in BS EN 1176 point to the playground
Action: Provide in accordance with the recommendations

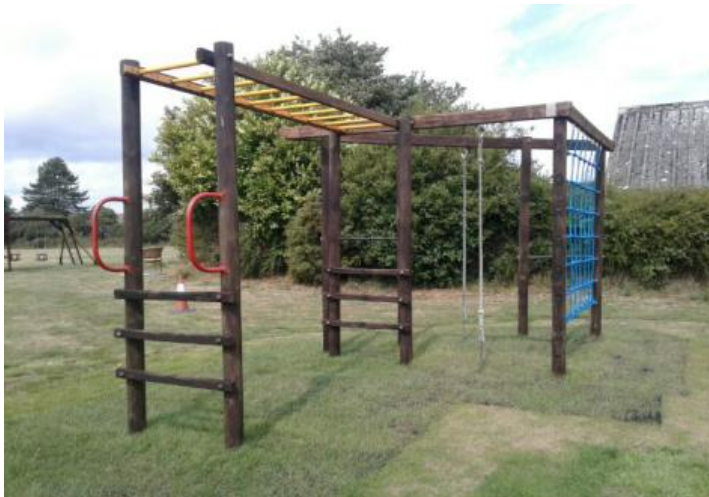
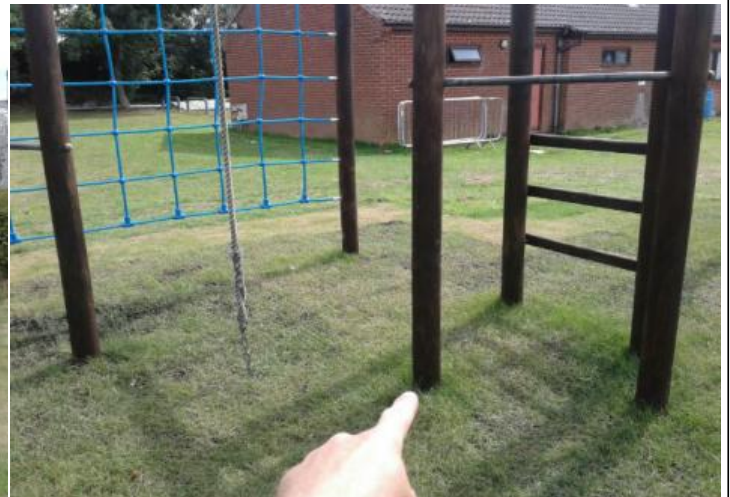
Item: Activity Equipment - Climbing Frame
Manufacturer: Not Identified

Finding: There are areas or parts of the timber on the structure that have rotted

Action: Replace all affected timbers

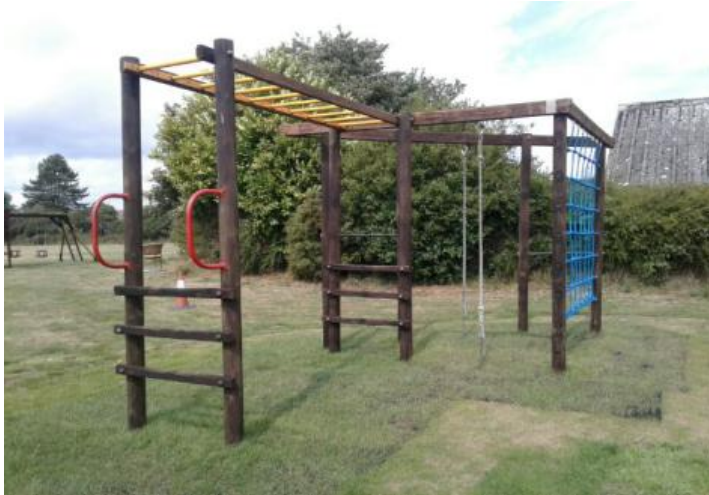
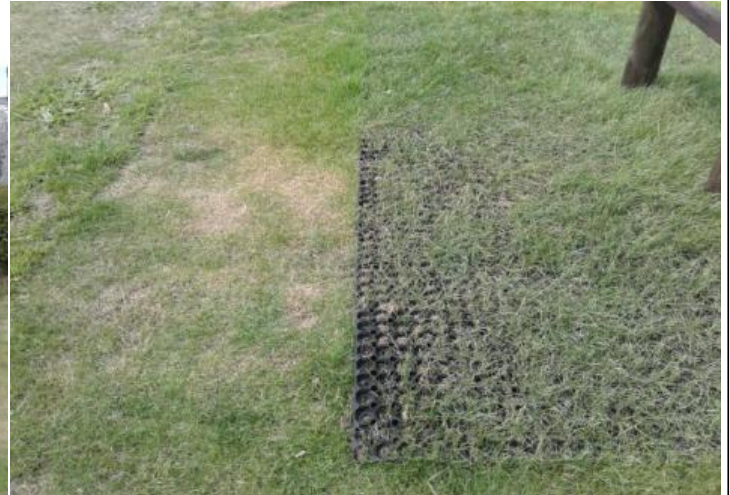
Item: Activity Equipment - Climbing Frame
Manufacturer: Not Identified

Finding: The edges of the grass mat surface have not been installed in accordance with the API Code of Practice
Action: Tuck in edges of grass mat to remove trip hazards

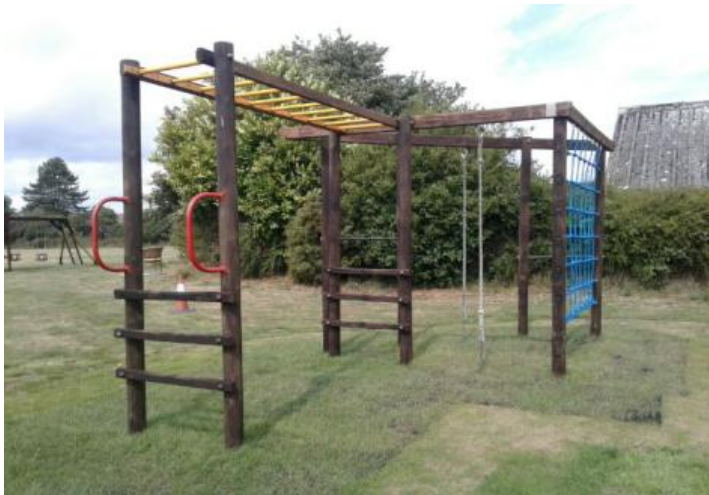
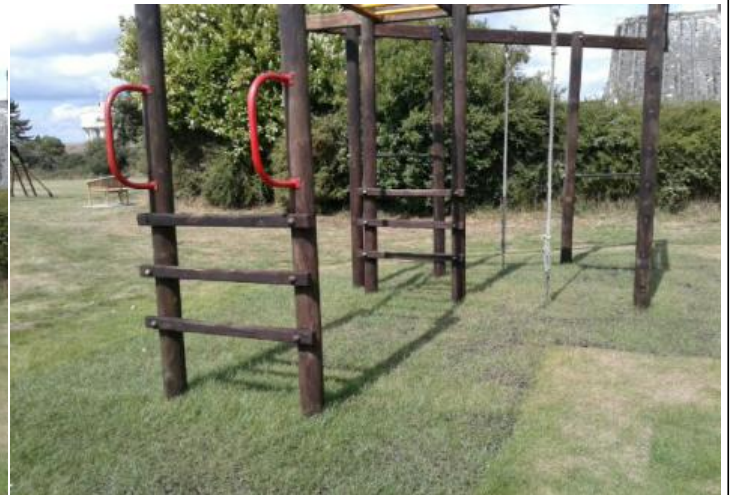
Item: Activity Equipment - Climbing Frame
Manufacturer: Not Identified

Finding: The item is slightly loose in its foundations
Action: Monitor for any further deterioration and repair as required

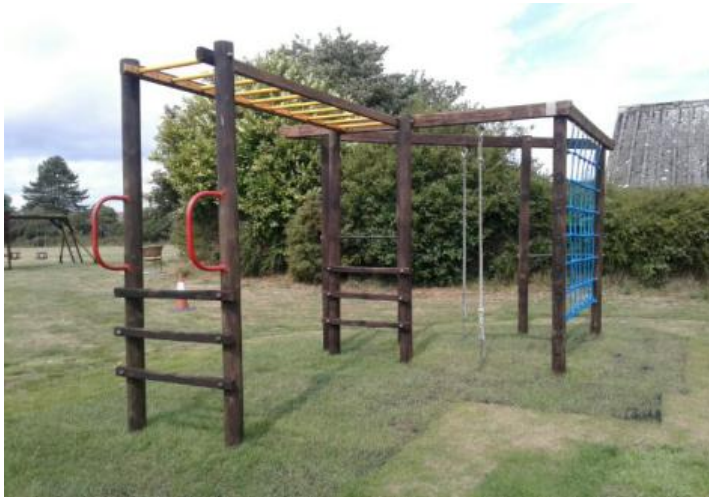
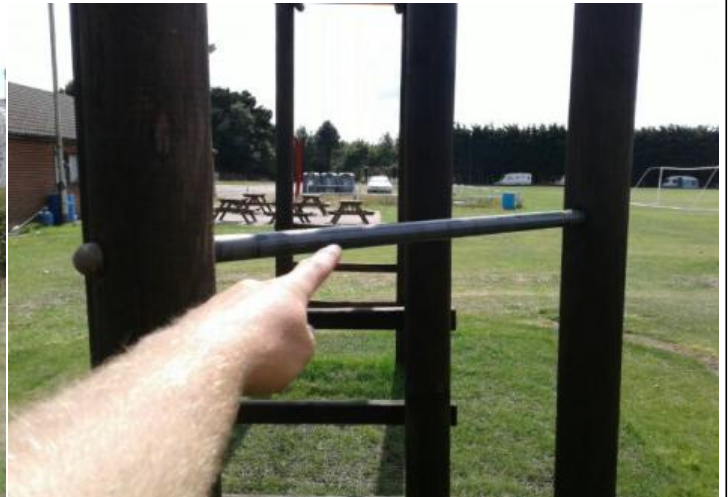
Item: Activity Equipment - Climbing Frame
Manufacturer: Not Identified

Finding: A number of fixing(s) have worked loose and the crossbeam rotates unexpectedly

Action: Secure all loose fixings

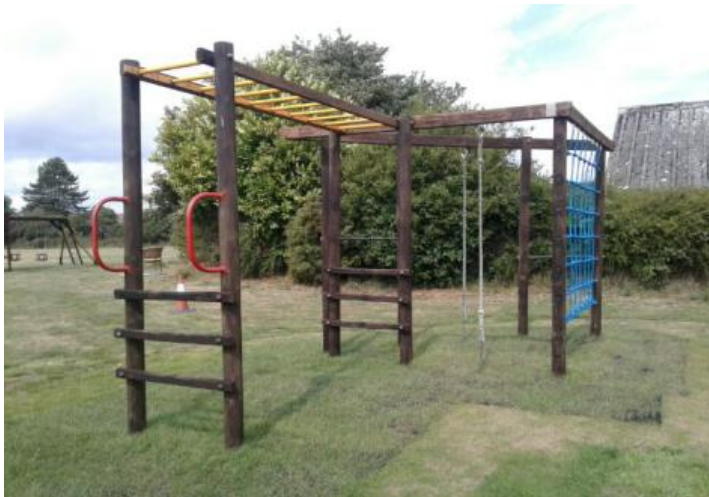
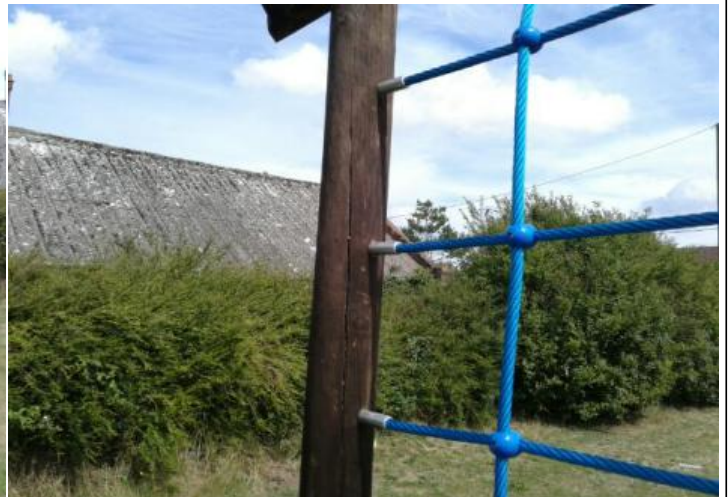
Item: Activity Equipment - Climbing Frame
Manufacturer: Not Identified

Finding: The timber has a number of splits/shakes or air cracks and this may affect the stability or allow water ingress which will accelerate the rotting process

Action: Monitor to ensure the splits do not cross through fixing points of the structure and/or cause any instability

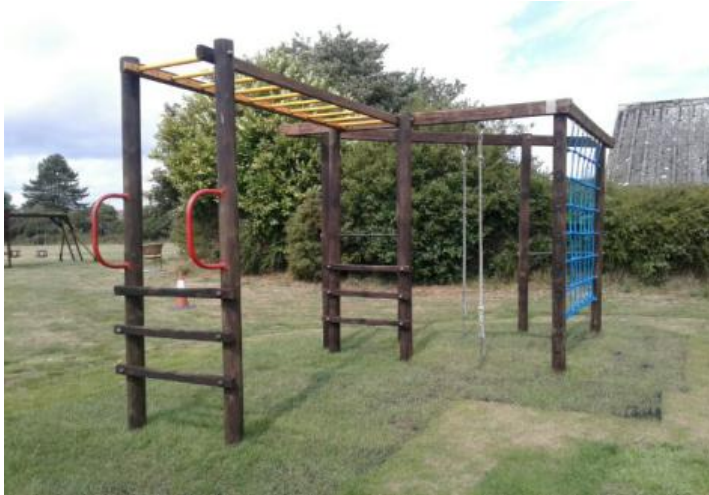
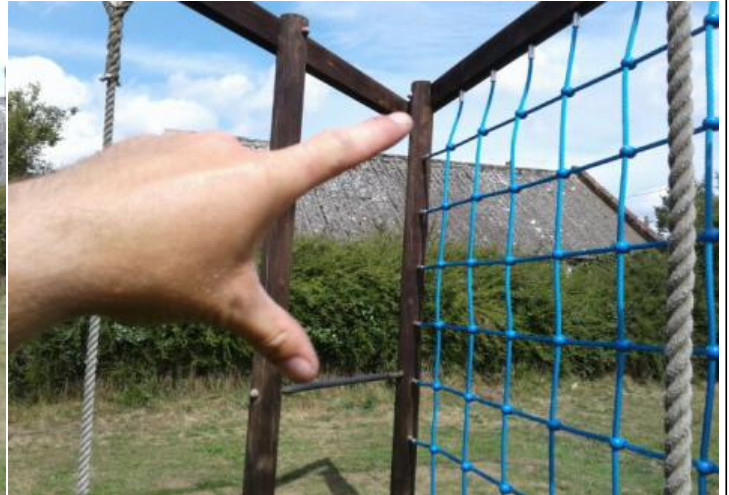
Item: Activity Equipment - Climbing Frame
Manufacturer: Not Identified

Finding: The crossbeam forms a hard object within the impact area of the equipment in contravention of the requirements of BS EN 1176 Part 1

Action: Monitor - No remedial work recommended

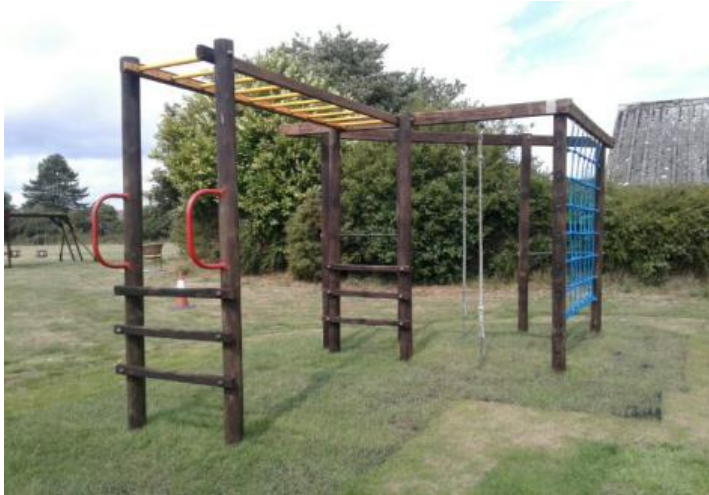
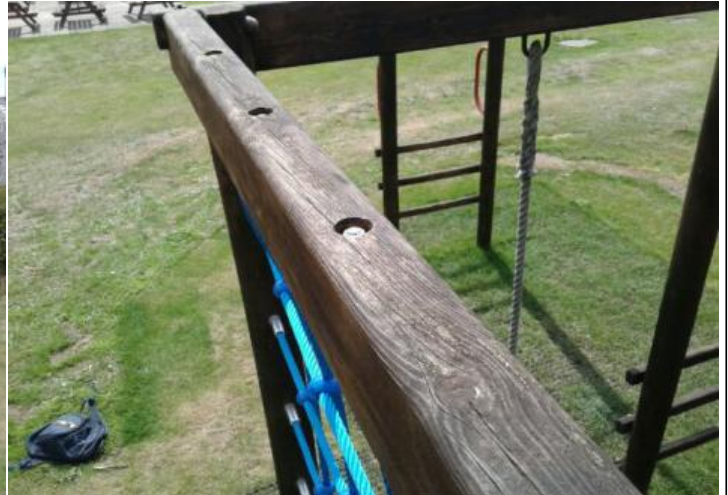
Item: Activity Equipment - Climbing Frame
Manufacturer: Not Identified

Finding: There is/are bolt cap covers missing or damaged on the item

Action: Replace missing or damaged bolt cap covers

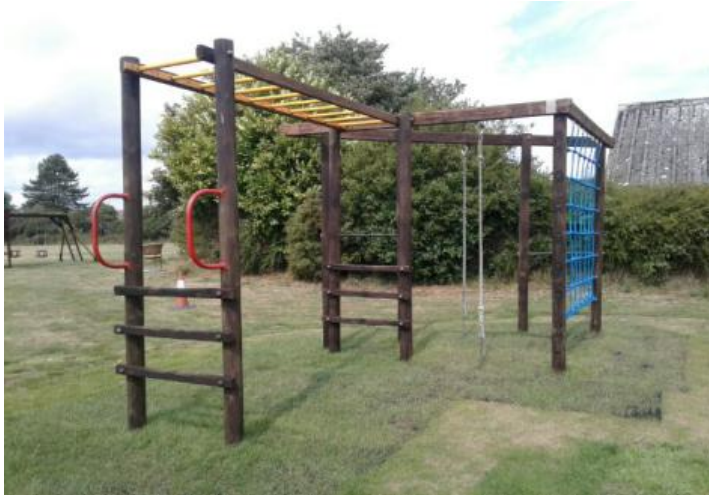
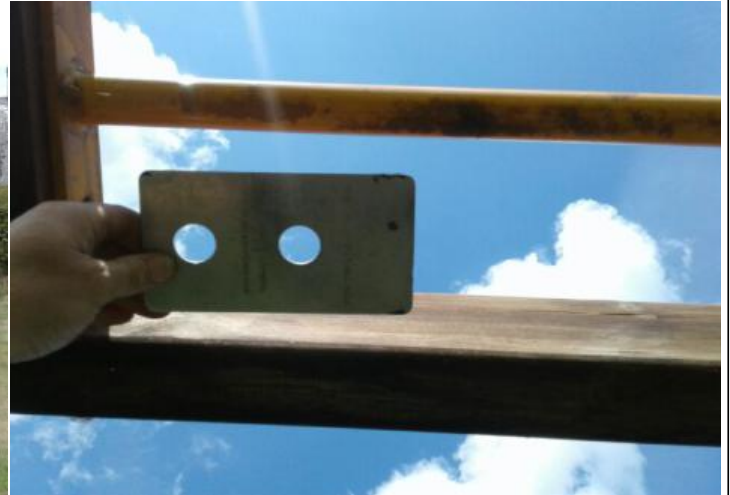
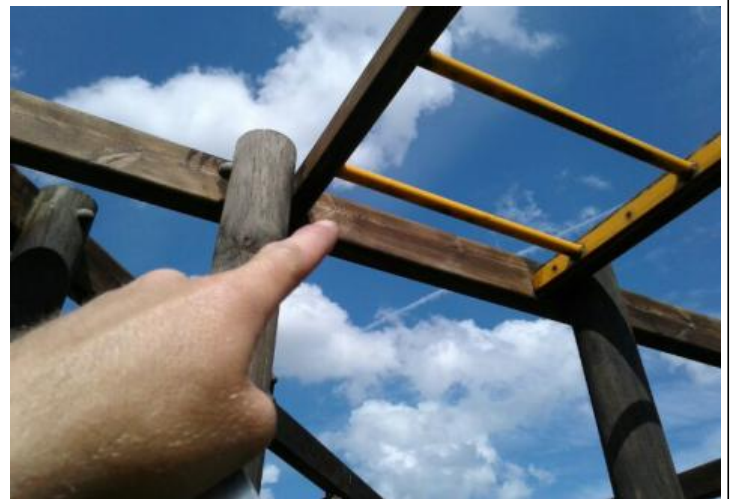
Item: Activity Equipment - Climbing Frame
Manufacturer: Not Identified

Finding: The item fails to meet the requirements of BS EN 1176 Part 1 4.2.7.2 for head and neck entrapment in the monkey bars

Action: Monitor - No remedial work recommended

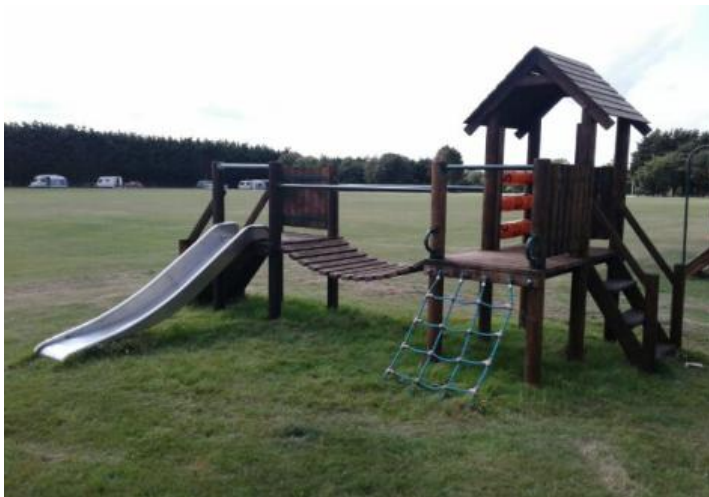
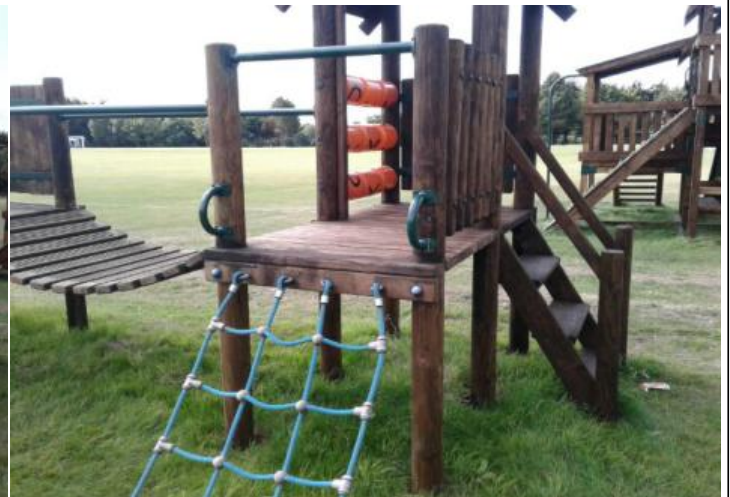
Item: Activity Equipment - Multi Play (Toddler)
Manufacturer: Adventure Playgrounds

Finding: There is an opening in the barriers exceeding the width allowed (500mm) in BS EN 1176, this is a low risk failure and no remedial action is required

Action: Monitor - No remedial work recommended

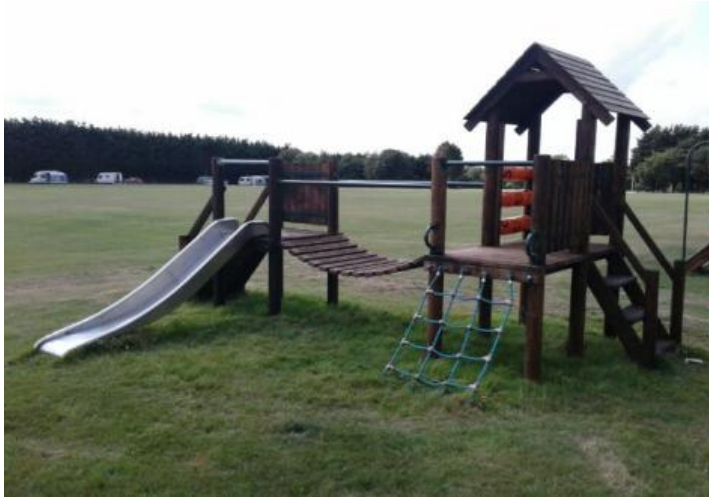
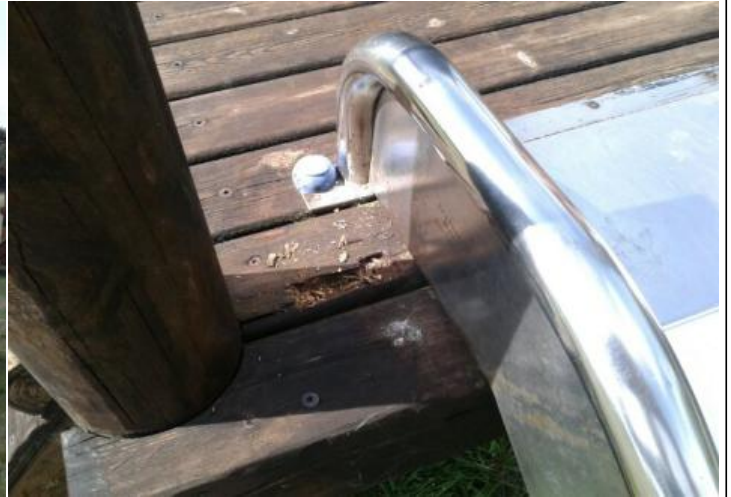
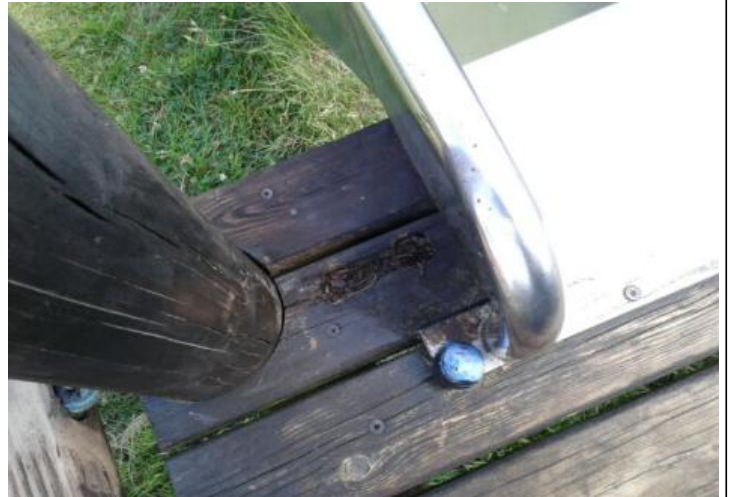
Item: Activity Equipment - Multi Play (Toddler)
Manufacturer: Adventure Playgrounds

Finding: There is some evidence of rot in the timber platform

Action: Monitor for any further deterioration and replace as required

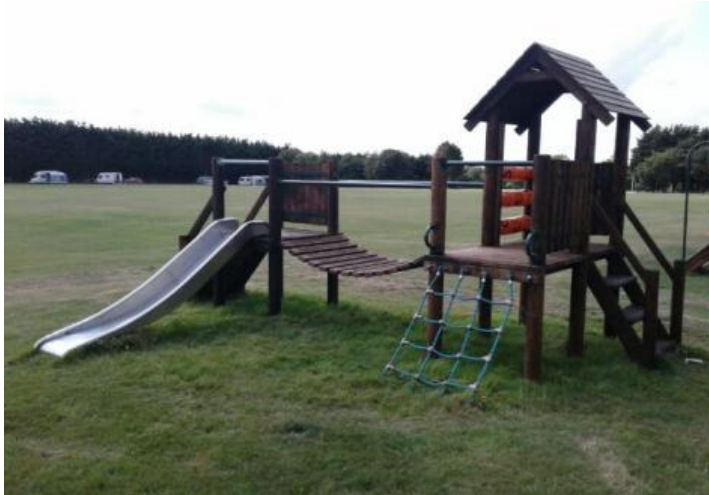
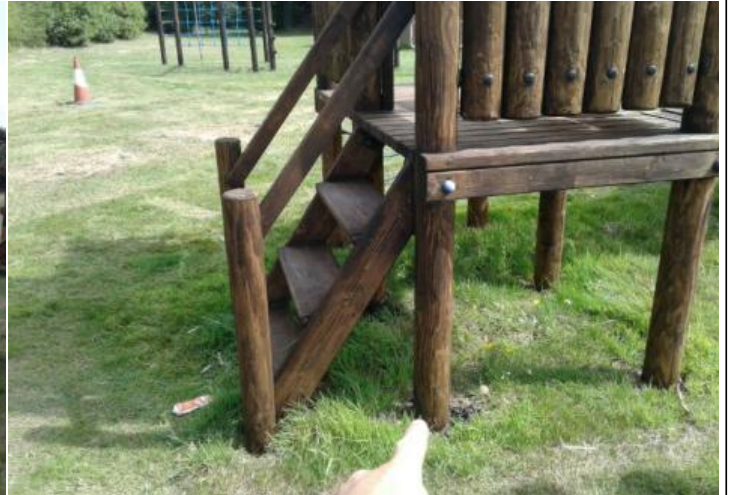
Item: Activity Equipment - Multi Play (Toddler)
Manufacturer: Adventure Playgrounds

Finding: The timber on this item has severe rot

Action: Remove and replace all affected timber sections

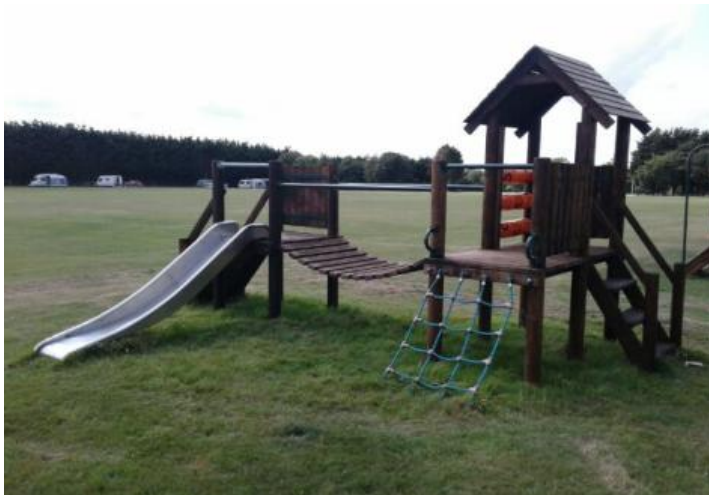
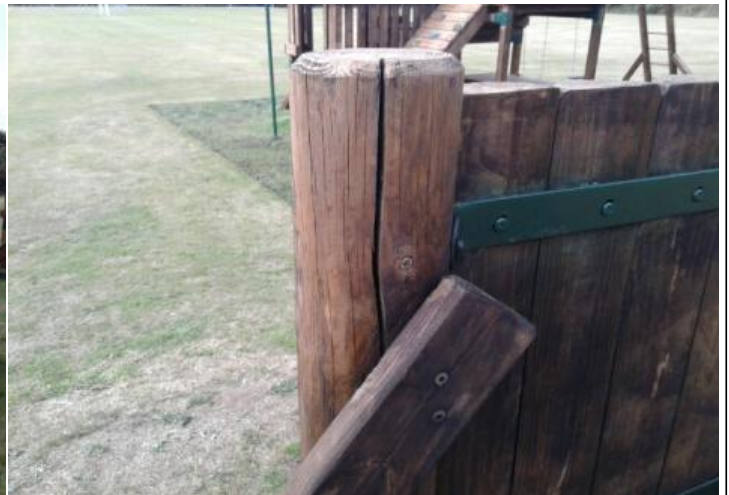
Item: Activity Equipment - Multi Play (Toddler)
Manufacturer: Adventure Playgrounds

Finding: The timber has a number of splits/shakes or air cracks and this may affect the stability or allow water ingress which will accelerate the rotting process

Action: Monitor to ensure the splits do not cross through fixing points of the structure and/or cause any instability

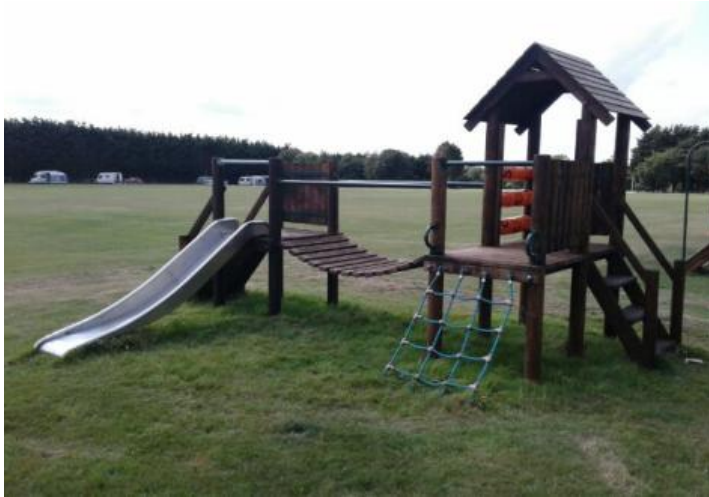
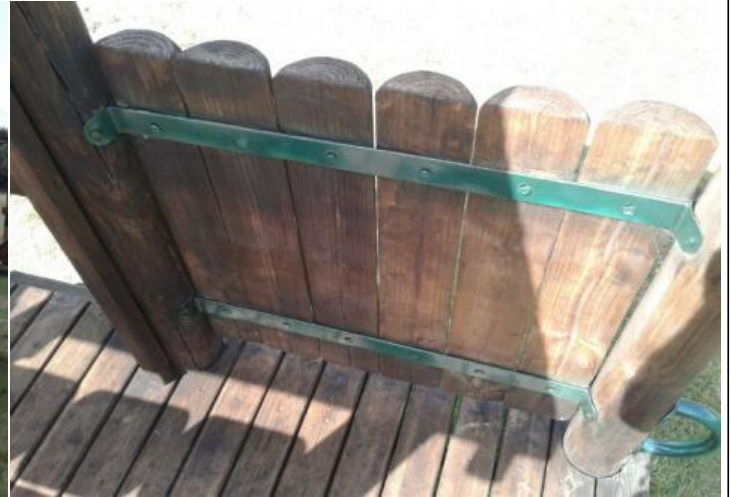
Item: Activity Equipment - Multi Play (Toddler)
Manufacturer: Adventure Playgrounds

Finding: A number of fixing(s) have worked loose on the barriers

Action: Secure all loose fixings

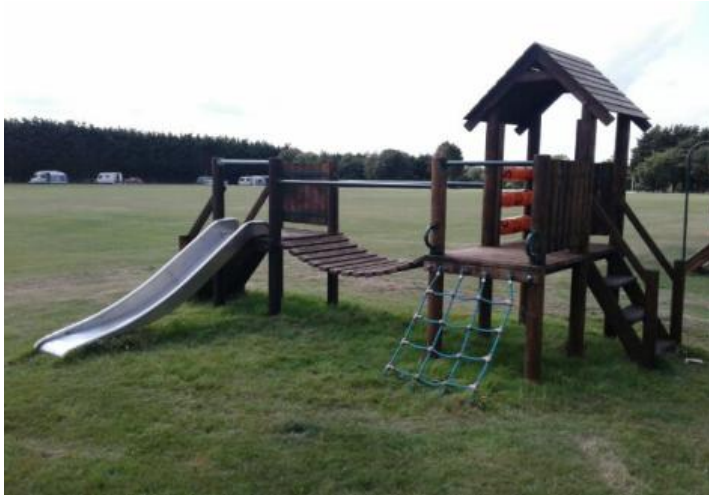
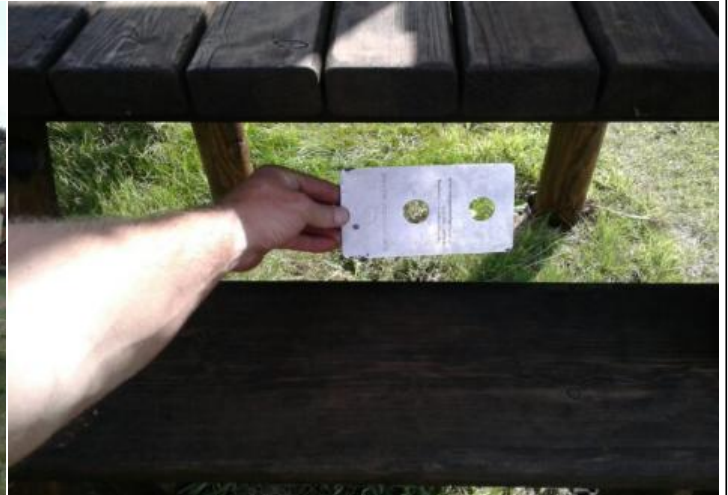
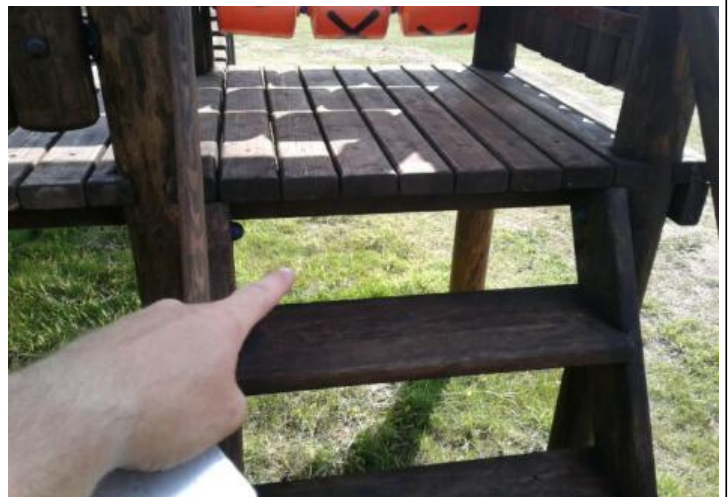
Item: Activity Equipment - Multi Play (Toddler)
Manufacturer: Adventure Playgrounds

Finding: The item fails to meet the requirements of BS EN 1176 Part 1 4.2.7.2 head and neck entrapment in the barriers and/or steps

Action: Monitor - No remedial work recommended

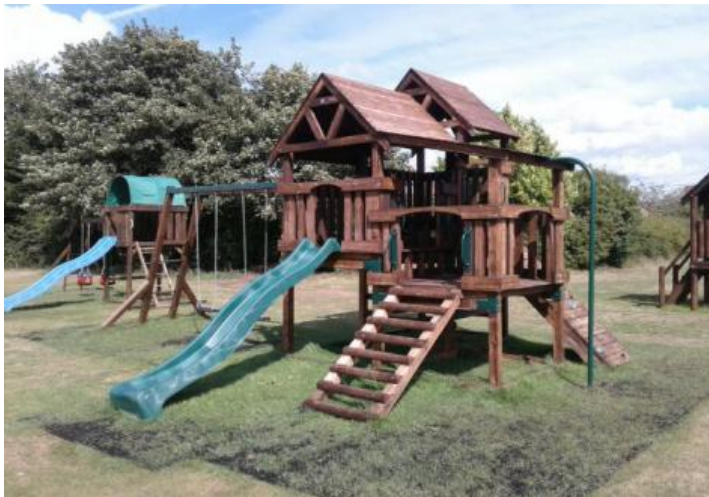
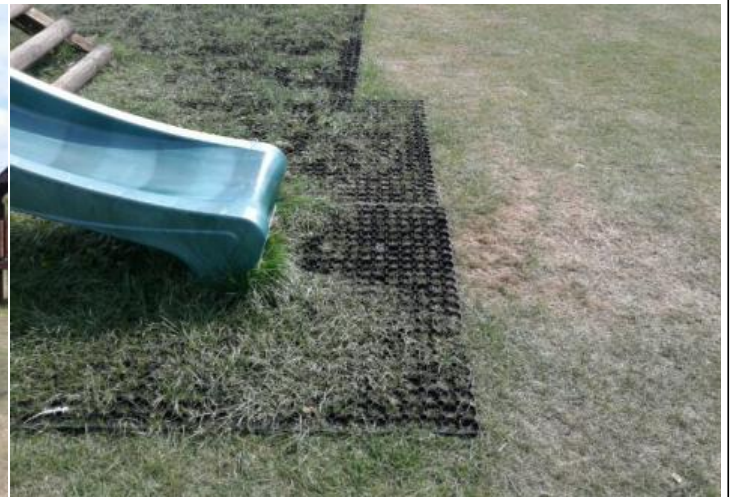
Item: Activity Equipment - Multi Play (Junior)
Manufacturer: Sovereign Leisure

Finding: The edges of the grass mat surface have not been installed in accordance with the API Code of Practice

Action: Tuck in edges of grass mat to remove trip hazards

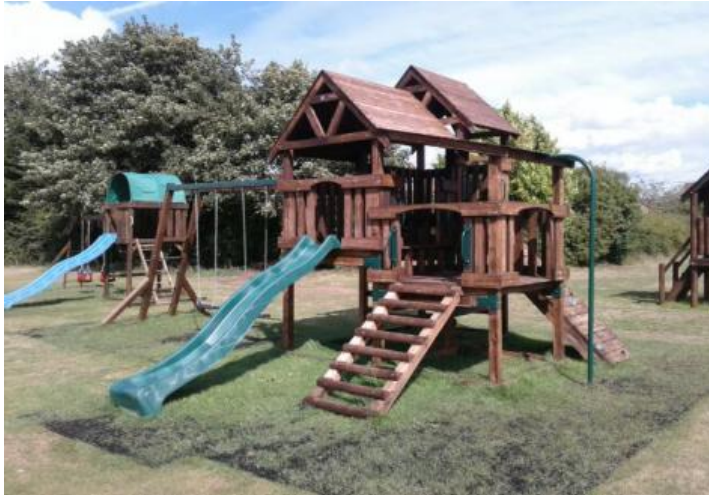
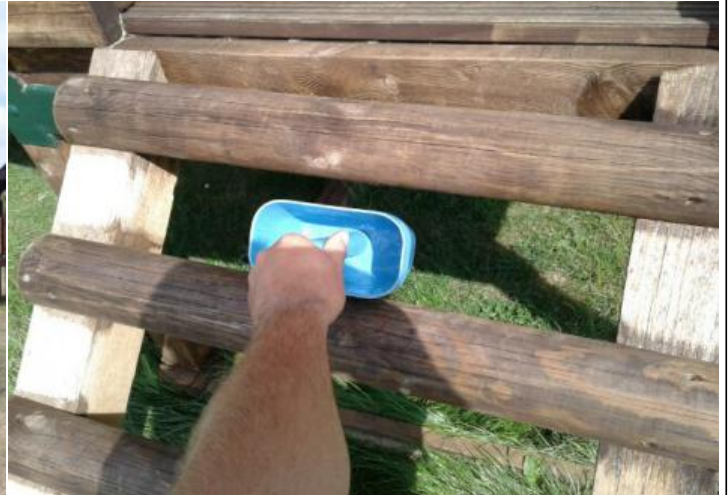
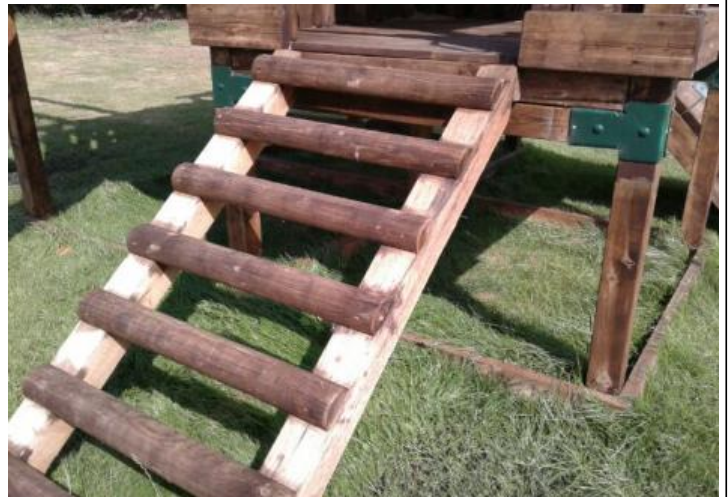
Item: Activity Equipment - Multi Play (Junior)
Manufacturer: Sovereign Leisure

Finding: The item fails to meet the requirements of BS EN 1176 Part 1 4.2.7.2 for head and neck entrapment in the access point

Action: Remove the entrapment

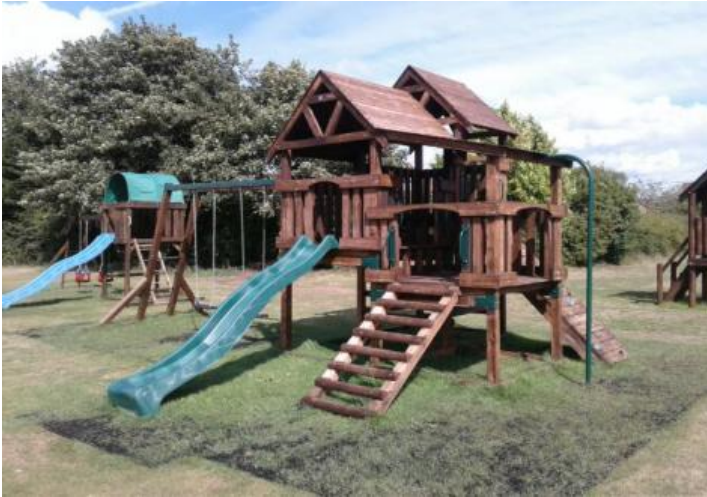
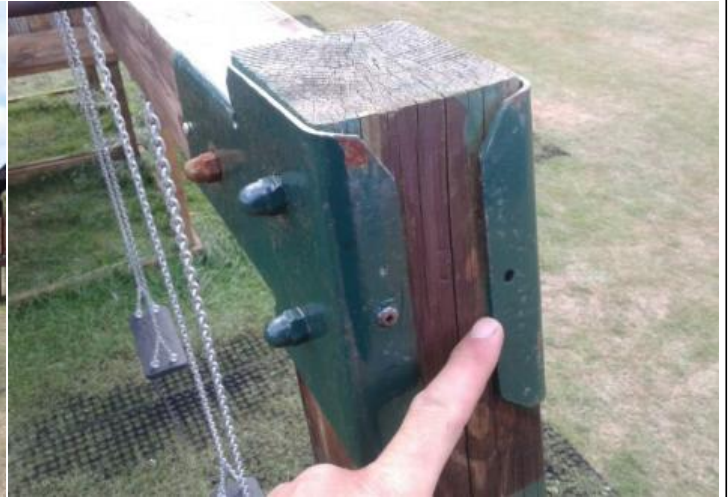
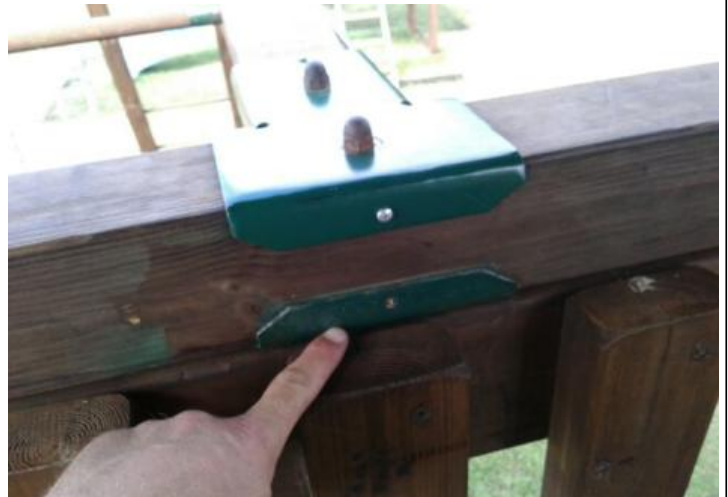
Item: Activity Equipment - Multi Play (Junior)
Manufacturer: Sovereign Leisure

Finding: There is or are fixings missing on the monkey bar connections

Action: Replace all missing fixings

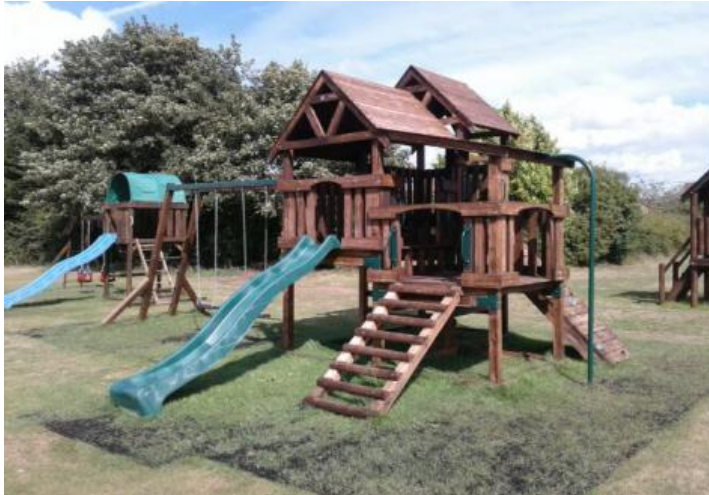
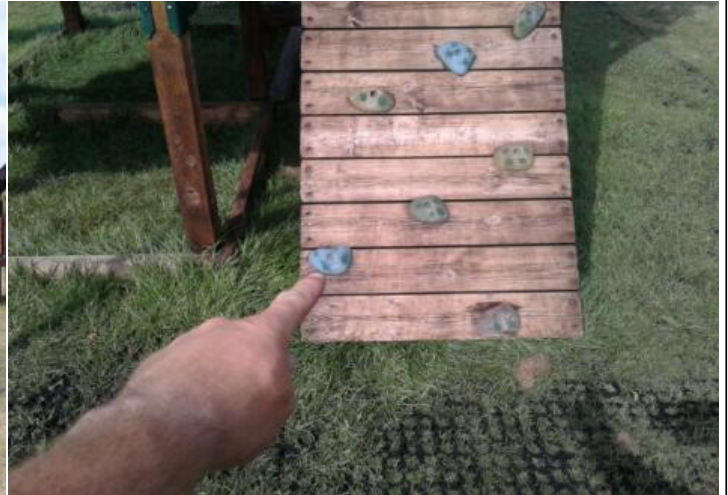
Item: Activity Equipment - Multi Play (Junior)
Manufacturer: Sovereign Leisure

Finding: A number of fixing(s) have worked loose on the ramp grips

Action: Secure all loose fixings

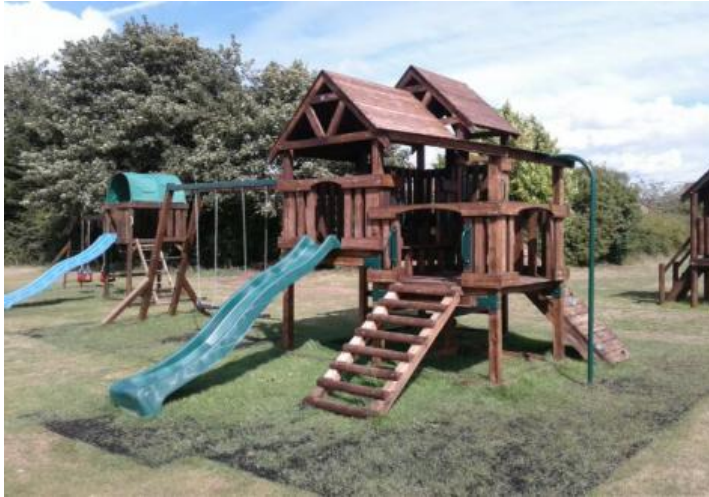
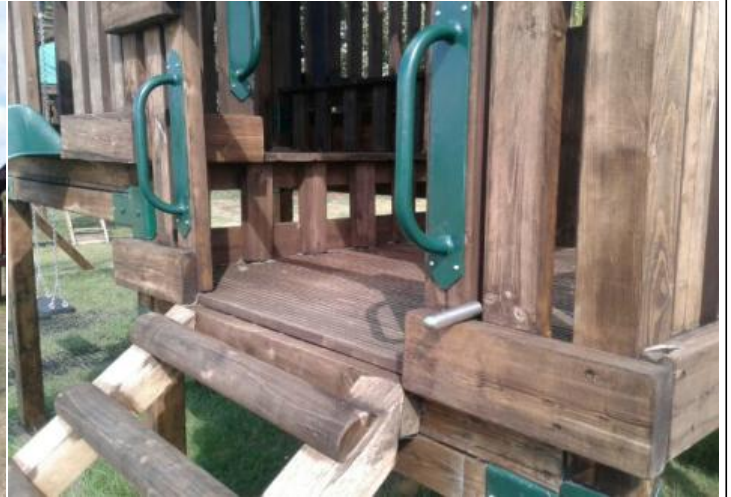
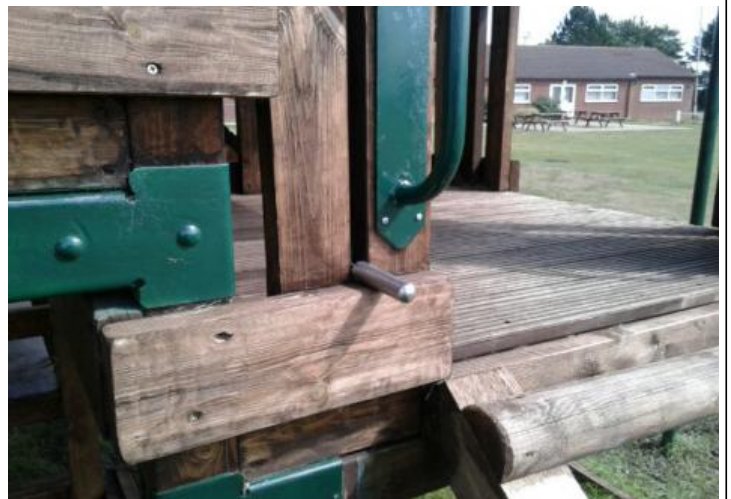
Item: Activity Equipment - Multi Play (Junior)
Manufacturer: Sovereign Leisure

Finding: There is/are finger entrapment/s in the barriers and the item fails to meet the requirements of BS EN 1176 Part 1 4.2.7.6 Entrapment of fingers **Action:** Remove the entrapment

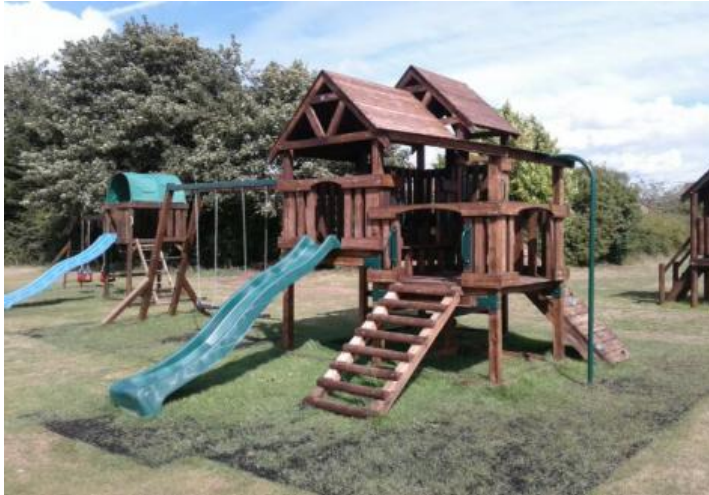
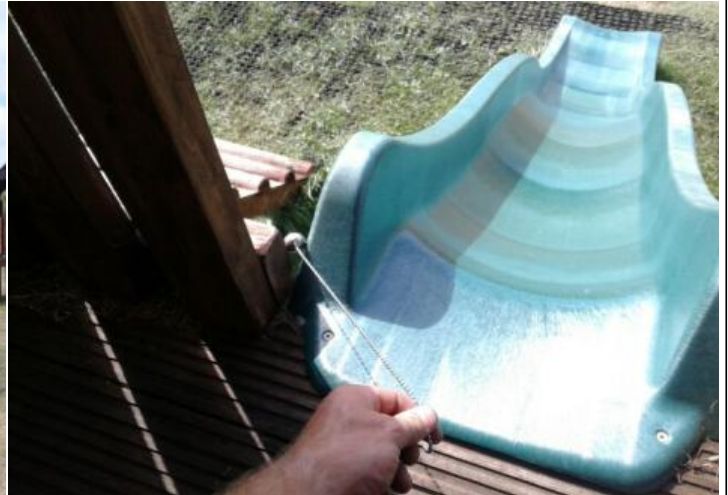
Item: Activity Equipment - Multi Play (Junior)
Manufacturer: Sovereign Leisure

Finding: There is a toggle entrapment at the top of the slide, in contravention of the recommendations set out in BS EN 1176 Part 3
Action: Remove the entrapment

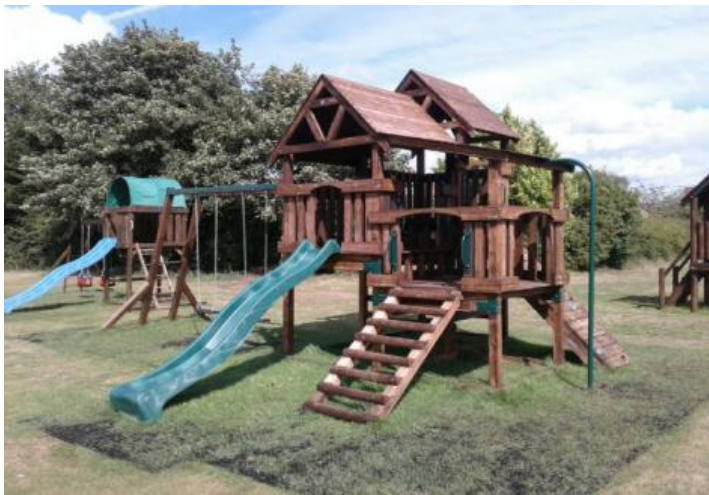
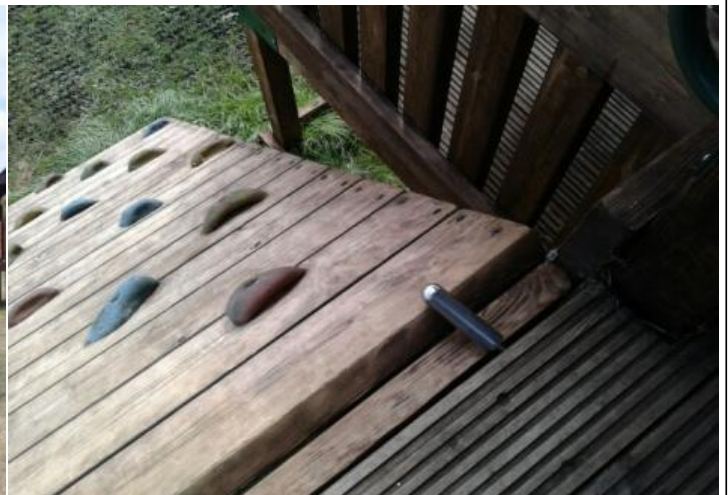
Item: Activity Equipment - Multi Play (Junior)
Manufacturer: Sovereign Leisure

Finding: There is/are finger entrapment/s in the top of the ramp and the item fails to meet the requirements of BS EN 1176 Part 1 4.2.7.6 Entrapment of fingers
Action: Remove the entrapment

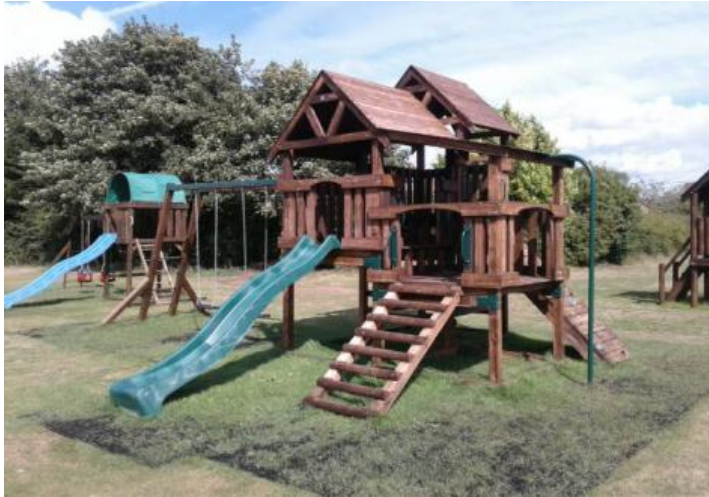
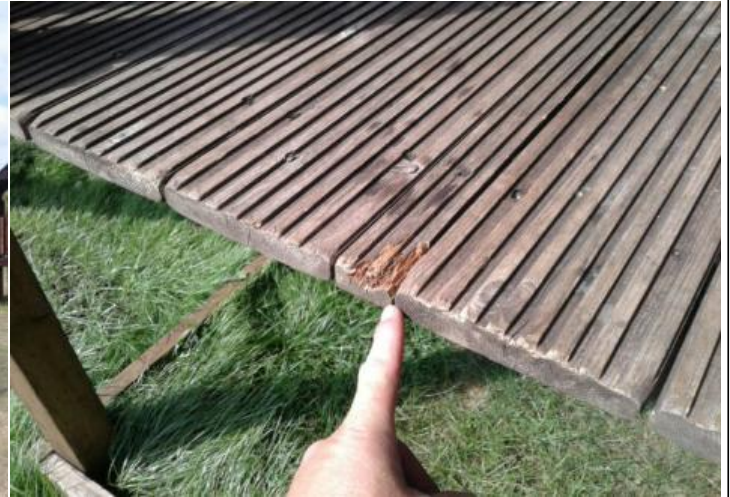
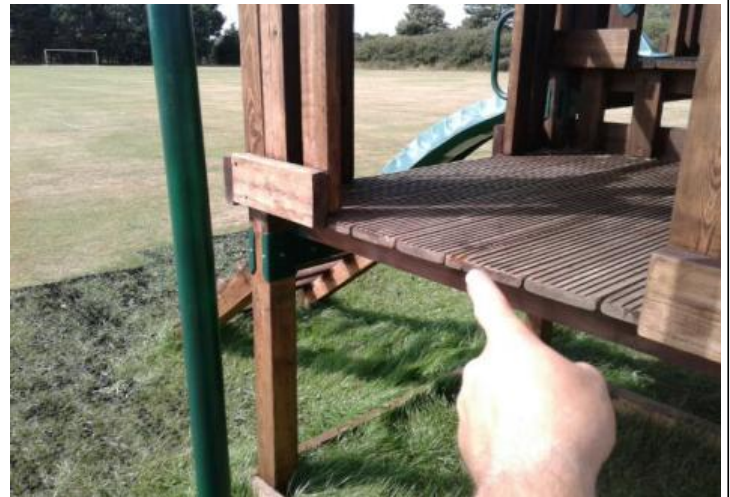
Item: Activity Equipment - Multi Play (Junior)
Manufacturer: Sovereign Leisure

Finding: There is some evidence of rot in the timber

Action: Monitor for any further deterioration and replace as required

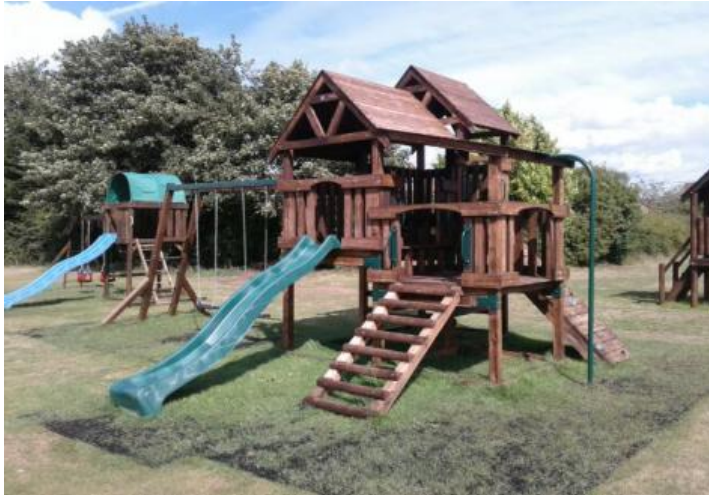
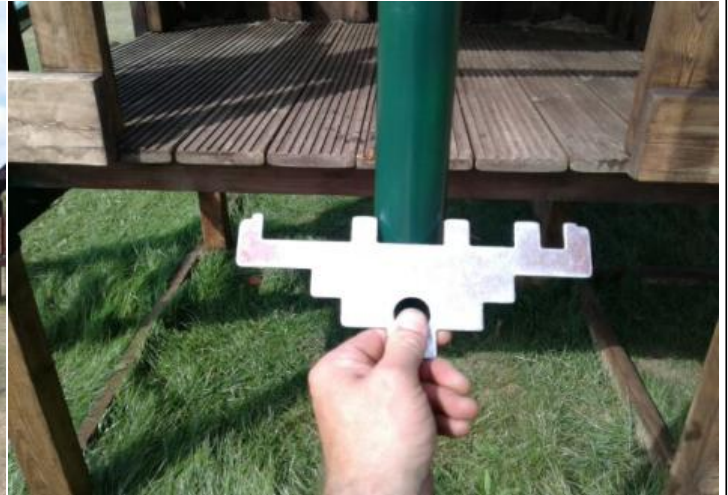
Item: Activity Equipment - Multi Play (Junior)
Manufacturer: Sovereign Leisure

Finding: The firemans pole fails the grip requirements (16mm-45mm) of BS EN 1176 Part 1

Action: Refer to the manufacturer

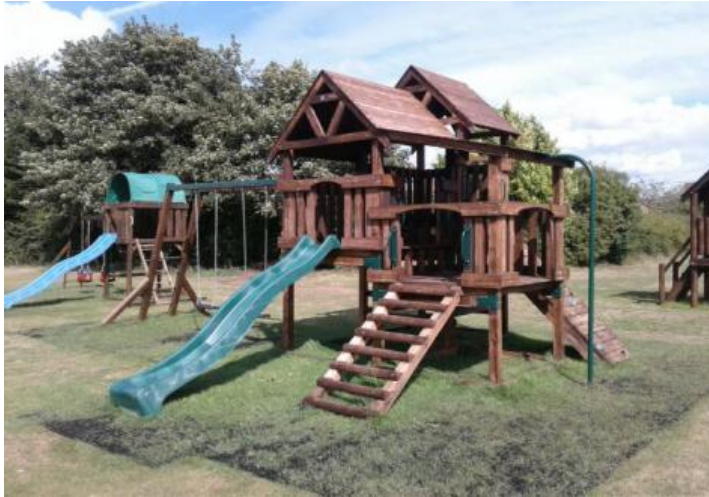
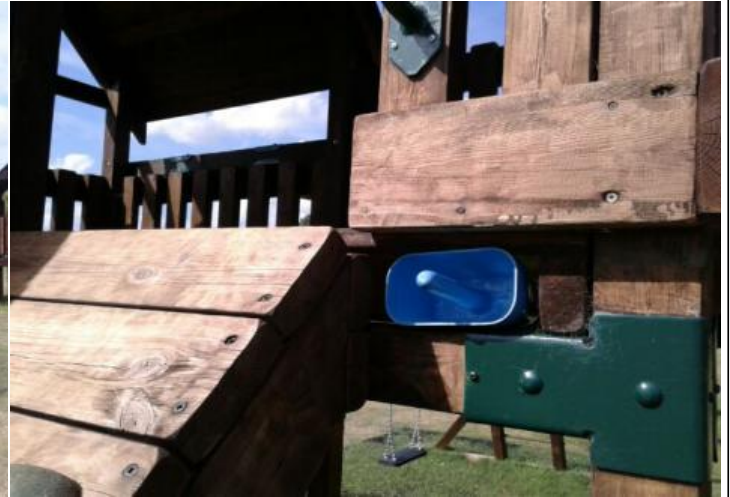
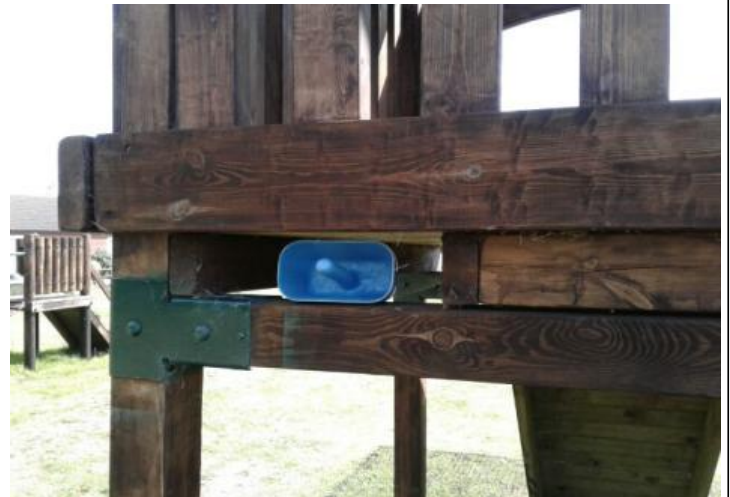
Item: Activity Equipment - Multi Play (Junior)
Manufacturer: Sovereign Leisure

Finding: The item fails to meet the requirements of BS EN 1176 Part 1 4.2.7.2 for head and neck entrapment in the framework beneath the platform

Action: Remove the entrapment

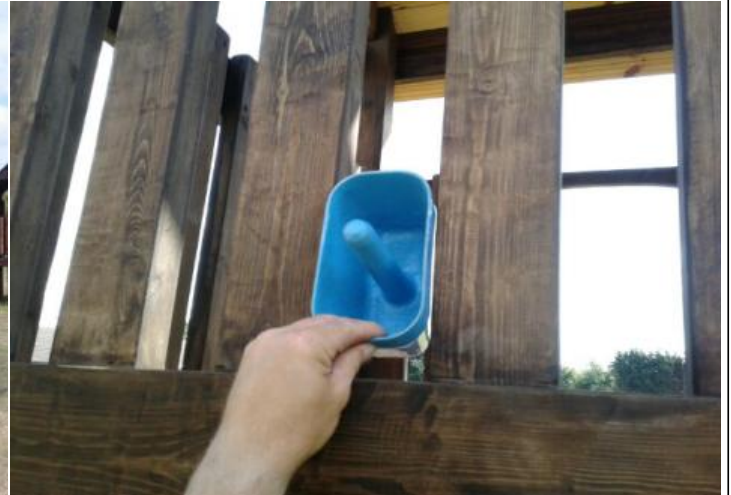
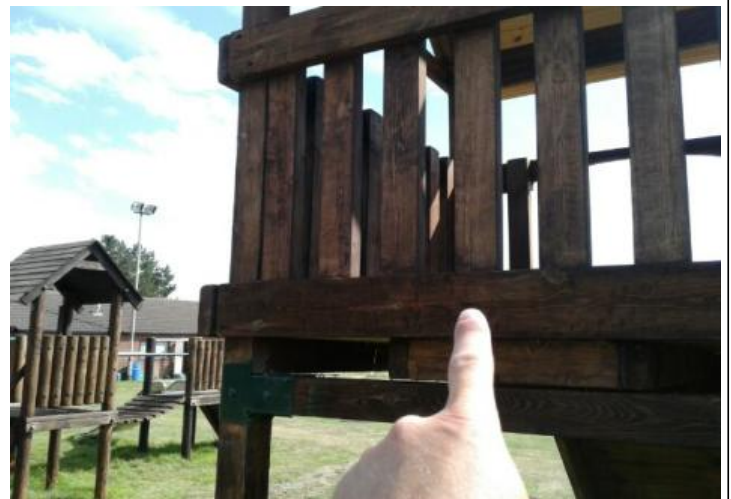
Item: Activity Equipment - Multi Play (Junior)
Manufacturer: Sovereign Leisure

Finding: The item fails to meet the requirements of BS EN 1176 Part 1 4.2.7.2 for head and neck entrapment in the barrier

Action: Remove the entrapment
