Post Installation Report

Knaption Parish Council

Mundesley & District Recreation Association

Hall Lane , Knaption, Walsham, NR28 0RZ

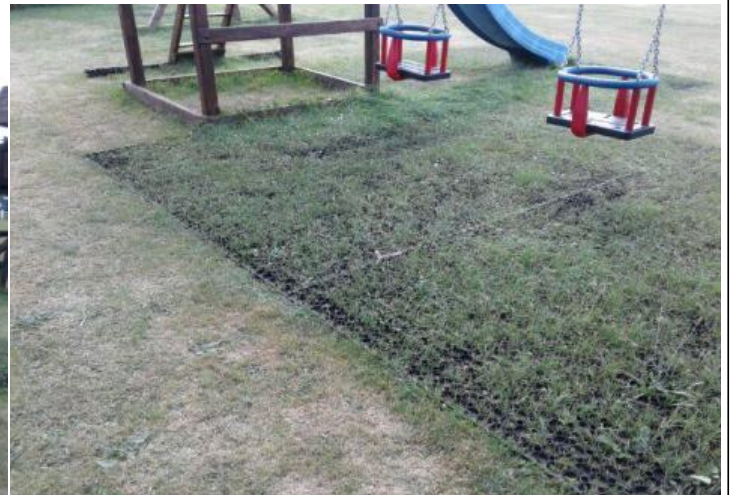
Item: Activity Equipment - Multi Play (Toddler)
Manufacturer: Not Identified

Finding: The edges of the grass mat surface have not been installed in accordance with the API Code of Practice

Action: Tuck in edges of grass mat to remove trip hazards

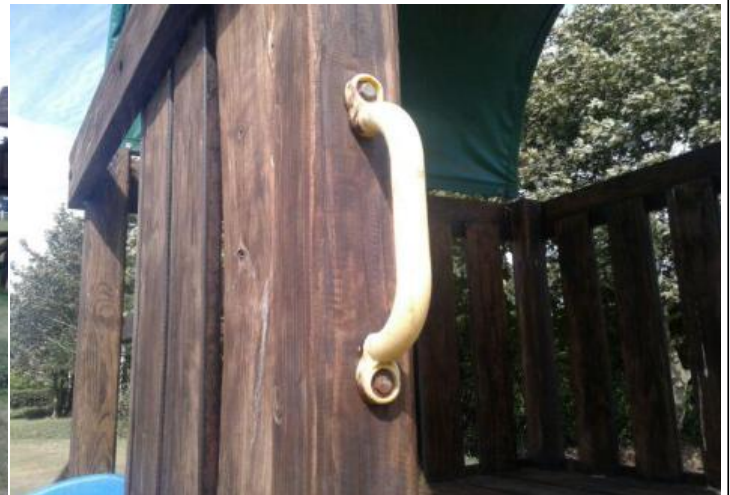
Item: Activity Equipment - Multi Play (Toddler)
Manufacturer: Not Identified

Finding: There is/are bolt cap covers missing or damaged on the item

Action: Replace missing or damaged bolt cap covers

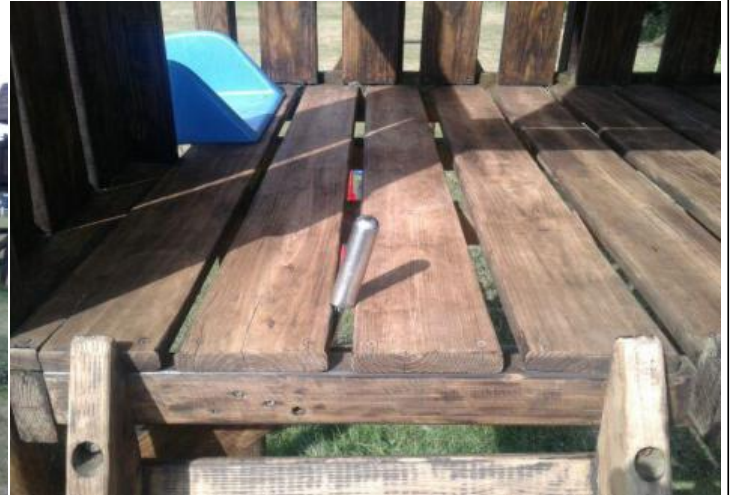
Item: Activity Equipment - Multi Play (Toddler)
Manufacturer: Not Identified

Finding: There is/are finger entrapment/s in the platforms and the item fails to meet the requirements of BS EN 1176 Part 1 4.2.7.6 Entrapment of fingers

Action: Remove the entrapment

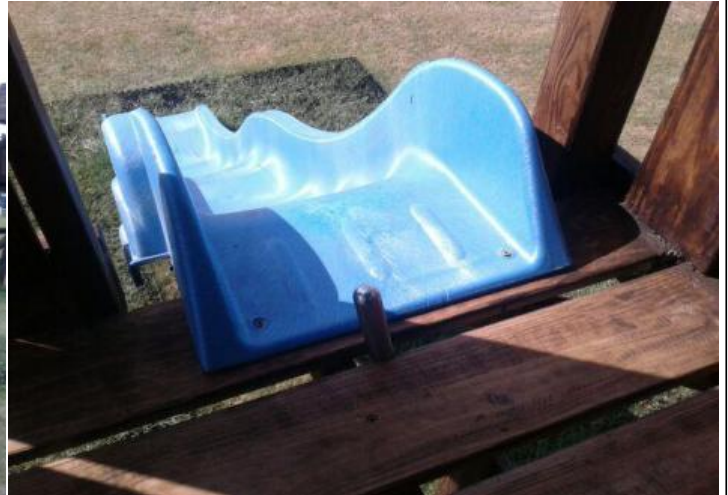
Item: Activity Equipment - Multi Play (Toddler)
Manufacturer: Not Identified

Finding: There is/are finger entrapment/s in the platform and the item fails to meet the requirements of BS EN 1176 Part 1 4.2.7.6 Entrapment of fingers

Action: Remove the entrapment

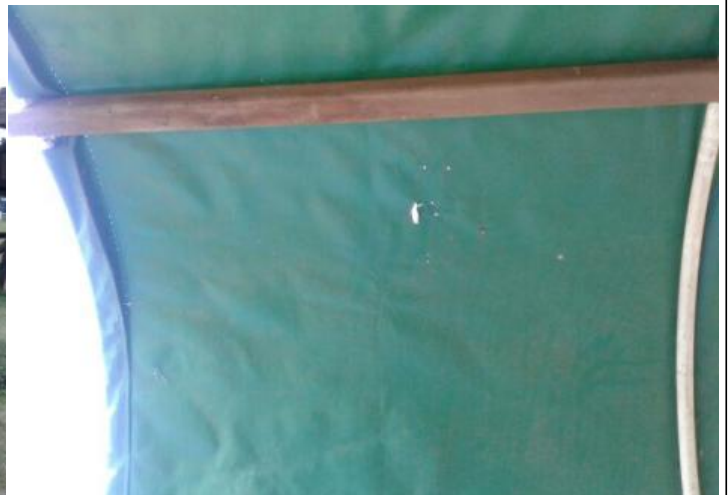
Item: Activity Equipment - Multi Play (Toddler)
Manufacturer: Not Identified

Finding: There is minor damage to the roof

Action: Monitor for any further deterioration and replace as required

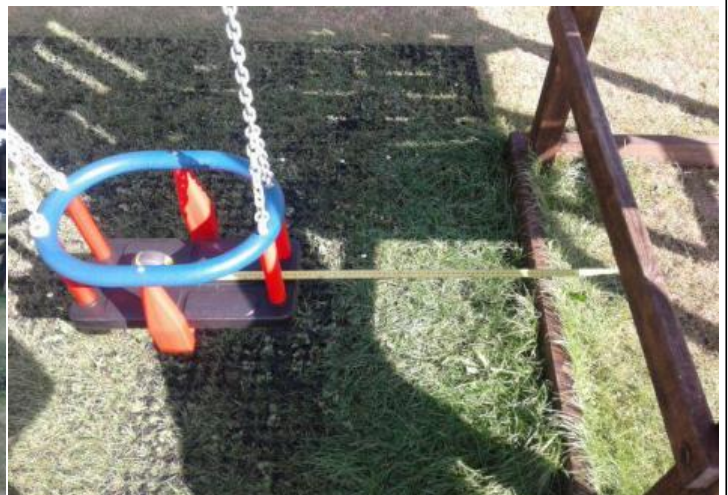
Item: Activity Equipment - Multi Play (Toddler)
Manufacturer: Not Identified

Finding: The surfacing width under each seat is less than 1.75 metres and fails the requirements of BS EN 1176 Part 2

Action: Refer to the manufacturer

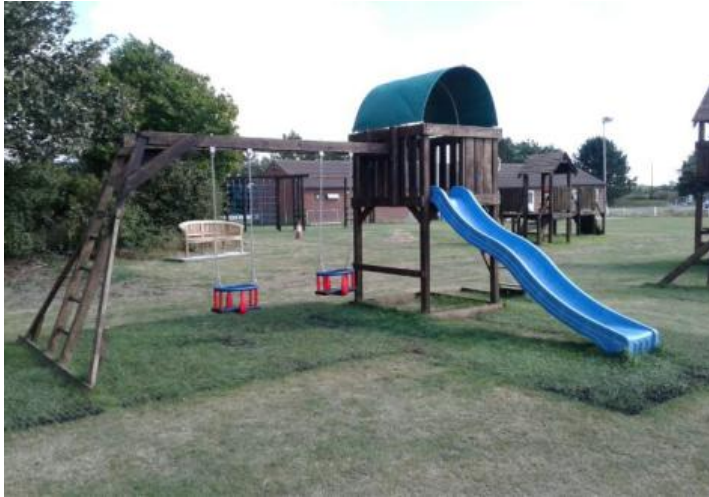
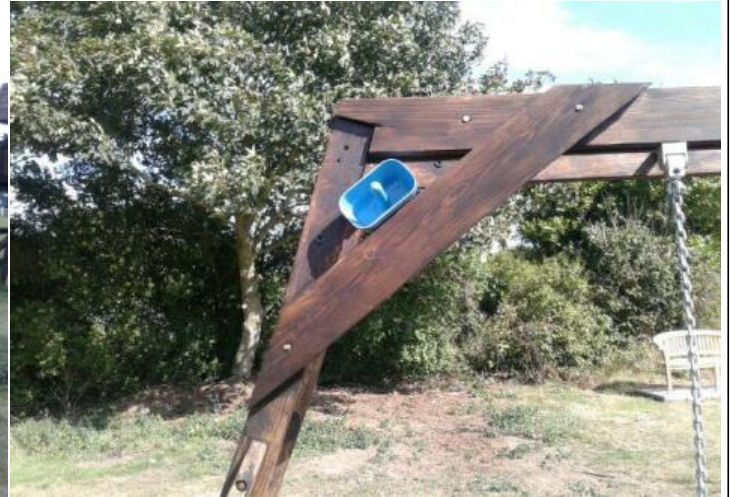
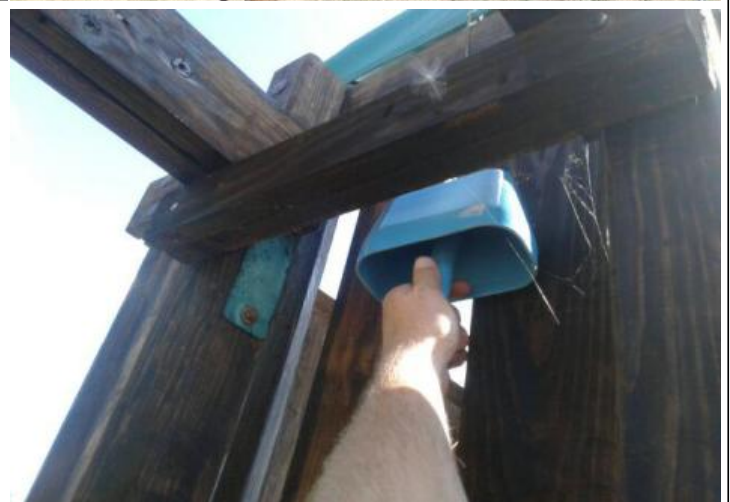
Item: Activity Equipment - Multi Play (Toddler)
Manufacturer: Not Identified

Finding: The item fails to meet the requirements of BS EN 1176 Part 1 4.2.7.2 for head and neck entrapment in the monkey bar framework

Action: Remove the entrapment

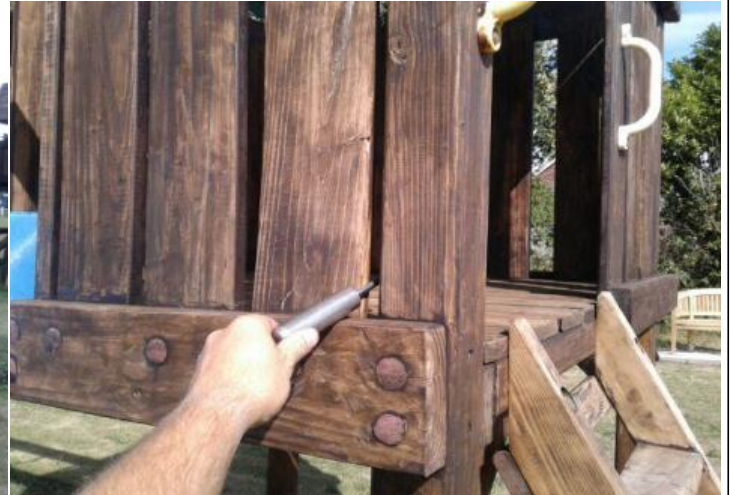
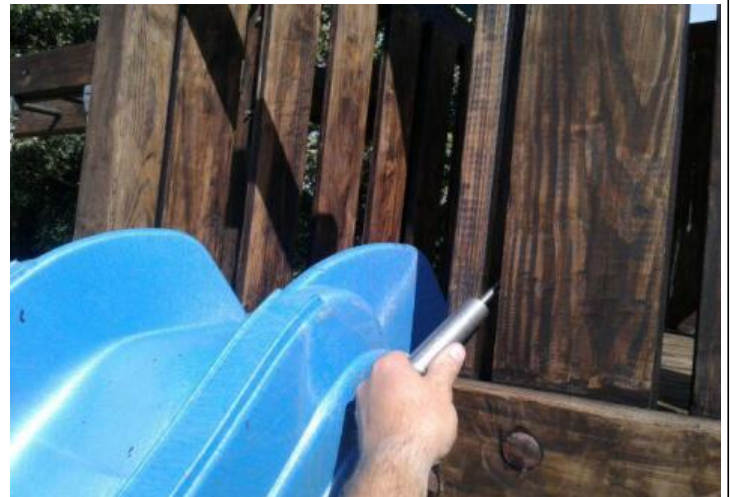
Item: Activity Equipment - Multi Play (Toddler)
Manufacturer: Not Identified

Finding: There is/are finger entrapment/s in the barriers and the item fails to meet the requirements of BS EN 1176 Part 1 4.2.7.6 Entrapment of fingers **Action:** Remove the entrapment
