## Annual Inspection

Knaptton Parish Council

Mundesley & District Recreation Association

## Mundesley & District Recreation Association

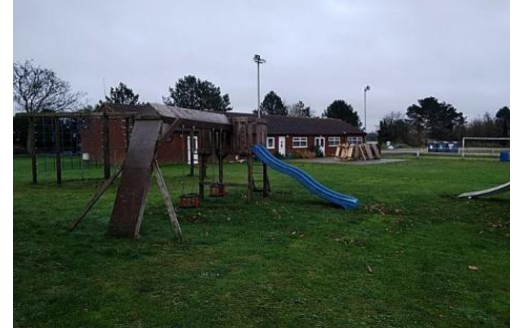
It is recommended that signage, with information including the site address, contact information for maintenance issues and emergency contact details are provided for the facility - Provide in accordance with the recommendations

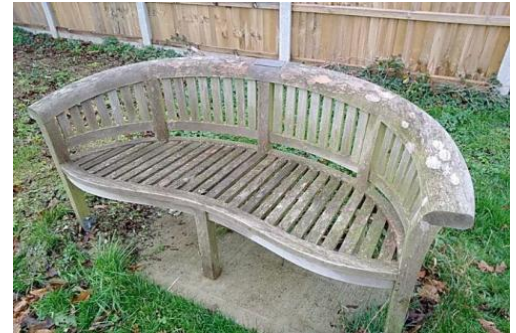
There is algae or moss on the surface of the equipment - Clean and treat appropriately

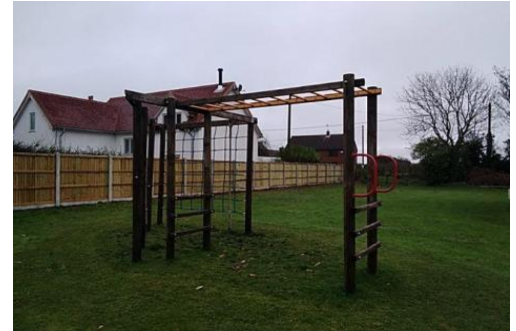
This item of equipment has a fall height in excess of 2.5m and grass mats have been installed as an impact absorbing surface; these mats rely heavily on the underlying surface to achieve their critical fall height properties. - Ensure surfacing certification is sought and consider HIC testing to ensure the surfacing is performing adequately

There is/are bolt cap covers missing or damaged on the item - Replace missing or damaged bolt cap covers

The item is slightly loose in its foundations - Monitor for any further deterioration and repair as required

The item fails to meet the requirements of BS EN 1176 Part 1 4.2.7.2 for head and neck entrapment in the framework - Monitor - No remedial work recommended

There are areas or parts of the timber on the structure that have rotted - Replace all affected timbers

There are falls in excess of 600mm between adjacent components on the structure, in contravention of the recommendations set out in BS EN 1176 Part 1; 4.2.8.4 - Monitor - No remedial work recommended

There is/are finger entrapment/s in the framework by the monkey bars and the item fails to meet the requirements of BS EN 1176 Part 1 4.2.7.6 Entrapment of fingers - Monitor - No remedial work recommended

The surfacing dimensions are short and do not meet with the requirements of the current applicable standard - Monitor - no remedial action recommended

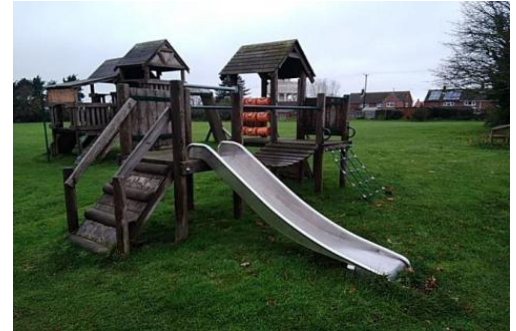
There is algae or moss on the surface of the equipment - Clean and treat appropriately

The chain openings are in excess of 8.6mm and do not meet the recommendations of BS EN 1176 Part 1 - Monitor - No remedial work recommended

There is an opening in the barriers exceeding the width allowed (500mm) in BS EN 1176, this is a low risk failure and no remedial action is required - Monitor - No remedial work recommended

There are areas or parts of the timber on the structure that have rotted - Replace all affected timbers

The paintwork on this item has been damaged or worn exposing the metal underneath which is rusting - Treat any rusting components and repaint

There is surface corrosion present on the item - Consider treating the item

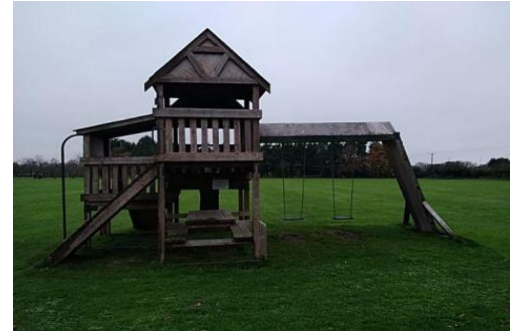
The plywood has delaminated in some places - Remove all rough or splintered edges.

This design of swing joint has been known to fail on the weld connecting the joint to the threaded stud - We would recommend that the joint be dismantled and checked on a regular basis or a Secondary Safety Device be fitted

Swing frames or their top bar should only be attached to other equipment where specific measures are undertaken to segregate them from other activities, eg. additional 1.50m circulation area, barrier, or enclosures - BS EN 1176 Part 2 - 4.9 - Monitor - No remedial work recommended

Sections of the unit have been encased and it is not possible to determine the condition of the timber within - Create an inspection regime to inspect the internal components condition regularly

The lower framework forms a hard object within the impact area of the equipment in contravention of the requirements of BS EN 1176 Part 1 - Monitor - No remedial work recommended

The run out section of the slide has been damaged - Repair or replace the item

There is / are toggle entrapment/s present in contravention of the recommendations set out in BS EN 1176 Part 3 - Monitor - no remedial work recommended

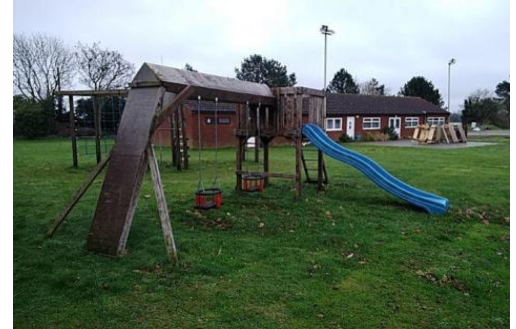
Swing frames or their top bar should only be attached to other equipment where specific measures are undertaken to segregate them from other activities, eg. additional 1.50m circulation area, barrier, or enclosures - BS EN 1176 Part 2 - 4.9 - Monitor - No remedial work recommended

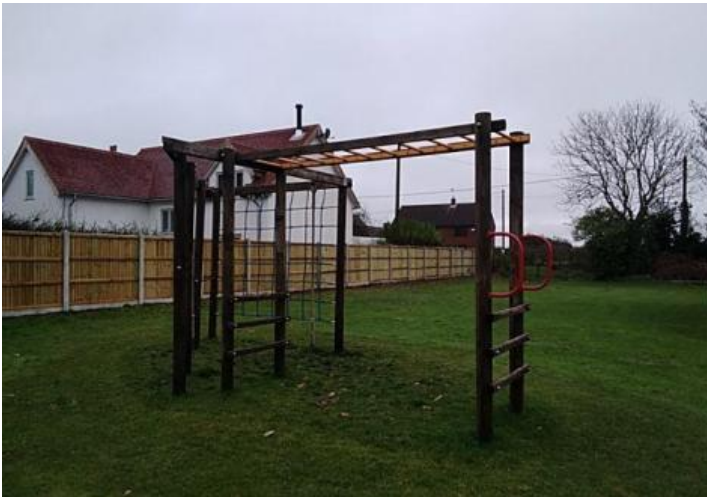
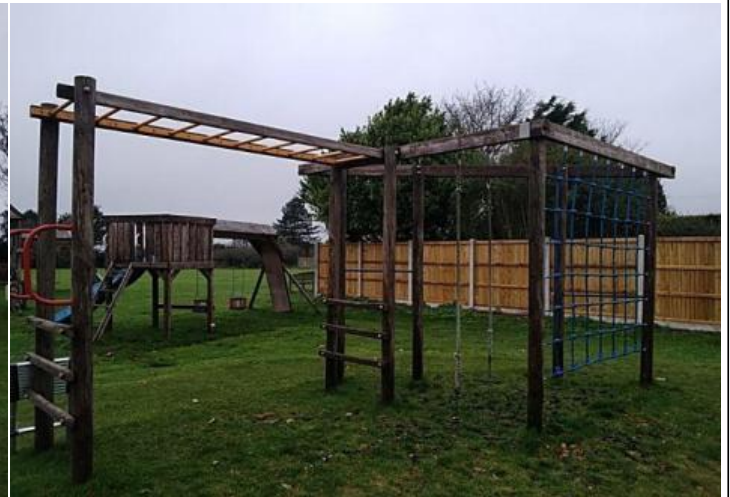
**Item:** Activity Equipment - Climbing Frame  
**Manufacturer:** Not Identified

**Finding:** This item of equipment has a fall height in excess of 2.5m and grass mats have been installed as an impact absorbing surface; these mats rely heavily on the underlying surface to achieve their critical fall height properties.

**Action:** Ensure surfacing certification is sought and consider HIC testing to ensure the surfacing is performing adequately

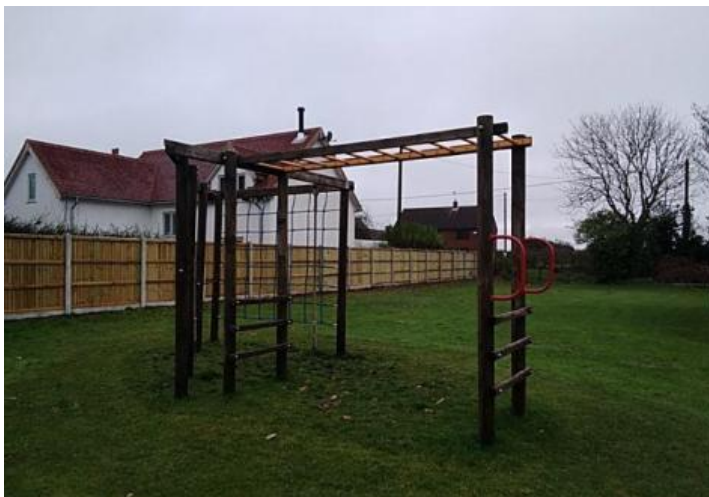
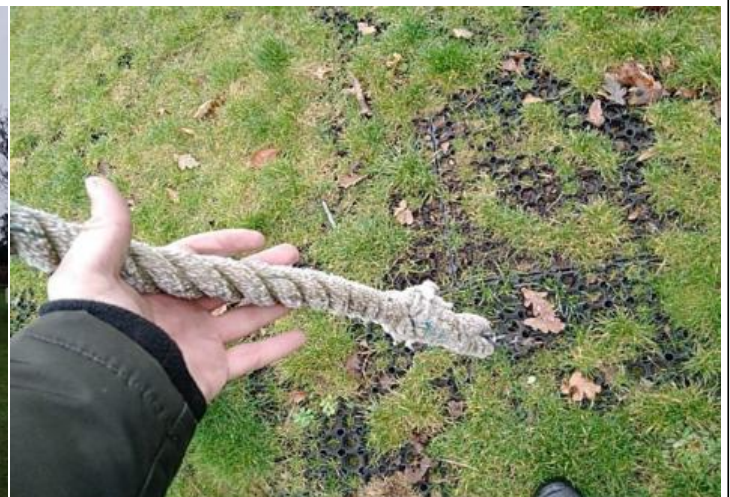
**Item:** Activity Equipment - Climbing Frame  
**Manufacturer:** Not Identified

**Finding:** There is algae or moss on the surface of the equipment

**Action:** Clean and treat appropriately

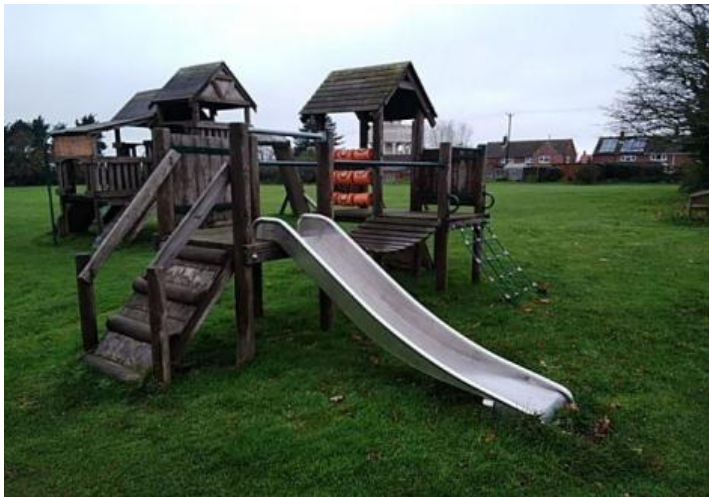
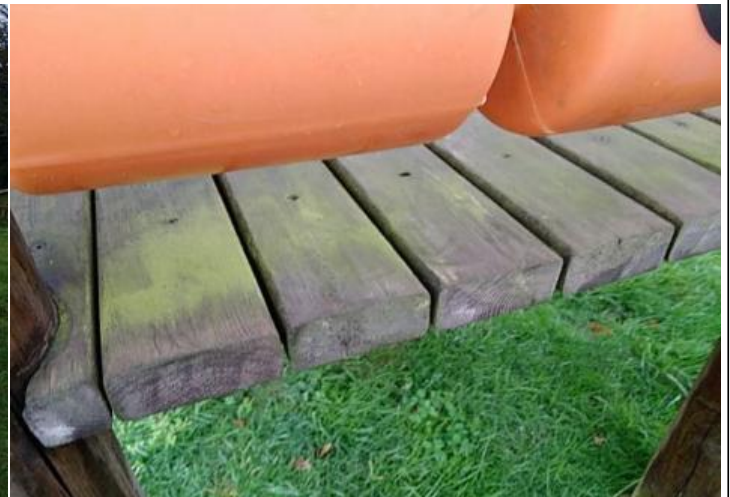
**Item:** Activity Equipment - Multi Play (Toddler)  
**Manufacturer:** Adventure Playgrounds

**Finding:** There is algae or moss on the surface of the equipment

**Action:** Clean and treat appropriately

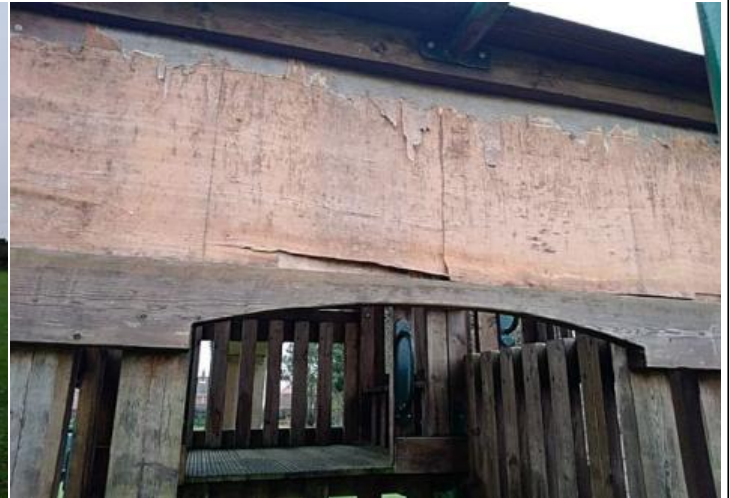
**Item:** Activity Equipment - Multi Play (Junior)  
**Manufacturer:** Sovereign Leisure

**Finding:** The plywood has delaminated in some places

**Action:** Remove all rough or splintered edges.

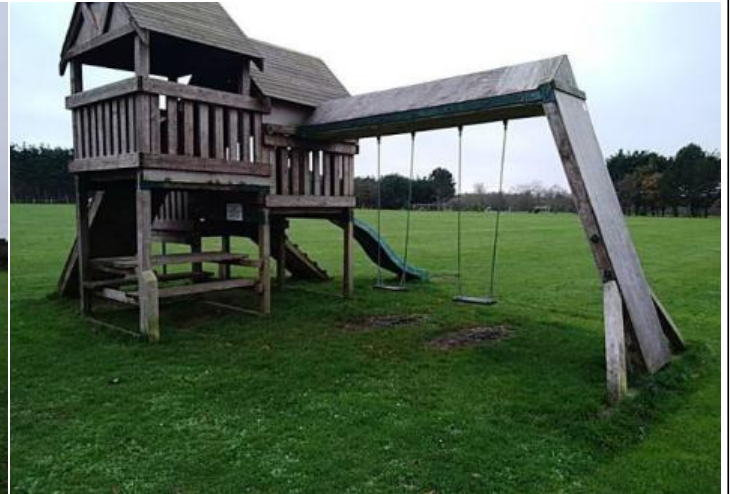
**Item:** Activity Equipment - Multi Play (Junior)  
**Manufacturer:** Sovereign Leisure

**Finding:** This equipment has not been designed or installed to meet with the requirements of BS EN 1176 for public playground equipment; we have however used our knowledge of these standards to assist in forming the basis of our risk assessment for the equipment and our report.

**Action:** Monitor use and review the use of the equipment and risk assessment regularly

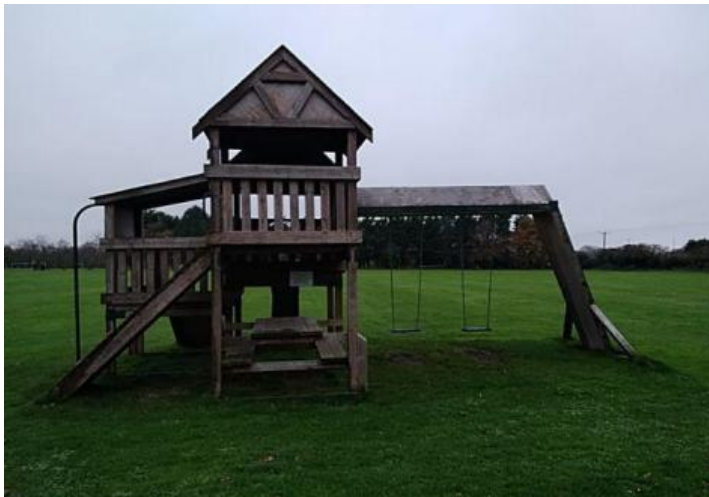
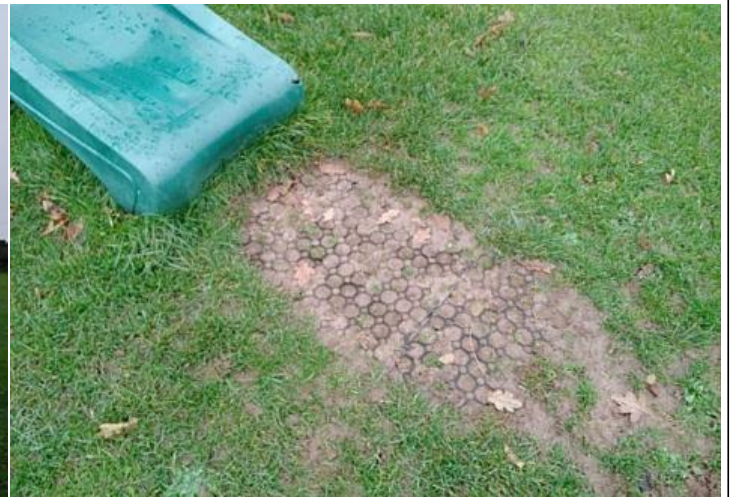
**Item:** Activity Equipment - Multi Play (Junior)  
**Manufacturer:** Sovereign Leisure

**Finding:** The grass mats are silted up, the soil is compacted and the area will become very slippery when the soil is wet.

**Action:** Reinstate as required

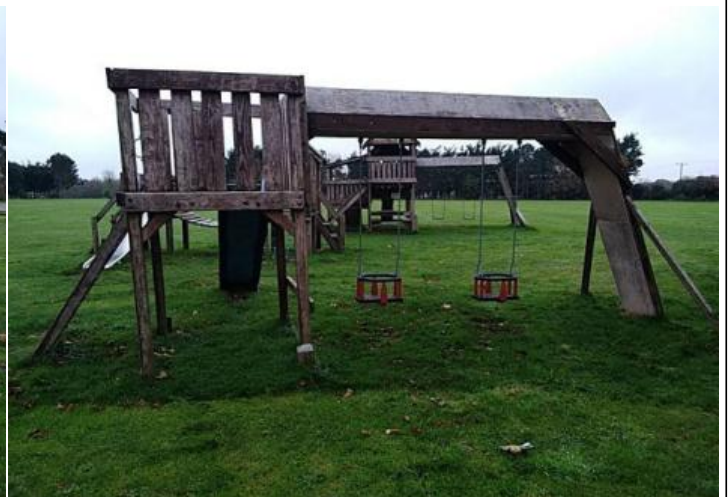
**Item:** Activity Equipment - Multi Play (Toddler)  
**Manufacturer:** Not Identified

**Finding:** This equipment has not been designed or installed to meet with the requirements of BS EN 1176 for public playground equipment; we have however used our knowledge of these standards to assist in forming the basis of our risk assessment for the equipment and our report.

**Action:** Monitor use and review the use of the equipment and risk assessment regularly

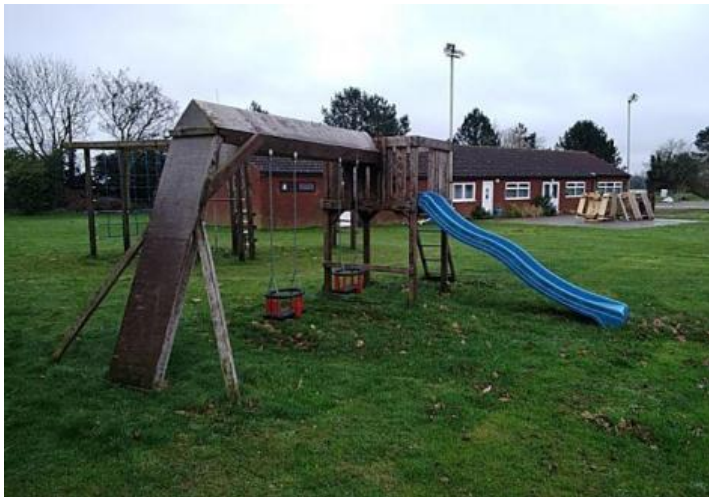
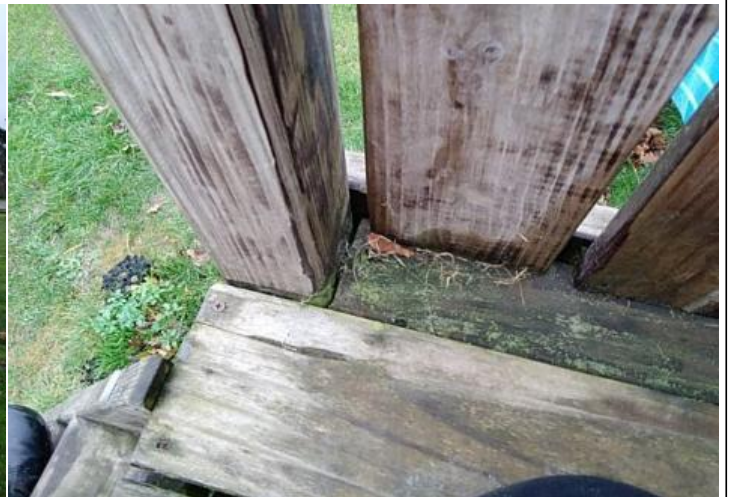
**Item:** Activity Equipment - Multi Play (Toddler)  
**Manufacturer:** Not Identified

**Finding:** There is algae or moss on the surface of the equipment

**Action:** Clean and treat appropriately
