Post Installation Report

Knaption Parish Council

Mundesley & District Recreation Association

Hall Lane , Knaption, Walsham, NR28 0RZ

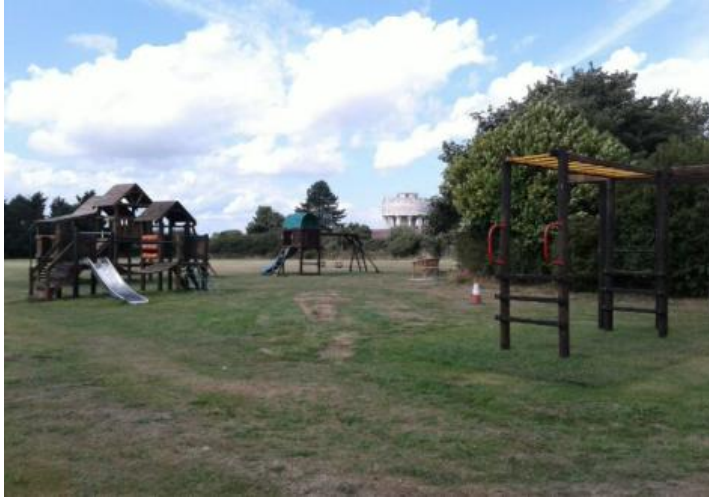
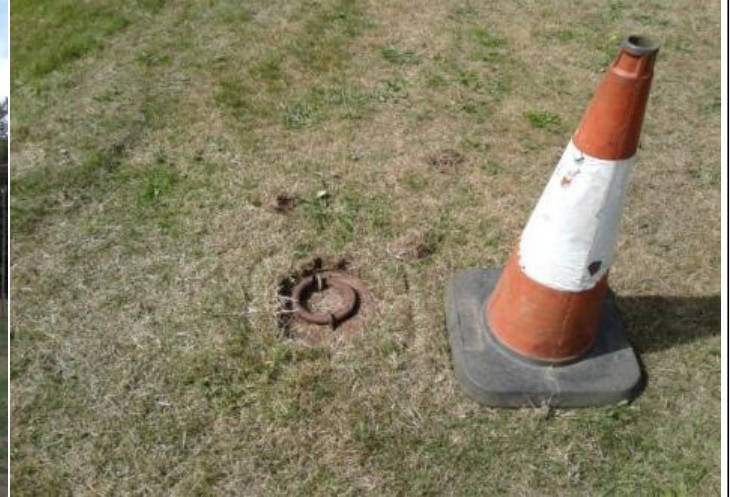
Finding: The remnants of a springy are still present

Action: Remove all remains and reinstate the surface to level

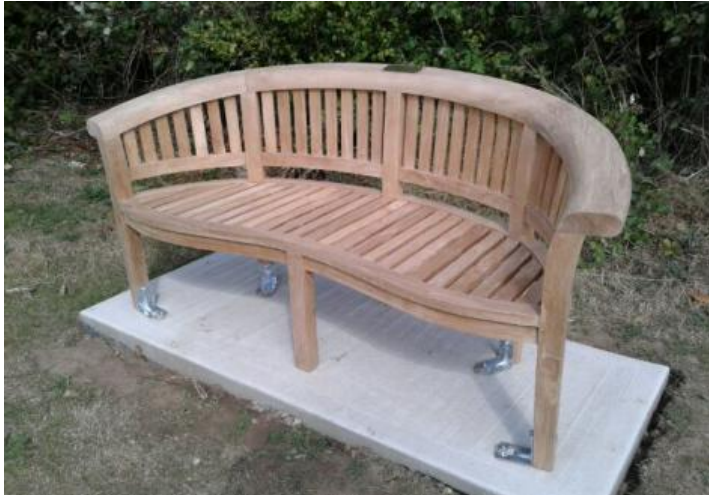
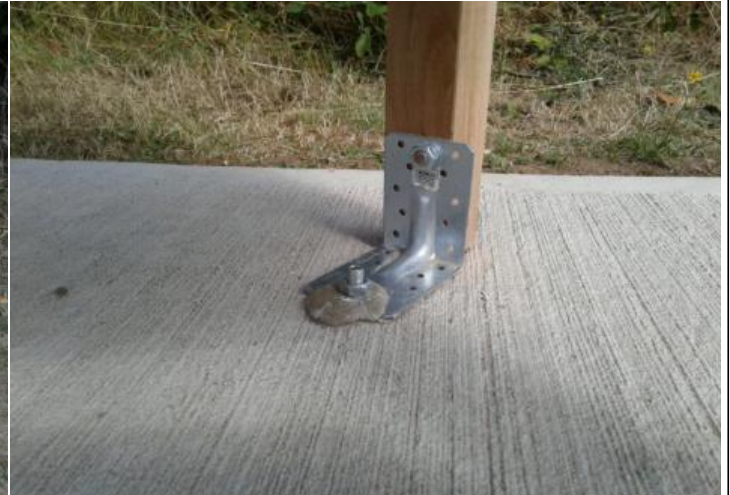
Finding: There are projecting bolt thread(s) present

Action: Remove excess thread length and deburr or provide cap

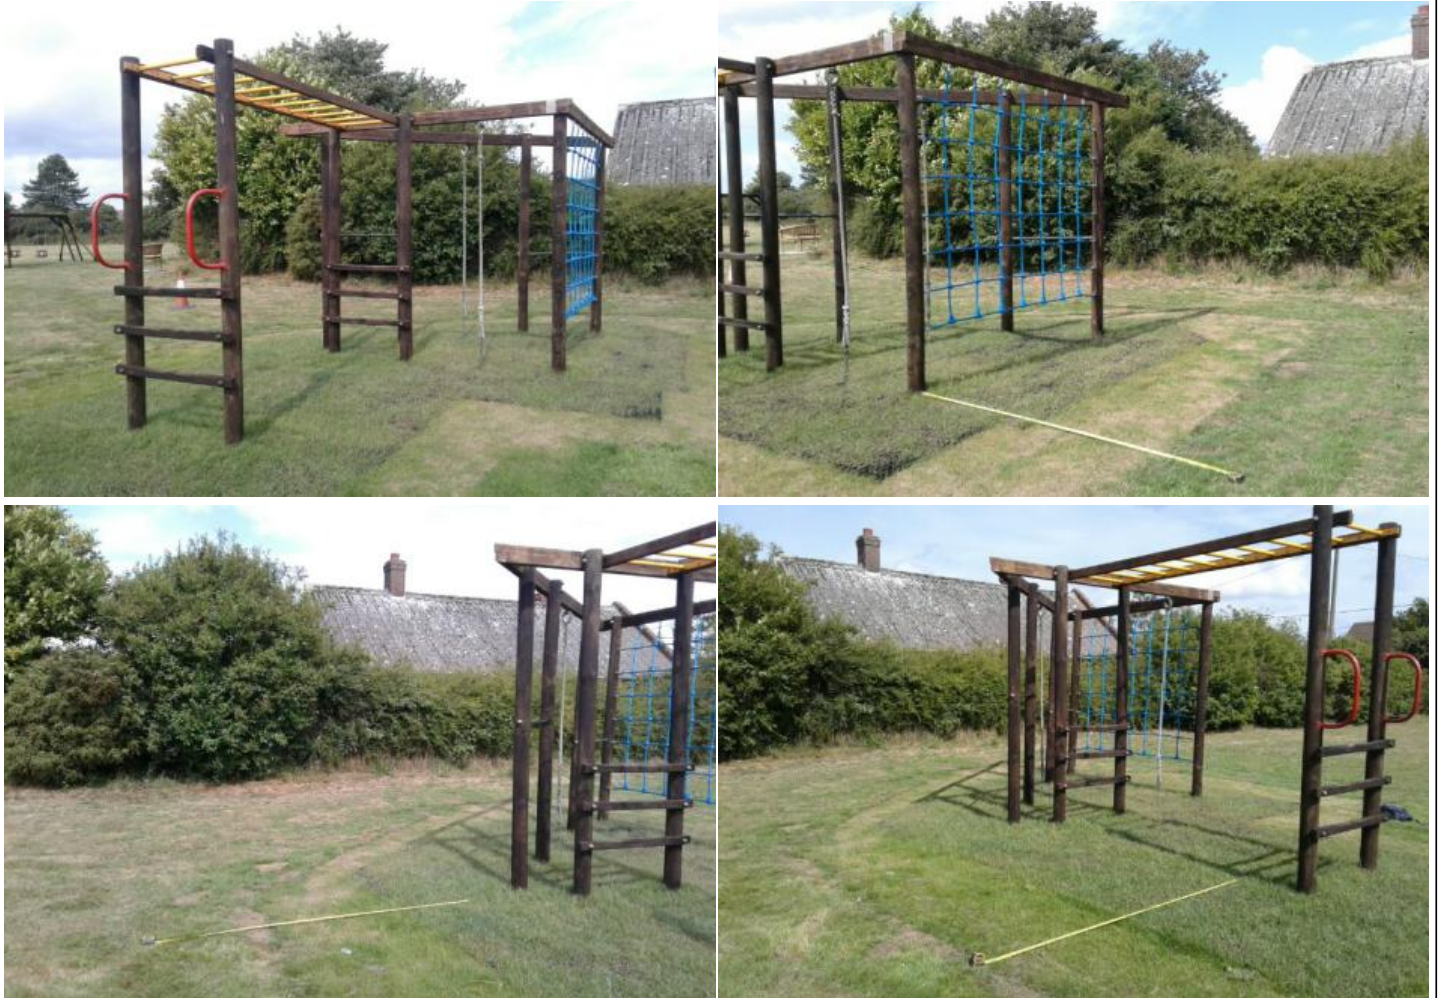
Finding: The surfacing dimensions do not meet with the requirements of the current applicable standard (2.32m required/ 0.60m provided)

Action: Extend surface area to comply

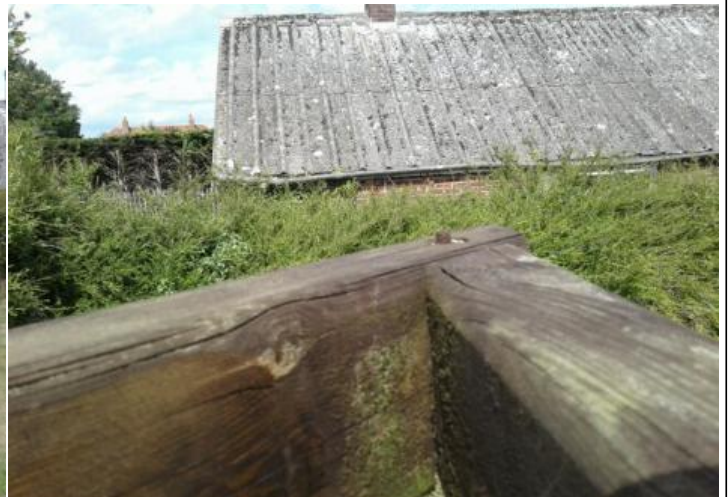
Finding: There are projecting bolt thread(s) present

Action: Remove excess thread length and deburr or provide cap

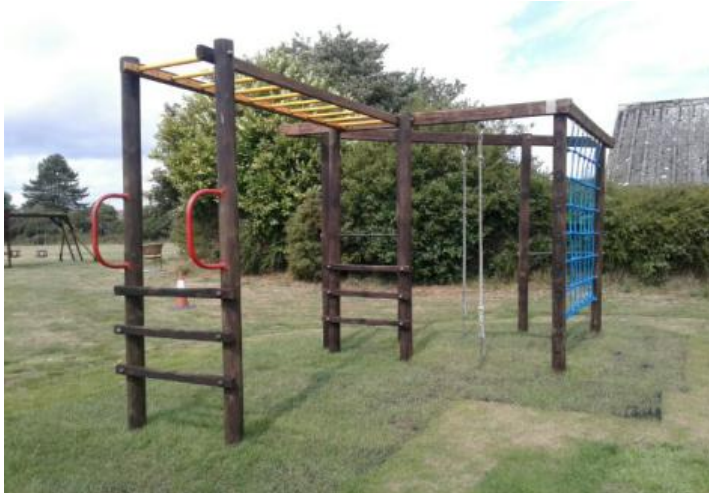
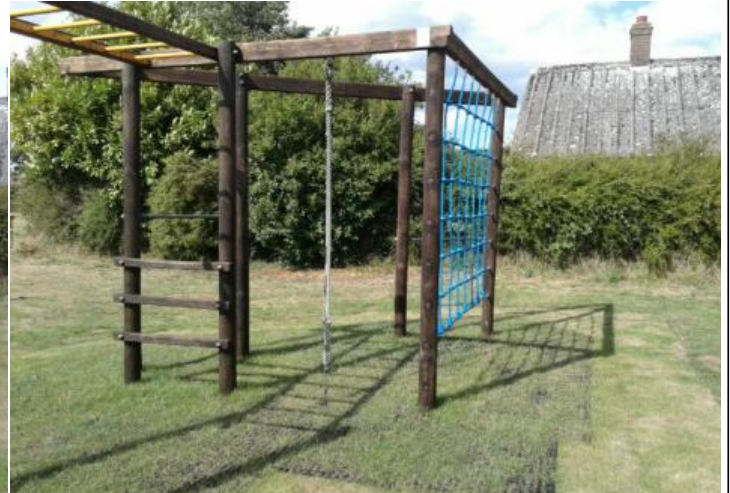
Finding: This item of equipment has a fall height in excess of 2.5m and grass mats have been installed as an impact absorbing surface; these mats rely heavily on the underlying surface to achieve their critical fall height properties.

Action: Ensure surfacing certification is sought and consider HIC testing to ensure the surfacing is performing adequately

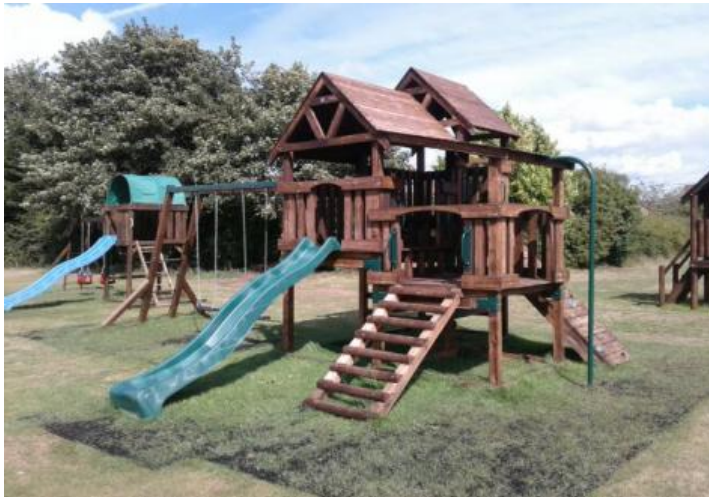
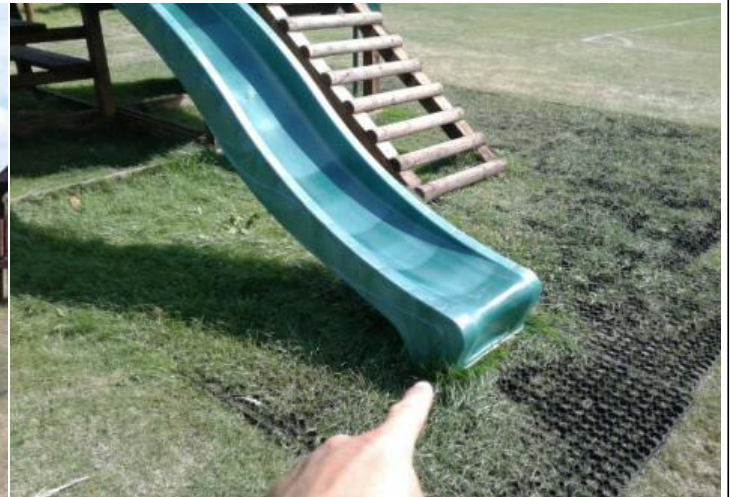
Finding: The slide run out is not secured

Action: Secure the slide

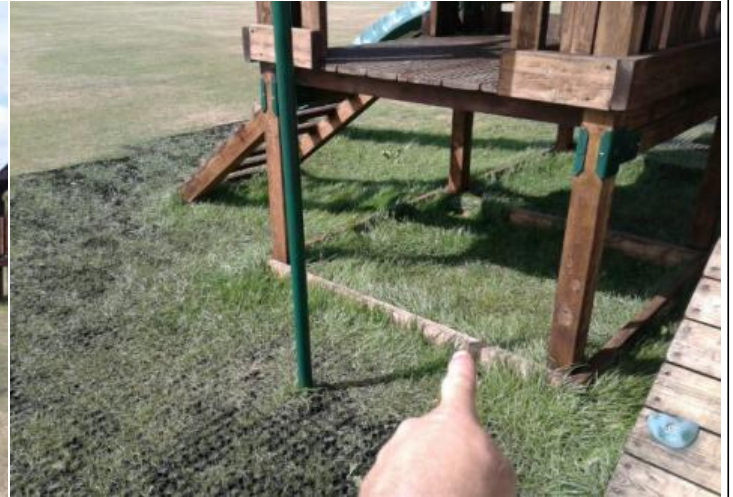
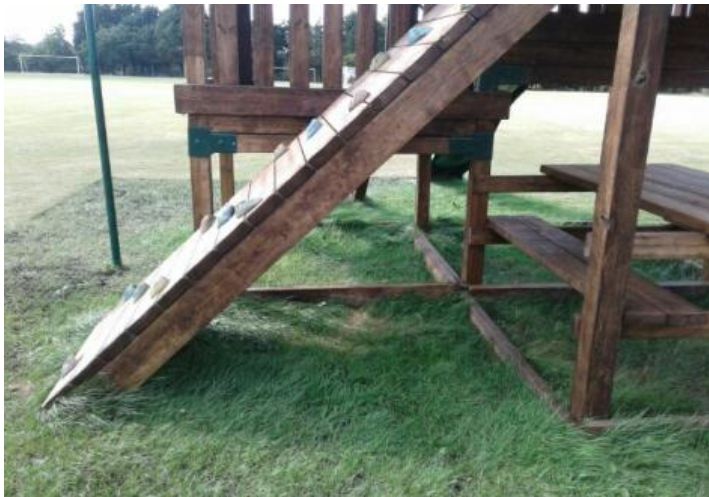
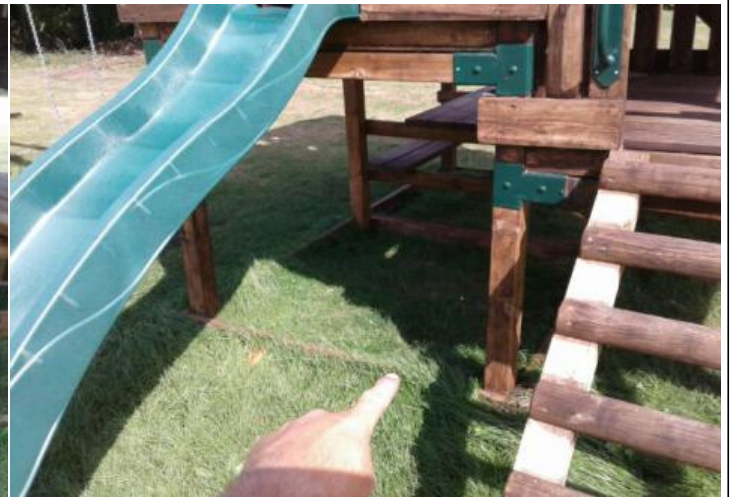
Finding: The timber edging forms a hard object within the impact area of the equipment in contravention of the requirements of BS EN 1176 Part 1

Action: Refer to the contractor

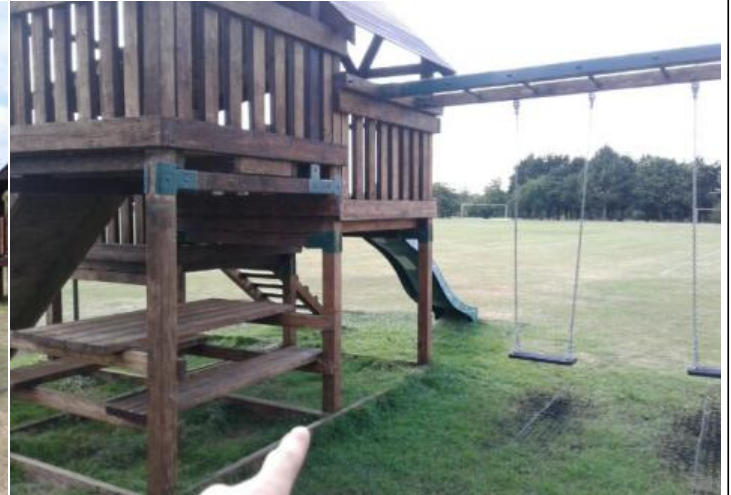
Finding: The timber edging forms a hard object within the impact area of the monkey bars in contravention of the requirements of BS EN 1176 Part 1 2.55

Action: Refer to the contractor

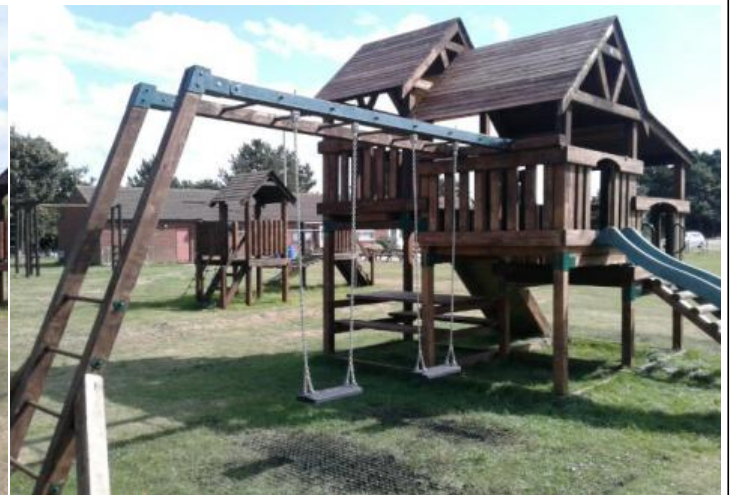
Finding: There is conflict of use between the users of the swings and of the users of the monkey bars

Action: Remove the swings

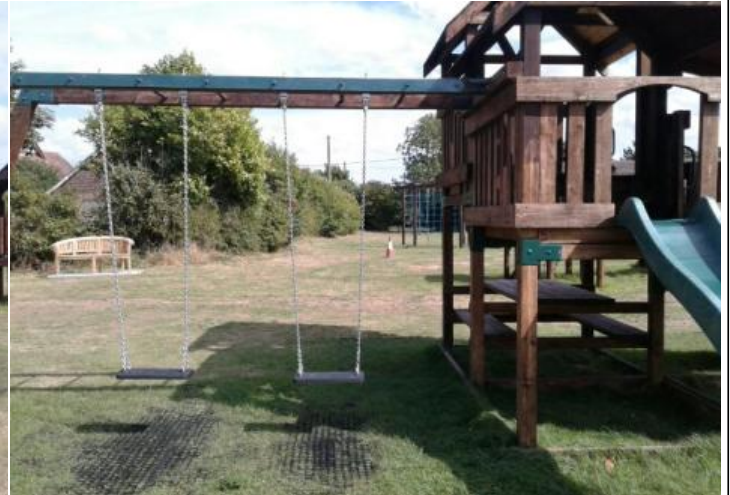
Finding: Swing frames or their top bar should only be attached to other equipment where specific measures are undertaken to segregate them from other activities, eg. additional 1.50m circulation area, barrier, or enclosures - BS EN 1176 Part 2 - 4.9

Action: Refer to the manufacturer

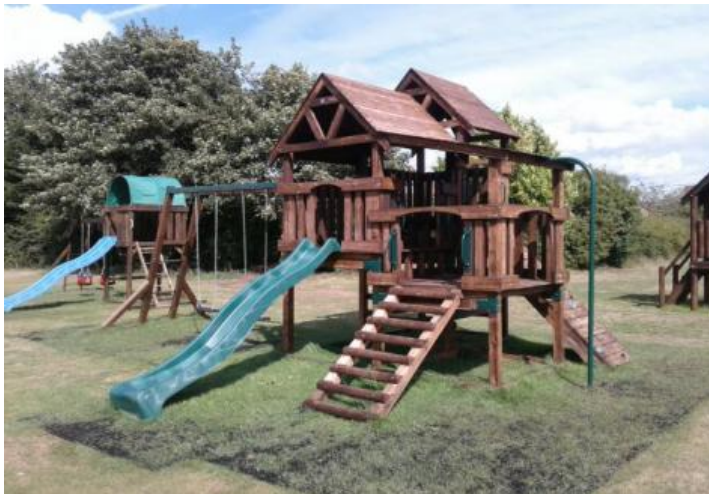
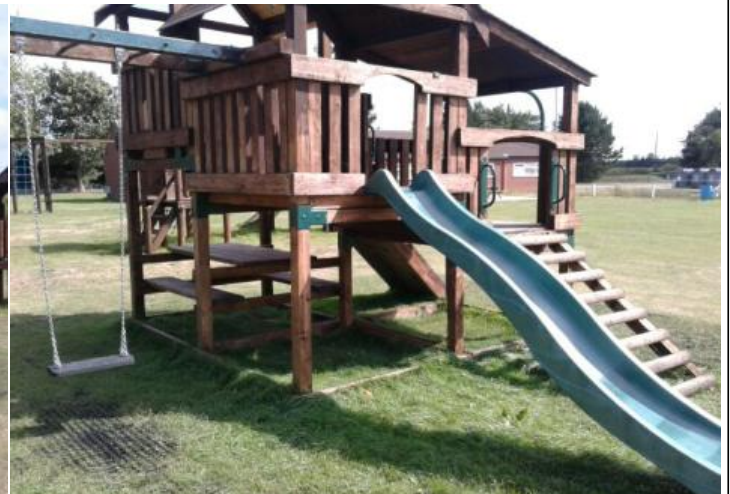
Finding: The item is not secured to the surface

Action: Secure the item

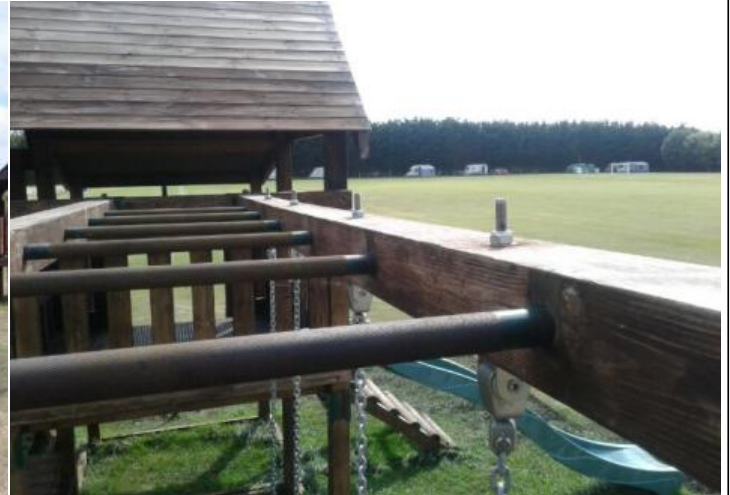
Finding: There are projecting bolt thread(s) present

Action: Remove excess thread length and deburr or provide cap

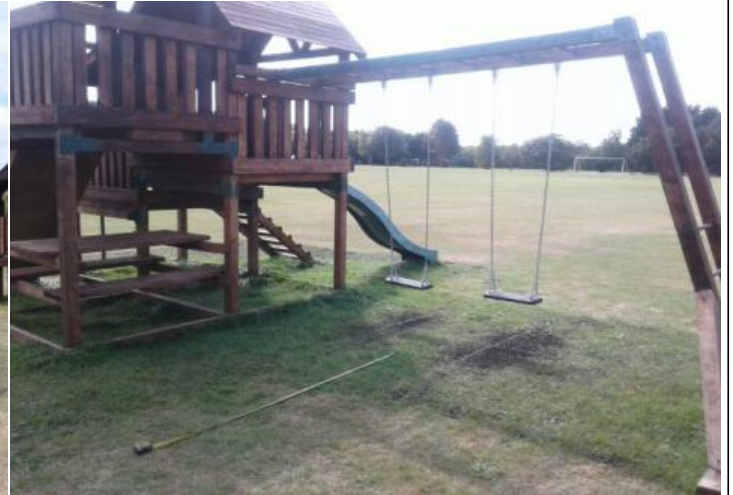
Finding: The surfacing dimensions of the monkey bars do not meet with the requirements of the current applicable standard (2.10m required/0.80m provided)

Action: Extend surface area to comply

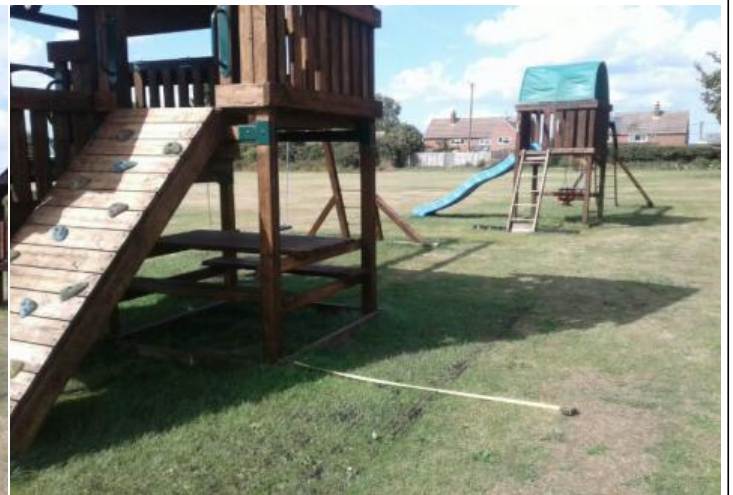
Finding: The surfacing dimensions of the platform do not meet with the requirements of the current applicable standard (1.70m required/1.0m provided)

Action: Extend surface area to comply

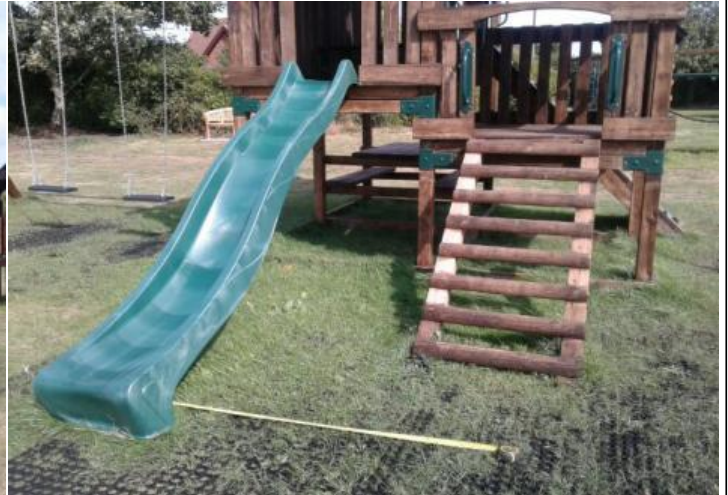
Finding: The ramp forms a hard object within the impact area of the slide in contravention of the requirements of BS EN 1176 Part 1

Action: Refer to the manufacturer

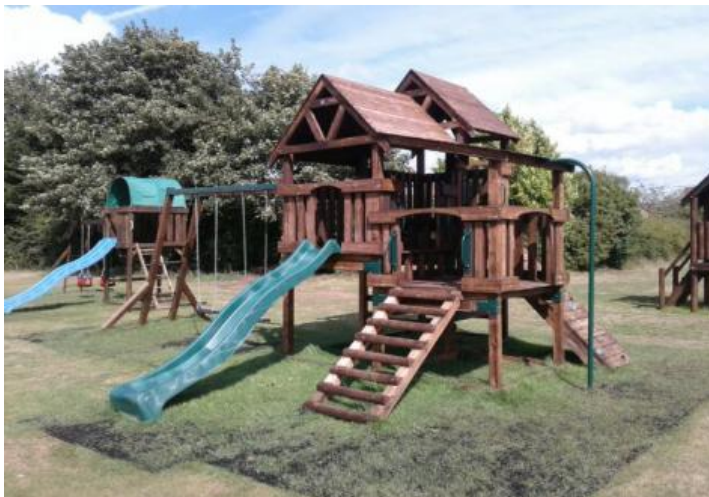
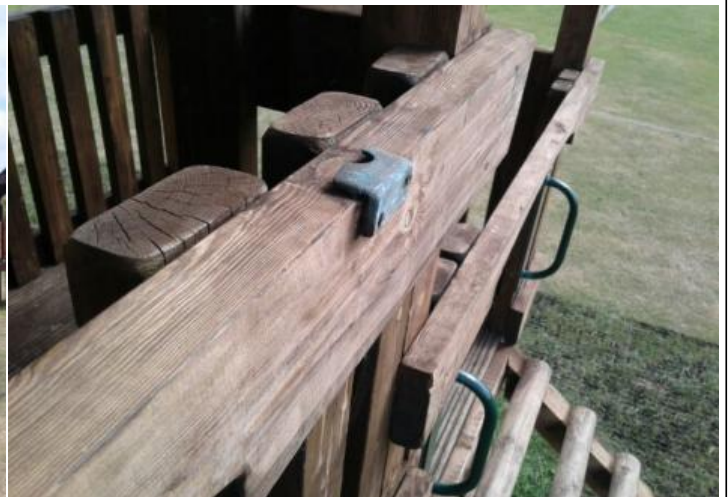
Finding: There is a redundant bracket on the frame

Action: Remove

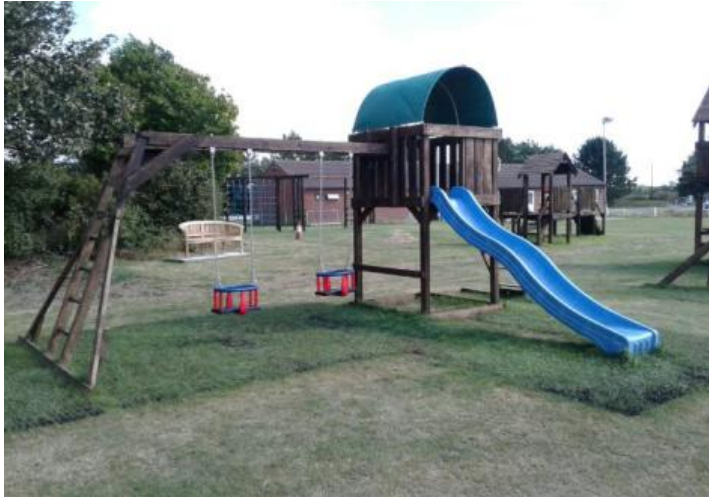
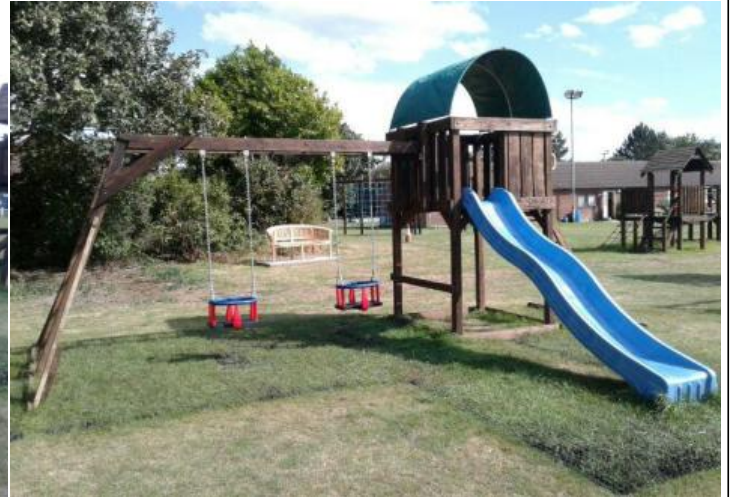
Finding: This equipment has not been designed or installed to meet with the requirements of BS EN 1176 for public playground equipment; we have however used our knowledge of these standards to assist in forming the basis of our report.

Action: The equipment should either be removed from use or written confirmation be sought from the supplier concerning the suitability of this equipment for the intended use

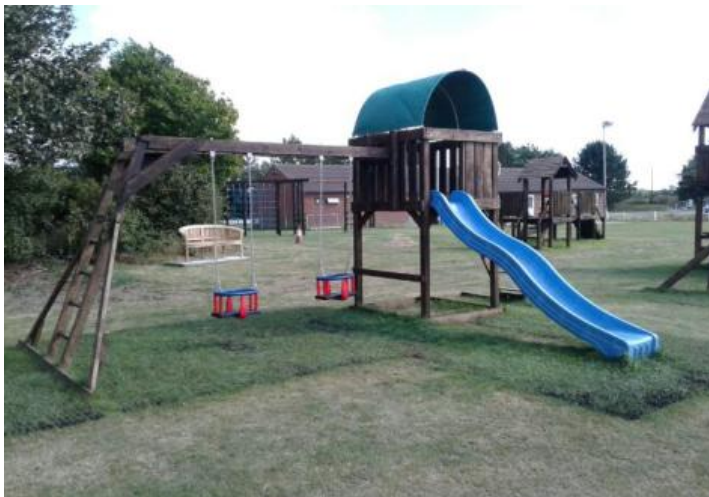
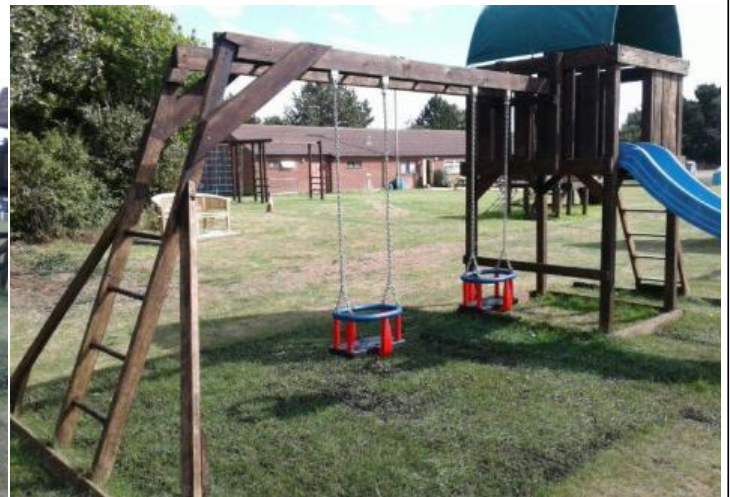
Finding: There is a conflict of use between the users of the swings and those of the monkey bars

Action: Remove the swing seats

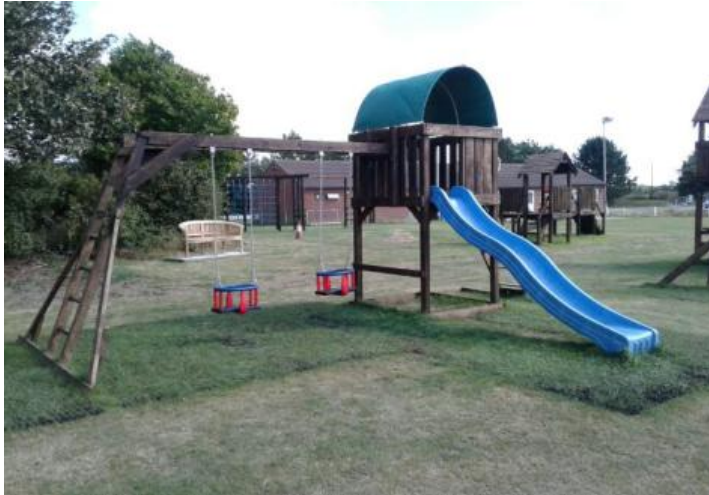
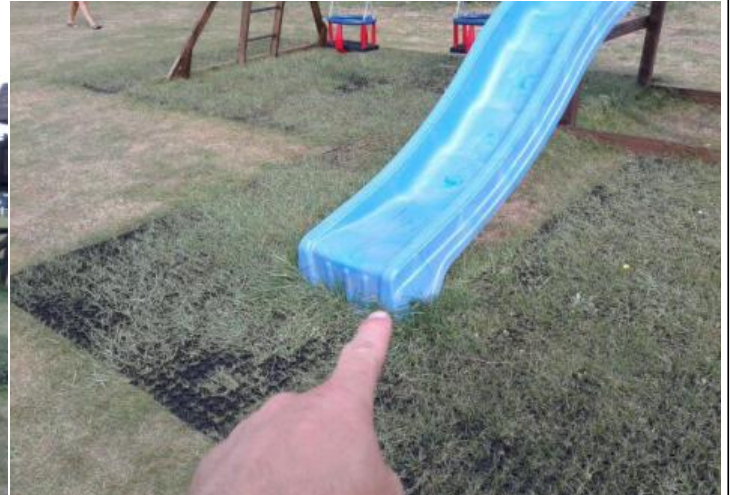
Finding: The slide run out is not secured to the surface

Action: Secure

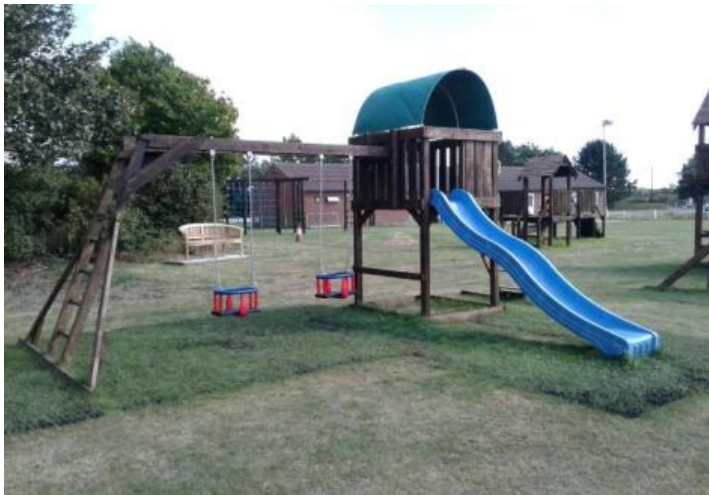
i 8 - Low Risk (Finding 4)

Finding: The edges of the grass mat surface have not been installed in accordance with the API Code of Practice

Action: Tuck in edges of grass mat to remove trip hazards

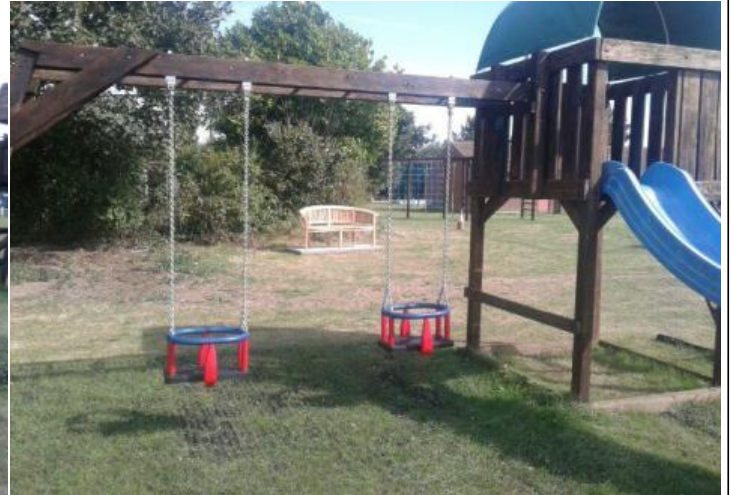
Finding: Swing frames or their top bar should only be attached to other equipment where specific measures are undertaken to segregate them from other activities, eg. additional 1.50m circulation area, barrier, or enclosures - BS EN 1176 Part 2 - 4.9

Action: Refer to the manufacturer

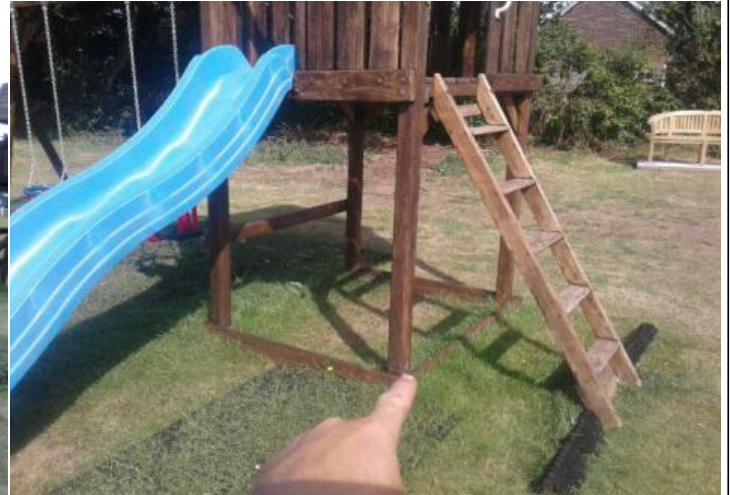
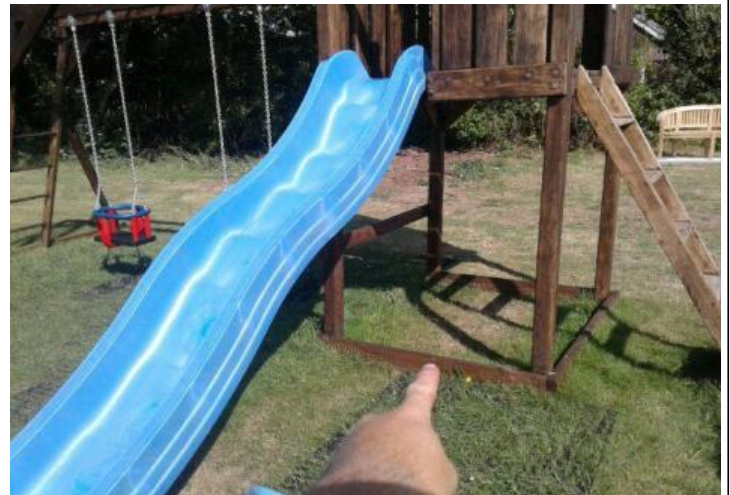
Finding: The lower framework forms a hard object within the impact area of the equipment in contravention of the requirements of BS EN 1176 Part 1

Action: Refer to the manufacturer

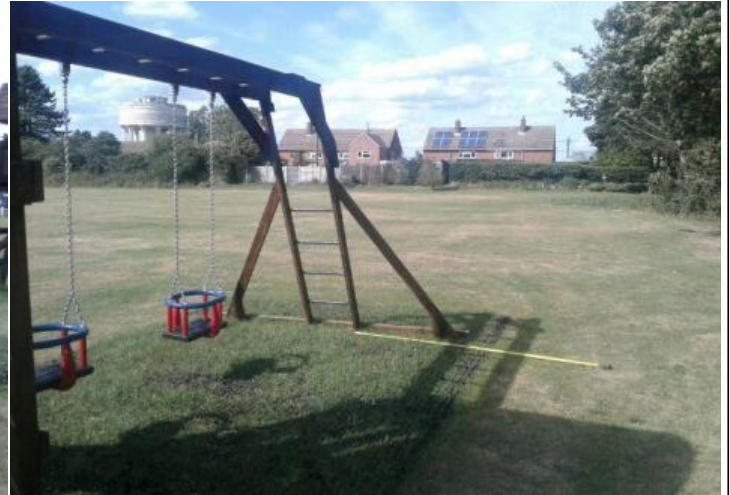
Finding: The surfacing dimensions do not meet with the requirements of the current applicable standard

Action: Extend surface area to comply

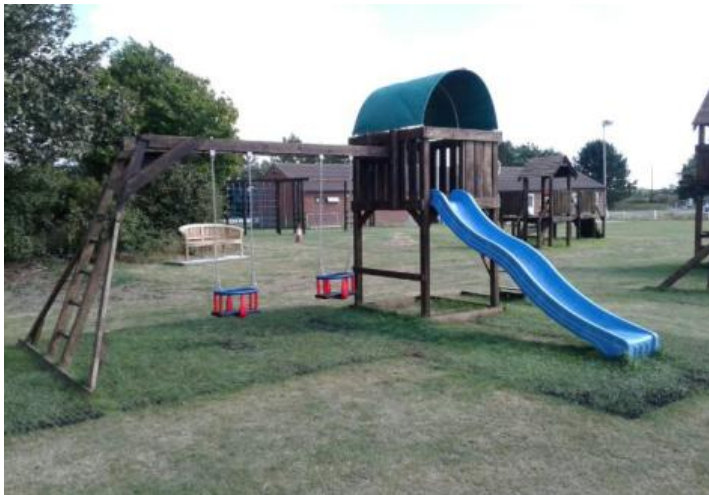
Finding: There is/are bolt cap covers missing or damaged on the item

Action: Replace missing or damaged bolt cap covers

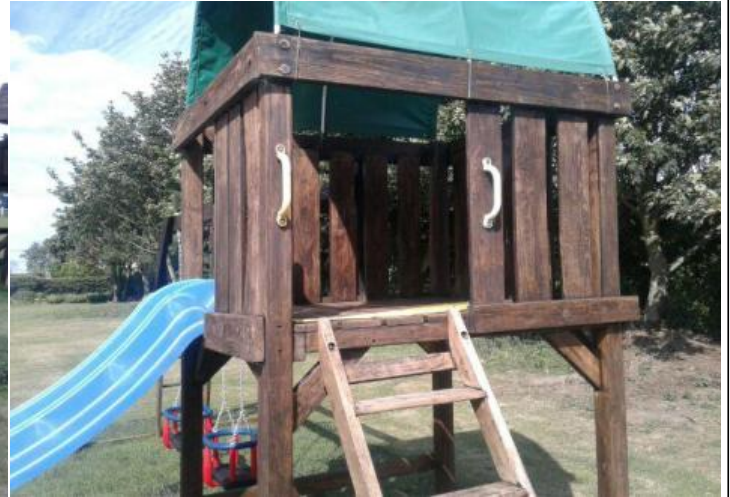
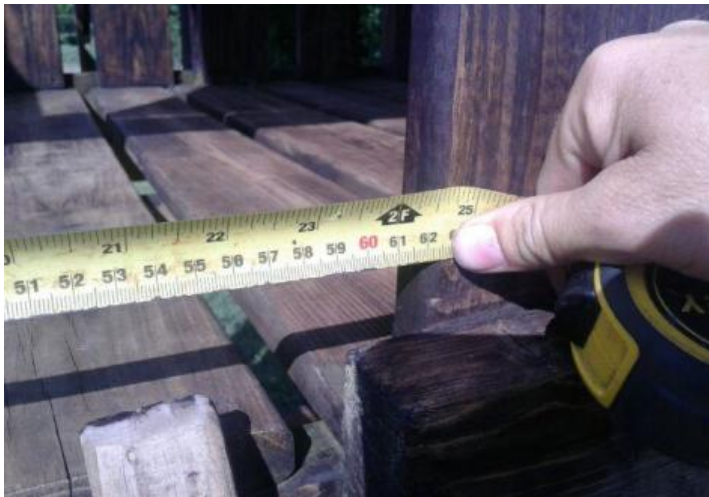
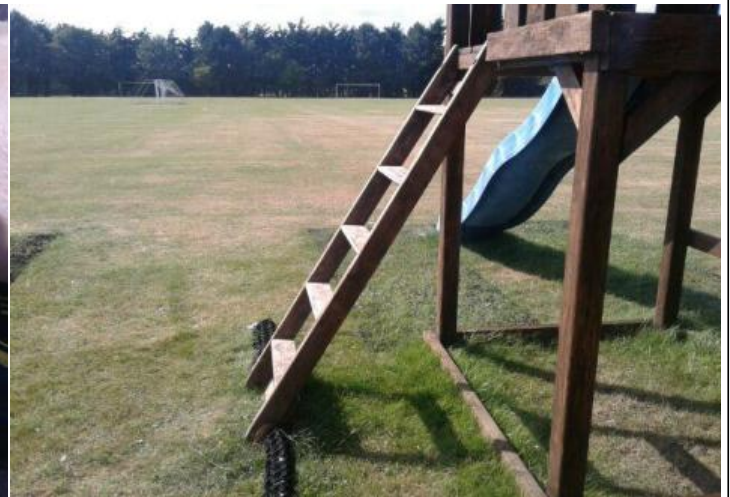
Finding: The unit is easily accessible and has an opening in the barrier to steep play elements in excess of 500mm
Action: Refer to the manufacturer

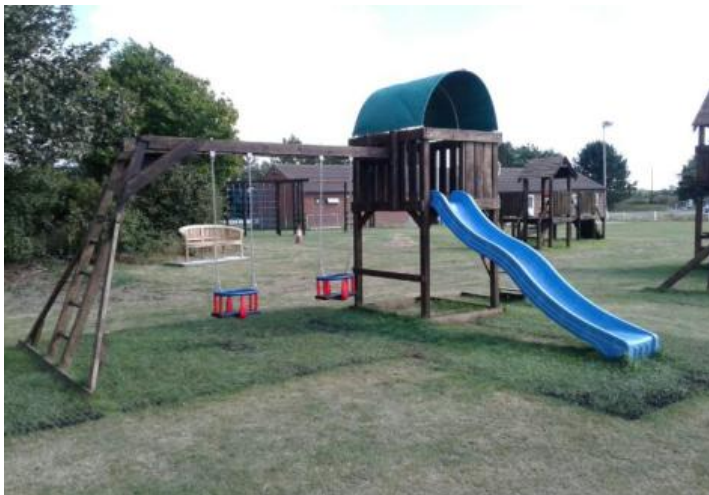
Finding: There is minor damage to the roof

Action: Monitor for any further deterioration and replace as required

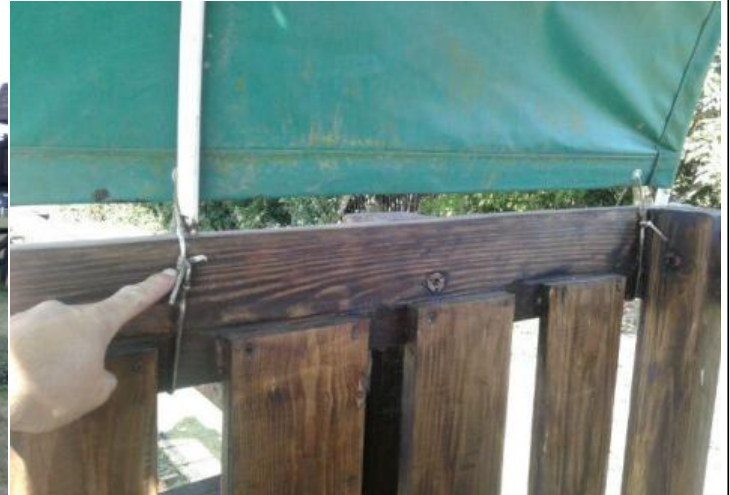
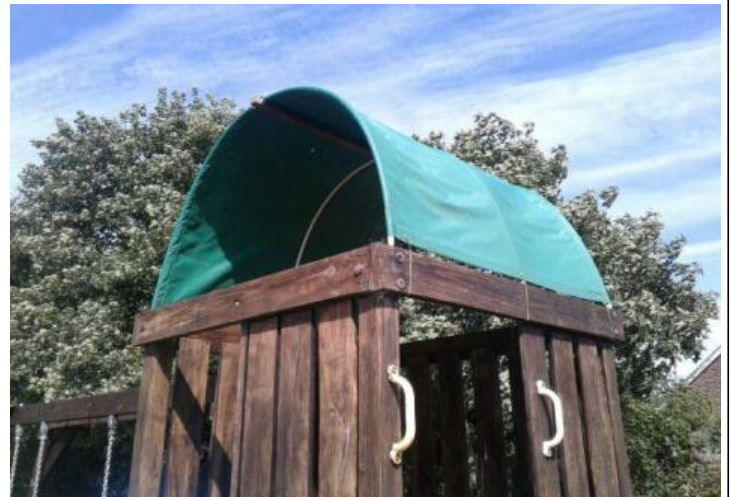
Finding: The roof canopy is held in place by twine

Action: Refer to the manufacturer

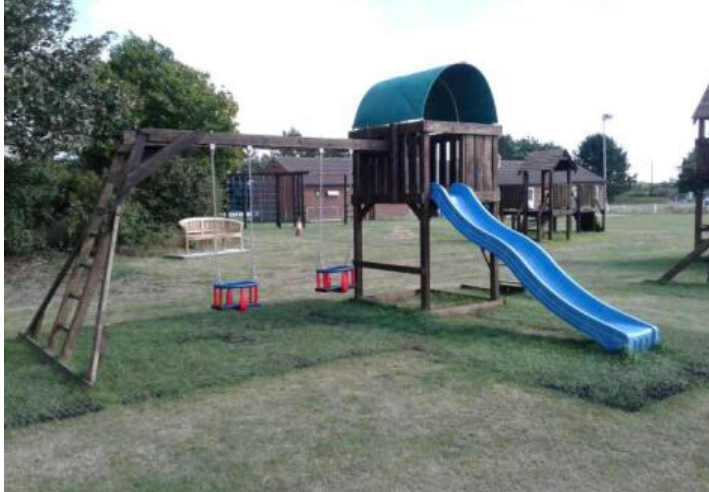
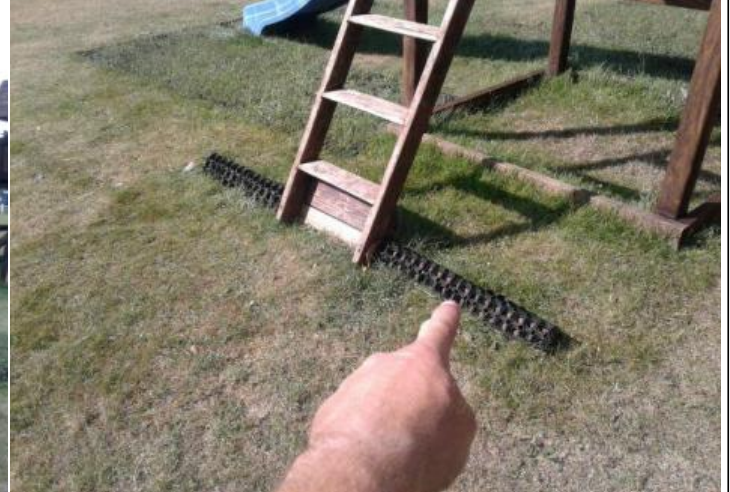
Finding: The base of the access point has been covered by grass matting and may not have the correct impact attenuating properties

Action: Refer to the manufacturer for confirmation of correct installation

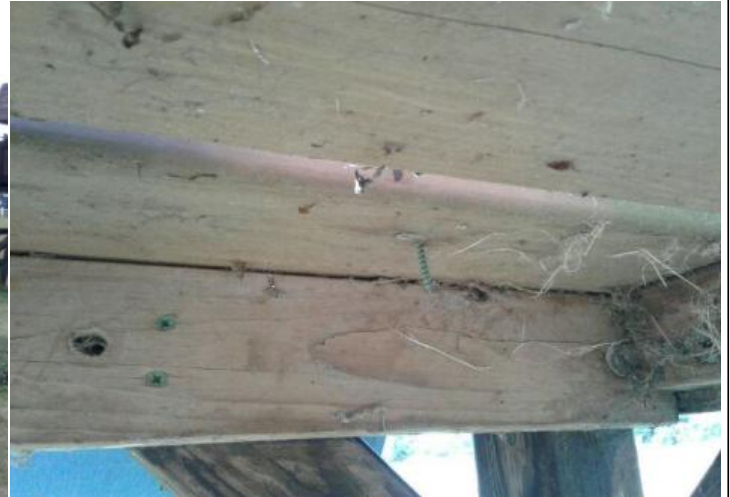
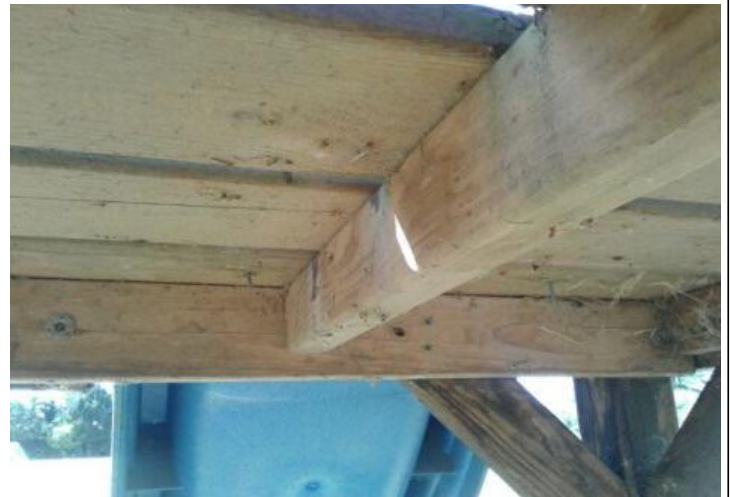
Finding: There are protruding screws beneath the platform **Action:** Remove the protrusions

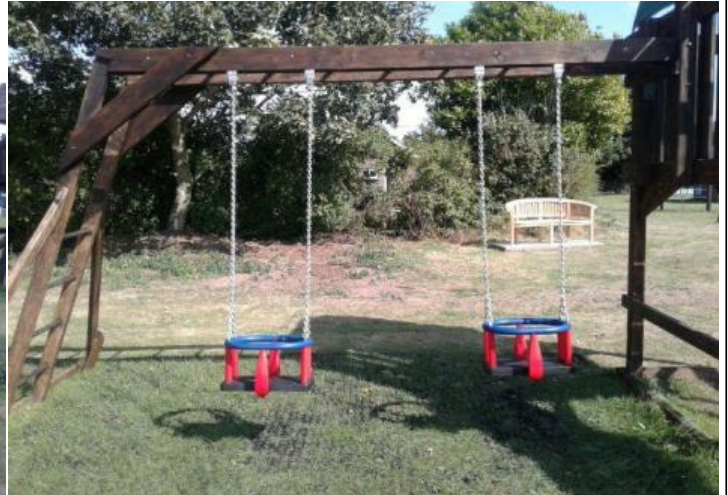
Finding: The lateral stability of the swing seat does not meet with the requirements of BS EN 1176 Part 2; the minimum distance between the suspension members should be the distance between the swing seat connections plus 5% of the suspension length. Distance between crossbeam connections required 44.8cm provided 39cm

Action: Refer to the manufacturer

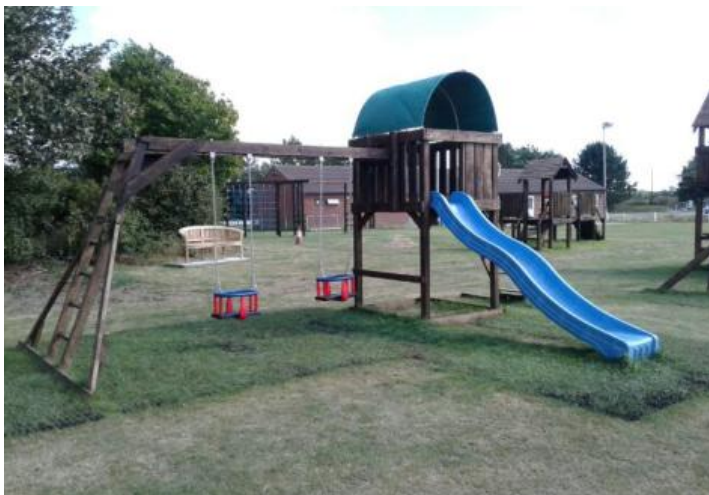
Finding: The surfacing width under each seat is less than 1.75 metres and fails the requirements of BS EN 1176 Part 2

Action: Refer to the manufacturer

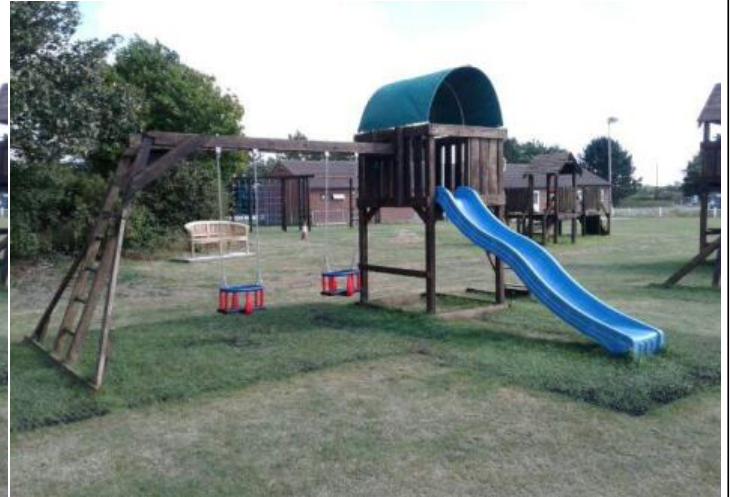
Finding: The item is not secured to the surface

Action: Secure to prevent the item toppling over
