The Church

SS Peter & Paul

KNAPTON

Conservation-Based Research and Analysis Report

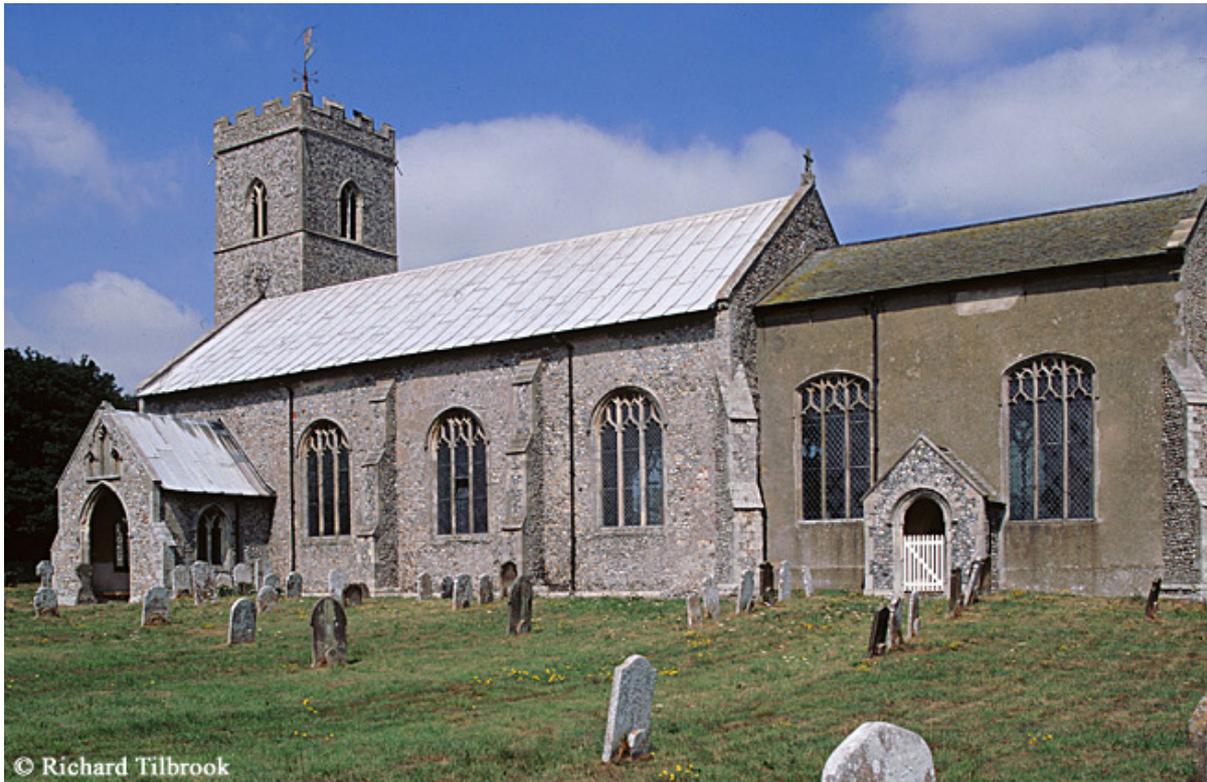
Fig. 1. Exterior from the south east.

The church consists of a very wide nave with a narrower and lower chancel and a bell tower at the north west corner of the nave (Figs.1 & 2). There is a vestry of 1845 to the north side of the chancel which replaces an earlier vestry and there is a fine south porch and, unusually, a porch to the priest's door also to the south. The fabric is largely of whole flints with some areas of original render with occasional modern repair. The tower is of knapped flints. The chancel south wall has a modern render. The nave roof is of lead and the chancel of slate. There are limestone ashlar dressings.

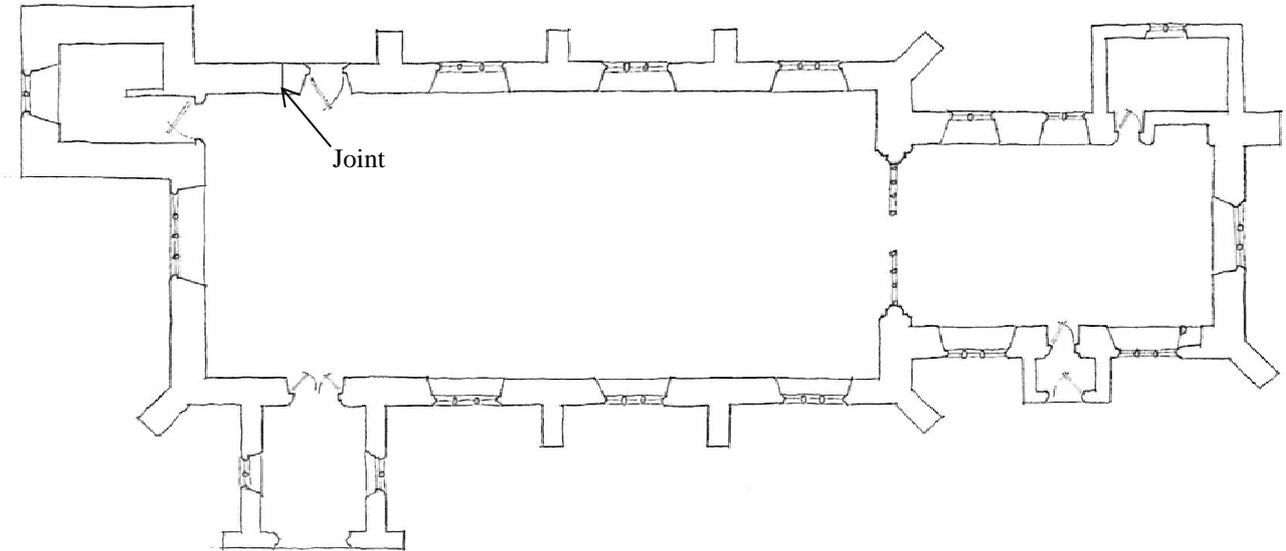
Fig.2. Plan by Ruth Blackman

The history of the fabric starts in the 14th century with the north and south doorways which have hollow chamfered mouldings and hoodmolds with human head label stops (Fig.2). The main fabric of the nave is contemporary with the doorways but the windows are later insertions (Fig.4). The tower has simple 'Y' tracery and may also belong to the 14th century. In the early 16th century the nave walls were heightened, the fenestration replaced and the nave roof replaced with the fabulous hammer beam roof.

The 14th-century wall has a straight joint just to the west of the north door and it appears to be neatly finished with rubble quoins (Figs 2 - 4). Abutting this joint is the return of the short section of the east wall of the tower. It extends from the re-entrant angle to join the 14th – century wall. It seems unlikely that this was the north west corner of the original nave because all the other quoins have buttressed corners and ashlar dressings, there is no corresponding joint on the south side and because the north and south doorways do not leave enough room for the thickness of a west wall. The only explanation is that the north wall was deliberately finished short in order to facilitate the building of the tower. It was not unusual to build a west tower independent of the nave to which it was going to be attached in order to allow the heavier structure of the tower to settle without damaging the nave. At Knapton the existence of the straight joint a few feet away from the tower indicates that a tower in this awkward position was intended from the first. The heightened section of the nave has of course no straight joint and is butted against the tower with four blocks of ashlar (Fig.3). Regarding where the tower joins the west wall of the nave it appears that the masons did not key in the masonry at the point of junction for the selfsame reason (Fig. 5).

The main body of the aisleless nave has diagonal buttresses to the three exposed corners and heavy buttresses between the window bays (Fig. 2). The 6 inserted windows have standard panel tracery, set, most unusually, within semi-circular arches (Figs 1, 4 & 8). This may be indicative of the gradual decline in the early 16th century of the Gothic in favour of Renaissance forms inspired from Antiquity. The windows on the south side have hood moulds with pretty pendant label stops. (Fig. 8) The chancel porch uses a similar semi-circular arch.

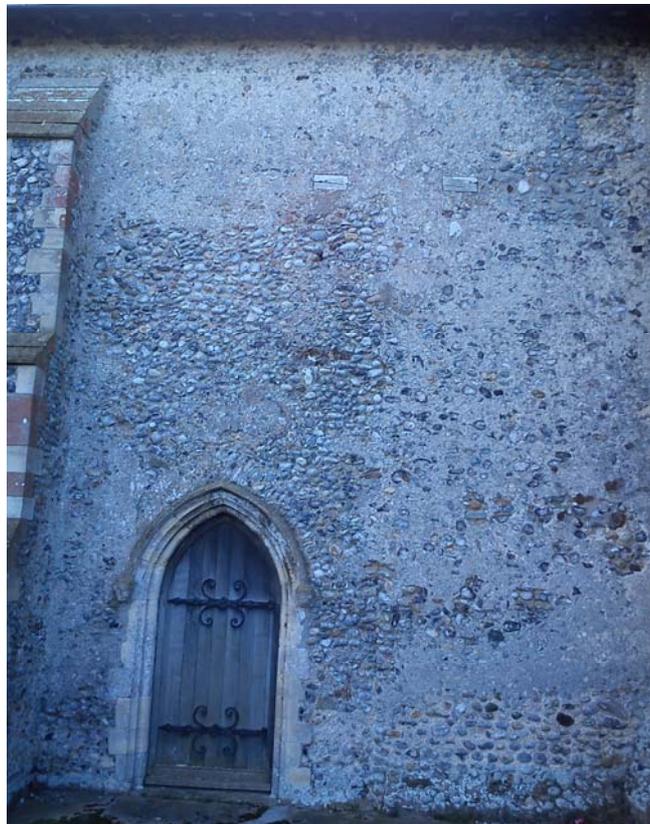
Fig. 3. West end of nave north wall showing door, straight joint and heightening.

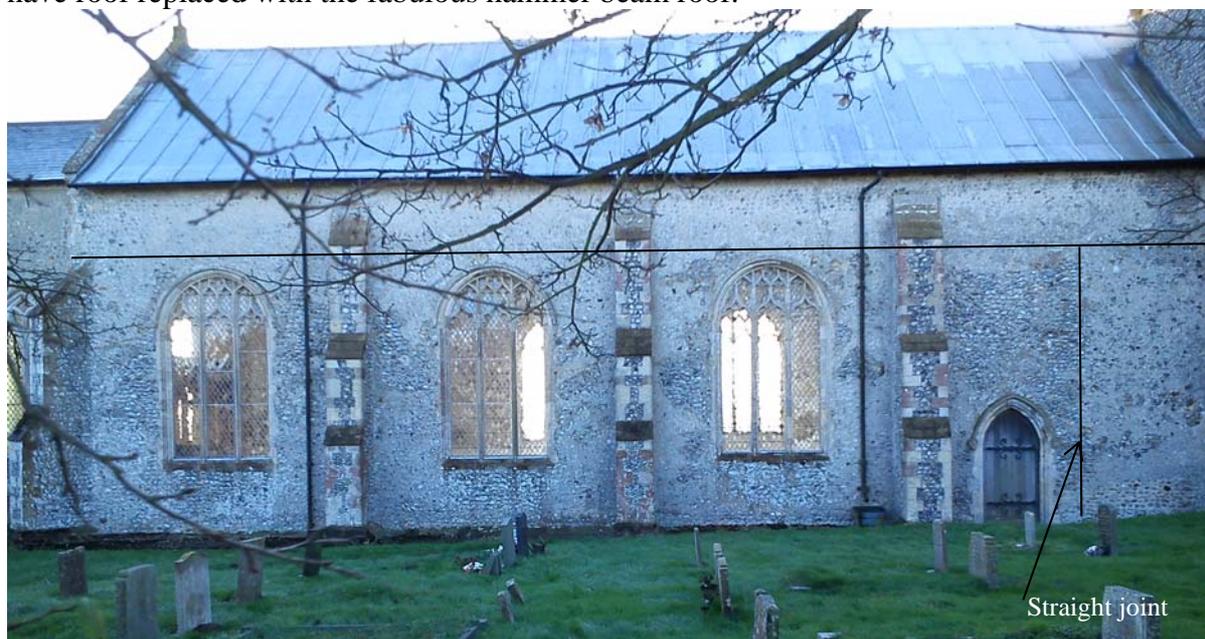
Fig. 4. Nave north wall showing heightening and straight joint.

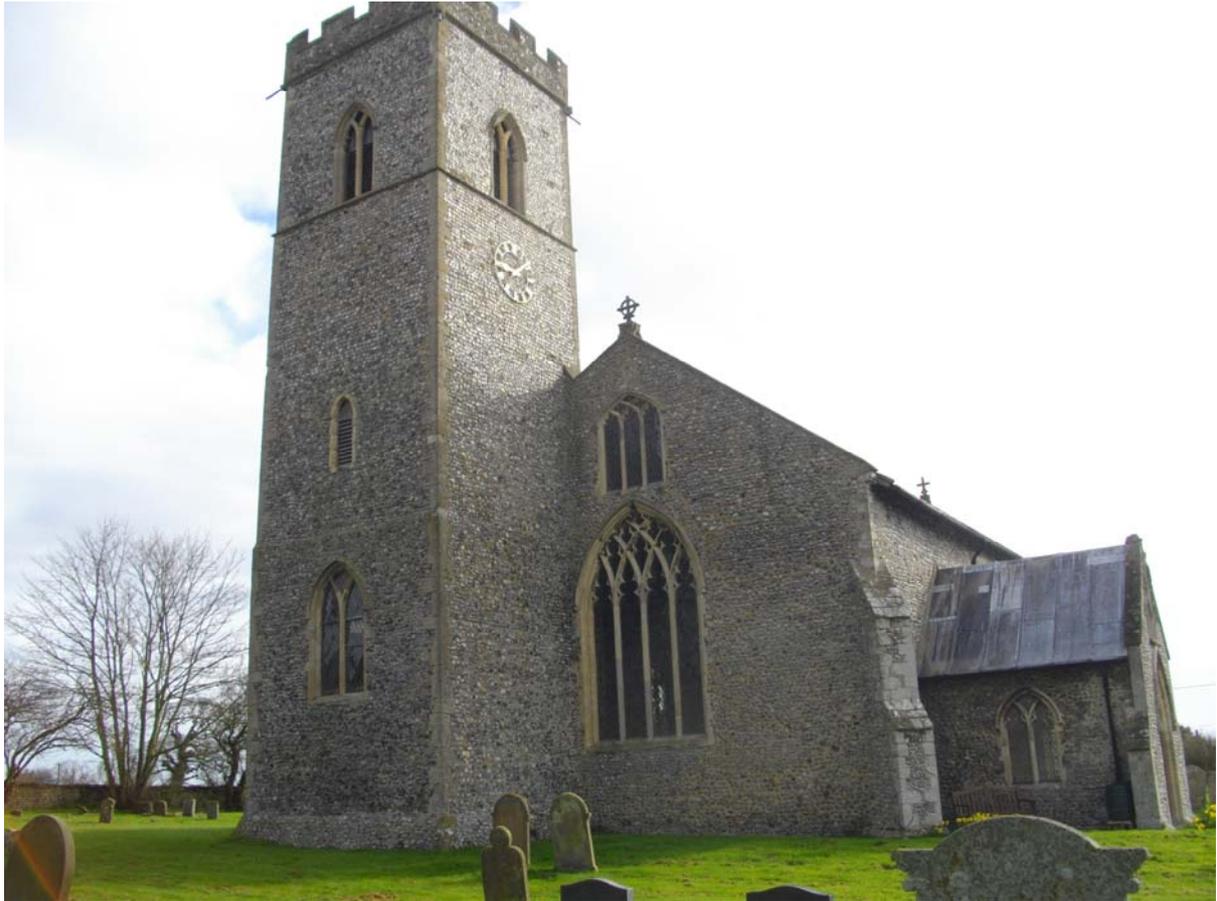
Fig 5. Tower and west window from south west

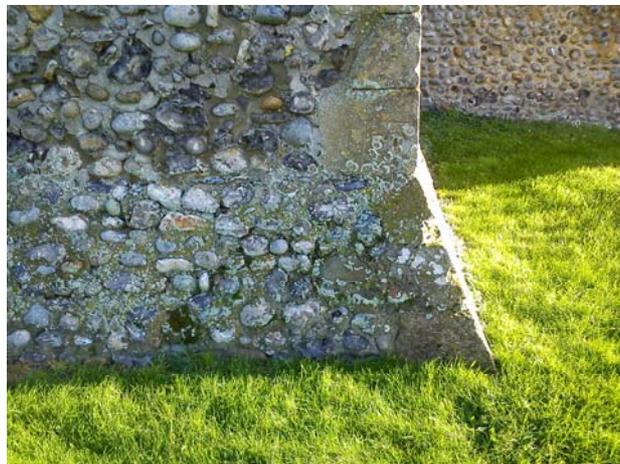
Fig. 6. South west corner of tower.

The tower itself is unbuttressed with only a doorway connecting with the nave. The fabric is of roughly knapped flint. It has 'Y'-traciated bell openings and a similar west window. There is an elegant crenellated parapet and a weathercock designed by John Sell Cotman – it is said. At the base of the tower, instead of a plinth as such, there is very deliberate miniature buttressing similar to a sort of glacis at the foot of a castle in order to discourage sapping. Such a method of building is very unorthodox and there is a possibility that it is the result of an attempt to underpin or reinforce the foundations of the tower. However, it is well-finished and has an effect on the presence and mass of the tower (fig 6).

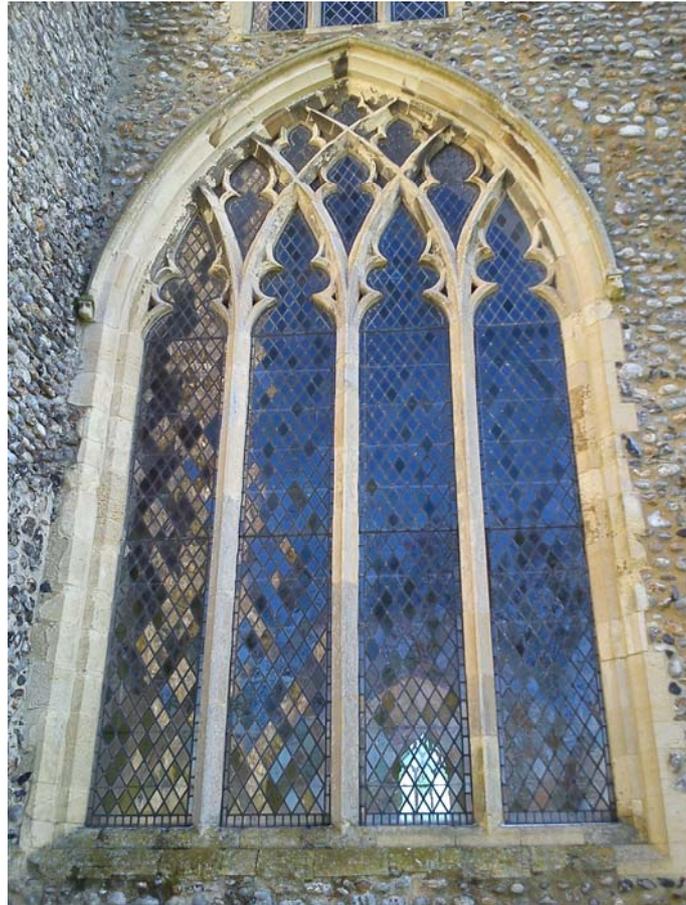
Fig. 7. West window.

As the tower is roughly contemporary with the nave it is remarkable that the habitual staged buttressing was not employed whilst it is on most of the corners of the adjoining building. First, of course, the question which needs to be posed is why was an asymmetrical, almost out of the way, position chosen for the tower. This was presumably in order to give the opportunity for the church to have a great west window which would be the glory of the west elevation as well as having the practical use of illuminating the nave. It may have been thought that the buttresses to the tower would draw attention away from the great west window. The four-light window of cusped 'Y' tracery is a typical early 14th –century window type particularly well executed at Knapton with elegant pierced cusping (Fig. 7). The window above is probably early 16th century and is contemporary with the nave heightening .

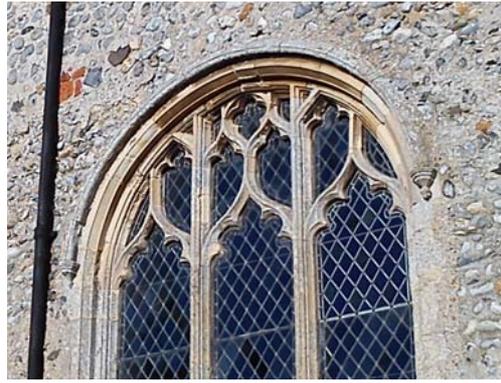
Fig 8. South west window head

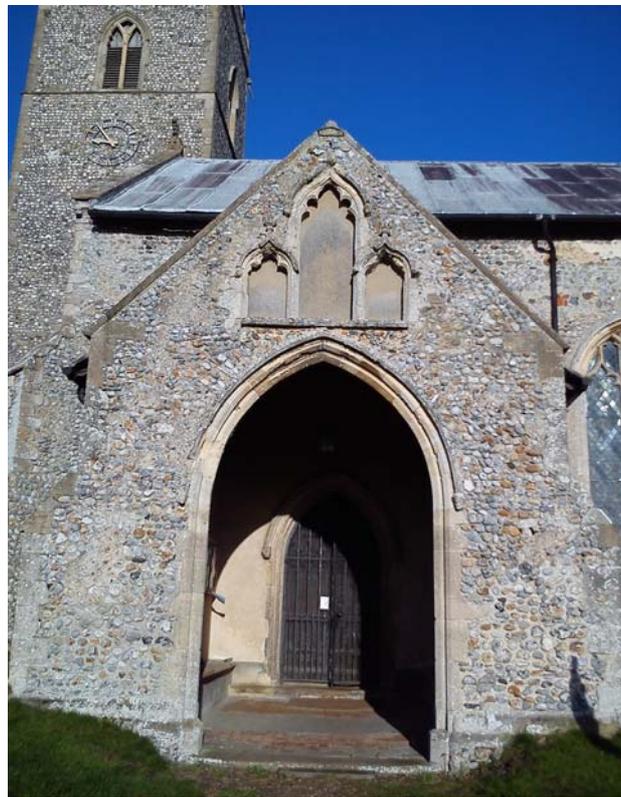
Fig 9. Nave south porch

The south porch is of 14th-century date and has only single side buttresses to its corners (Fig. 9). It has a plain two-centred archway with a remarkable triple niche above with cusped ogee arches.

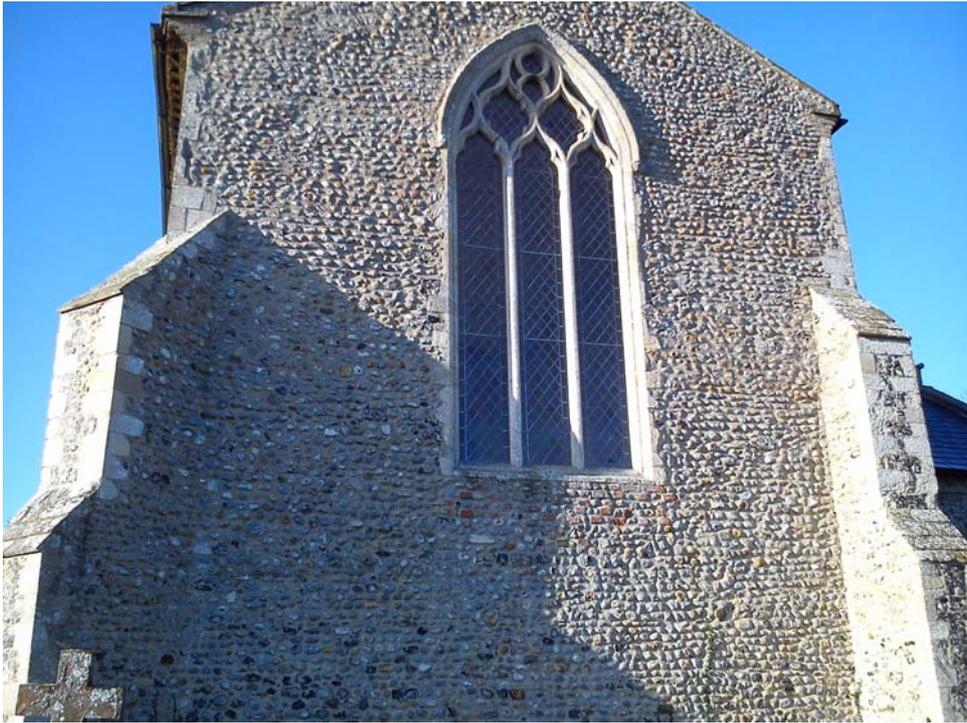
Fig. 10 East window.

The Chancel was greatly embellished by the rector John Smith *..qui hoc opus fabricari fecit..* in 1504, which is recorded by Blomefield (Blomefield 8, 134) and Anthony Norris (Rye 3, vol. 4) in the 18th century. Norris gives a more full description of the painted inscription as follows: *Round the bottom of chancel roof is the inscription in very large letters, so as to extend the length of the chancel on each side.* The *opus* probably refers to the chancel roof alone. There is 14th century reticulated tracery to the east of three lights and two light windows to the north with cusped ogee main lights and un-cusped mouchettes (Figs.10 & 11). There is a vestry to the north east of 1845 replacing one on the same site (PD 265/19). A horizontal offset above the building indicates that the earlier vestry had a lean-to roof (Fig.11). This may well have been a 14th century porticus because there is a single buttress to the corner allowing for the vestry whilst the southern angle is supported by a diagonal buttress (Fig. 10).

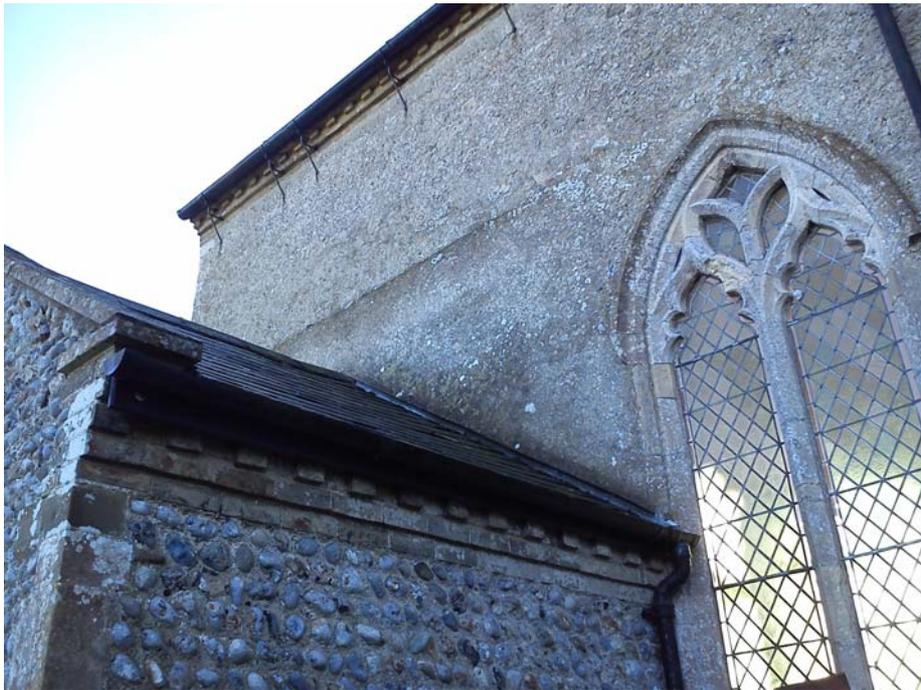
Fig. 11. Chancel at north east showing off-set.

There is evidence on the gable-end of the roof having had a much steeper pitch and thus the side walls have been heightened as in the nave. The heightening was probably carried out for the new shallow ceiling likely to be of *circa* 1780 and before Ladbrooke of *circa* 1820. The south wall has a modern render with two large 15th-century windows each of three lights with shallow heads and panel tracery (Fig.12). In the centre of the wall is the priest's door which has had a porch added to it. The distinctive semi-circular head like the nave windows dates it also to the early 16th century.

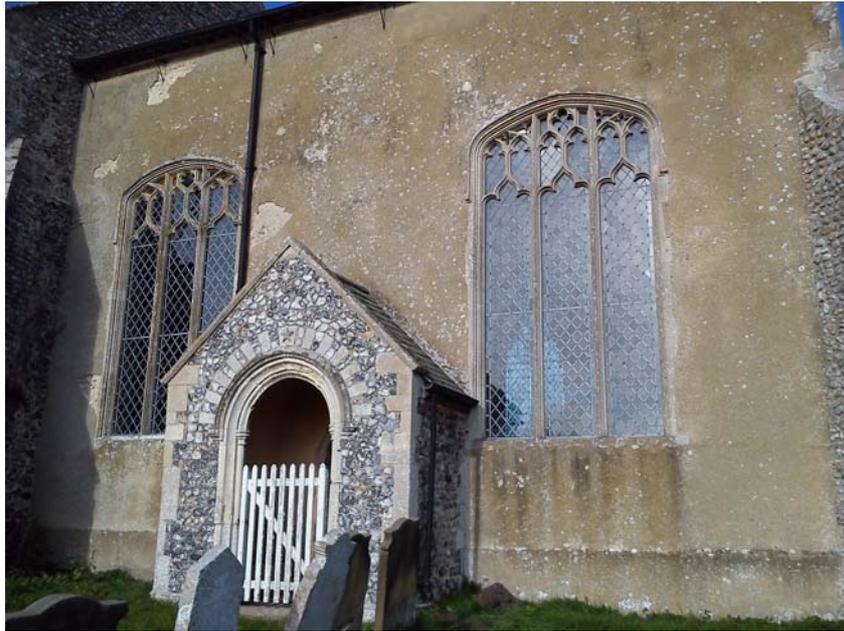
Fig 12. South wall of chancel

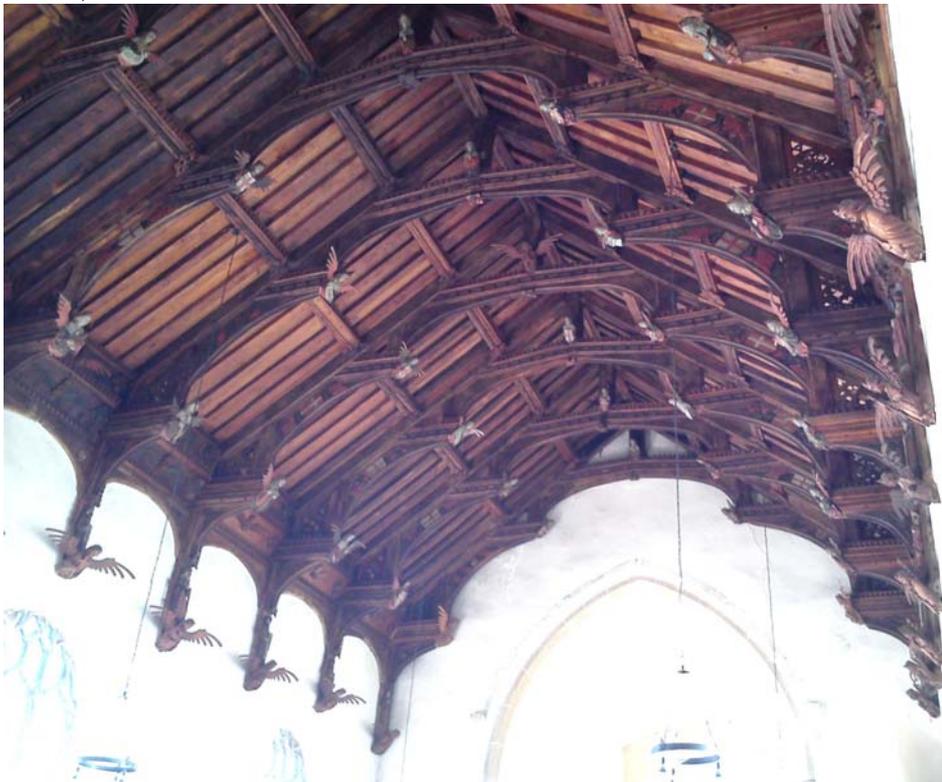
Fig.13. Nave roof looking east

The Interior is dominated by the magnificent double hammer beam roof with its myriad carved and painted angels (Fig. 13). The roof is widely attributed to the patronage of the rector John Smith but this is unlikely because a rector was responsible solely for his chancel as was recorded in the chancel roof. However, there is no reason not for it to date to about the same time as the now missing chancel roof. There is a will of 1511 leaving money towards the ‘pinyng’ (painting?) of the church roof (Cattermole & Cotton). Also Blomefield records a donation of 40 marks in 1506 towards ‘building of church’. In today’s money this is not far short of £20,000.

The most noticeable restorations of the roof are the re-introduced angels at the feet of the wall posts. A mid-19th-century engraving on display in the church clearly shows the tenons which held angels no doubt similar to the re-creations in place (Fig. 17). This new work was of George Gilbert Scott's restoration of 1882 and the names of the churchwardens and builders are displayed in the brattishing on the north side of the nave (Fig. 18) (PD265/20-21). Further major repairs were undertaken in 1930 and the drawn specification survives in the record office (PD 265/23). During this work a tie beam corresponding to the easternmost truss was removed and hammer beams substituted. The beam, which crossed the chancel arch, belonged to the original roof (photo in Lorraine 1970). The slightly truncated braces can be seen (Fig. 13).

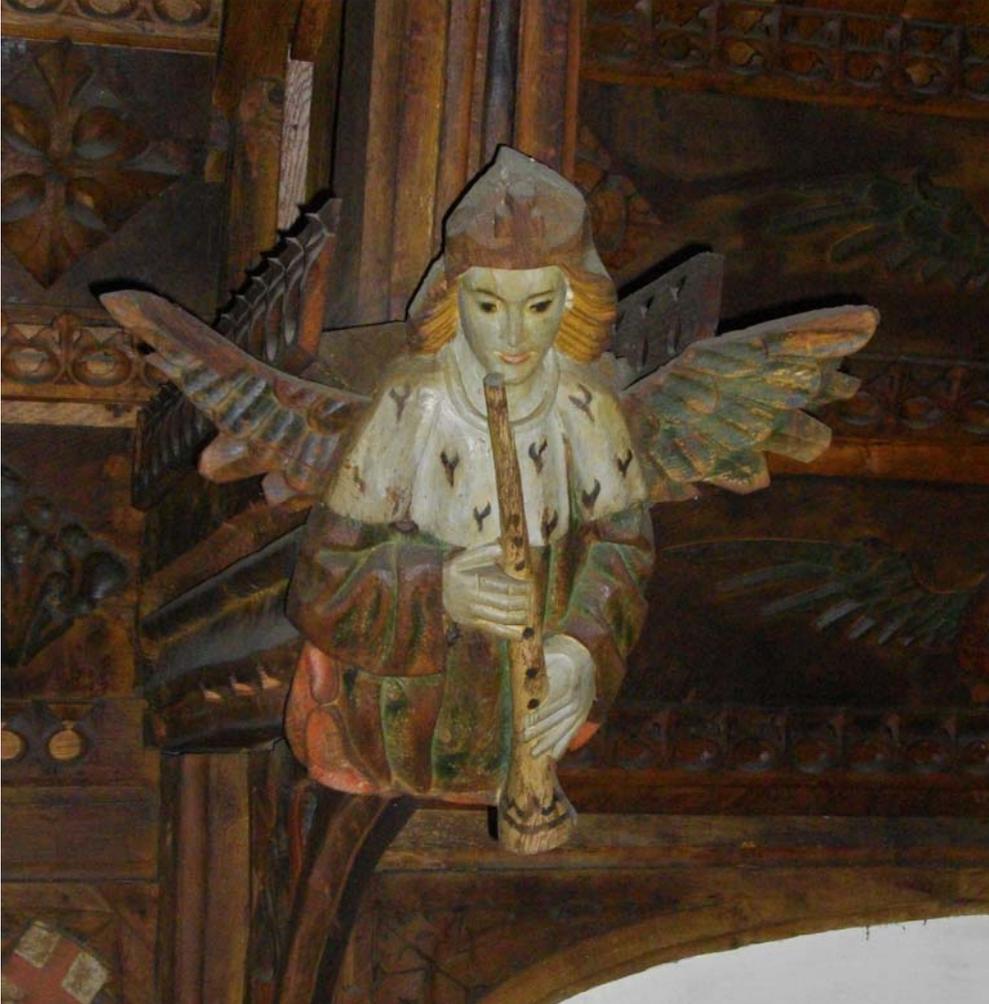
Fig. 14. Angel on hammer beam

All of the original figures are painted with pale faces and brightly coloured lips and hair with pupils and eyebrows in black. Clothes and wings are similarly coloured (Figs 14 & 15). There is speculation about the authenticity of the angels and especially considering that they would surely have been destroyed or disfigured by the iconoclasts. However, there is

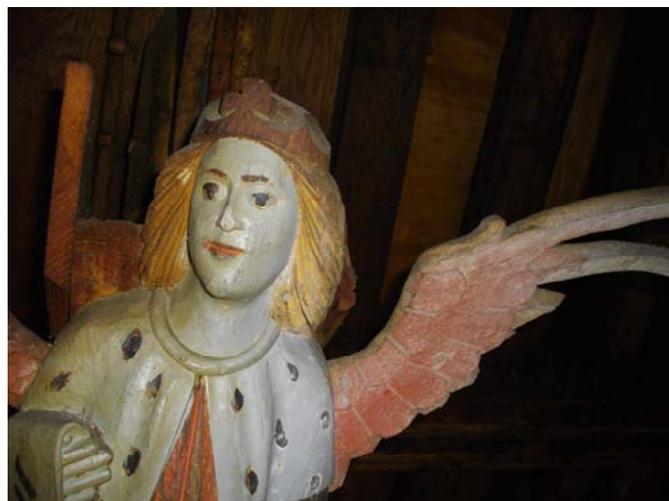
Fig. 15 Detail of angel

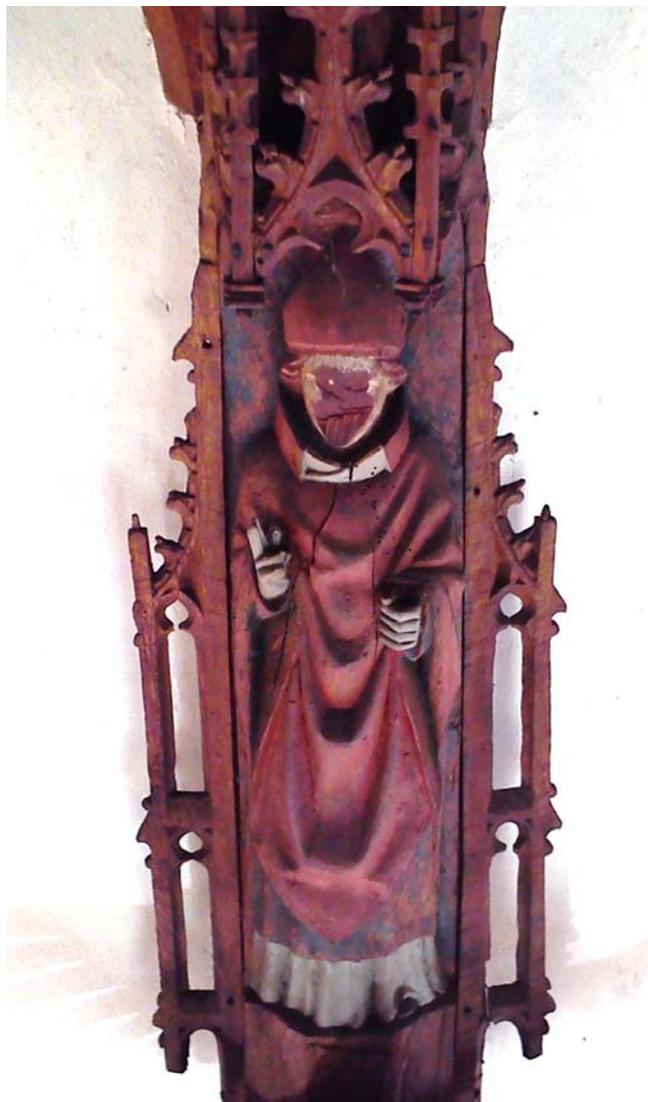
Fig. 16. Bishop figure with hacked face and missing crozier on wall post.

abundant evidence of iconoclasm at the lower levels. All the angels at the feet of the wall posts were destroyed, the cornices were damaged and the faces of the prophets on the wall posts are hacked. With the latter sufficient painted surfaces survive to match those on the higher angels (Fig. 16). Clearly the extent of destruction was determined by the length of the ladders.

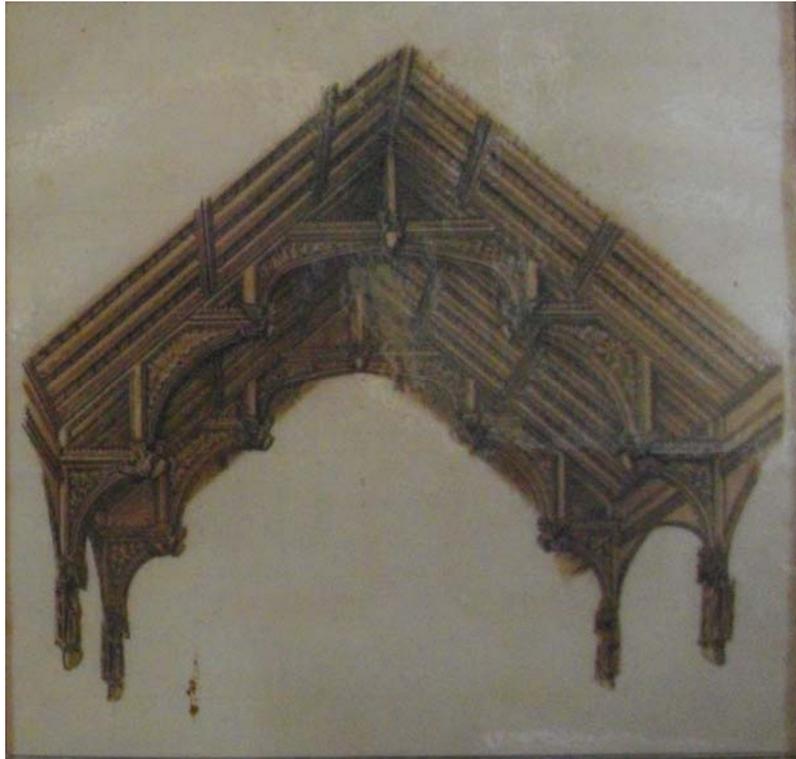
Fig. 17. Engraving of roof before re-introduction of angels at feet of wall posts

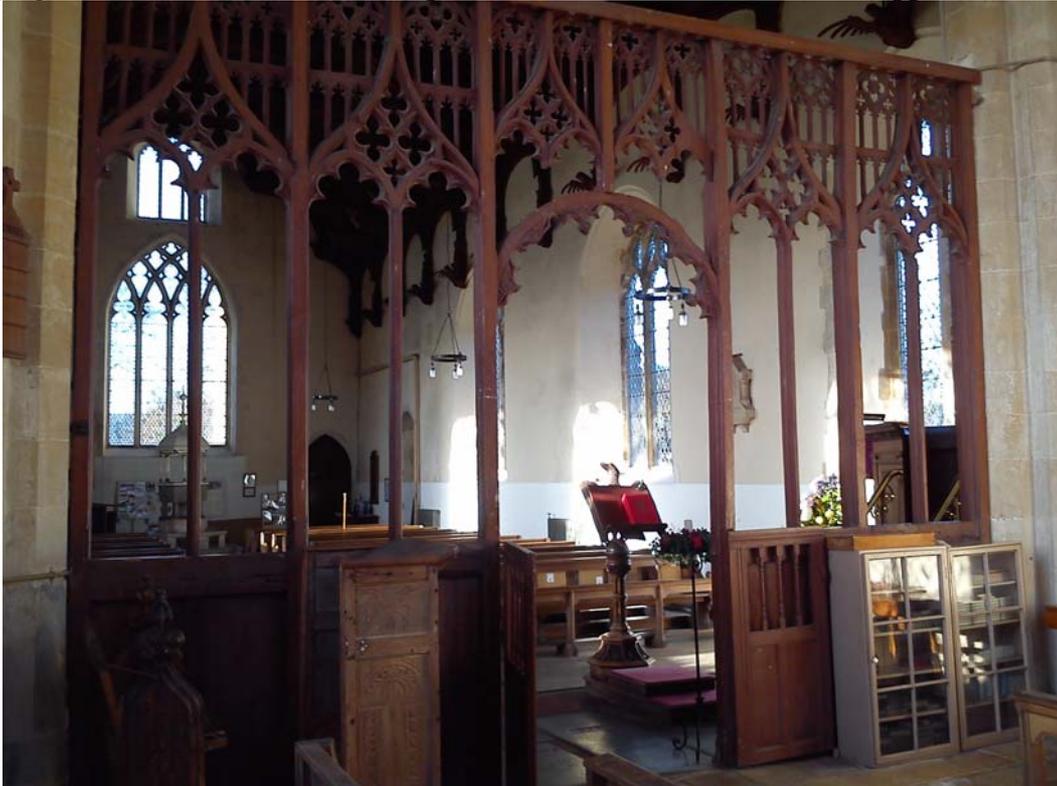
Fig.19. Screen from the east.

The screen survives almost complete with only its loft removed and the gates replaced with Jacobean versions (Fig. 19). It has been painted in wood grain and there is no visible original painted decoration. There is the typical intricate miniature tracery filling the heads of ogee

arches with a large multi-cusped central doorway. The rood stair survives and above the springing level of the chancel arch are pair of corbels which would have supported the rood.

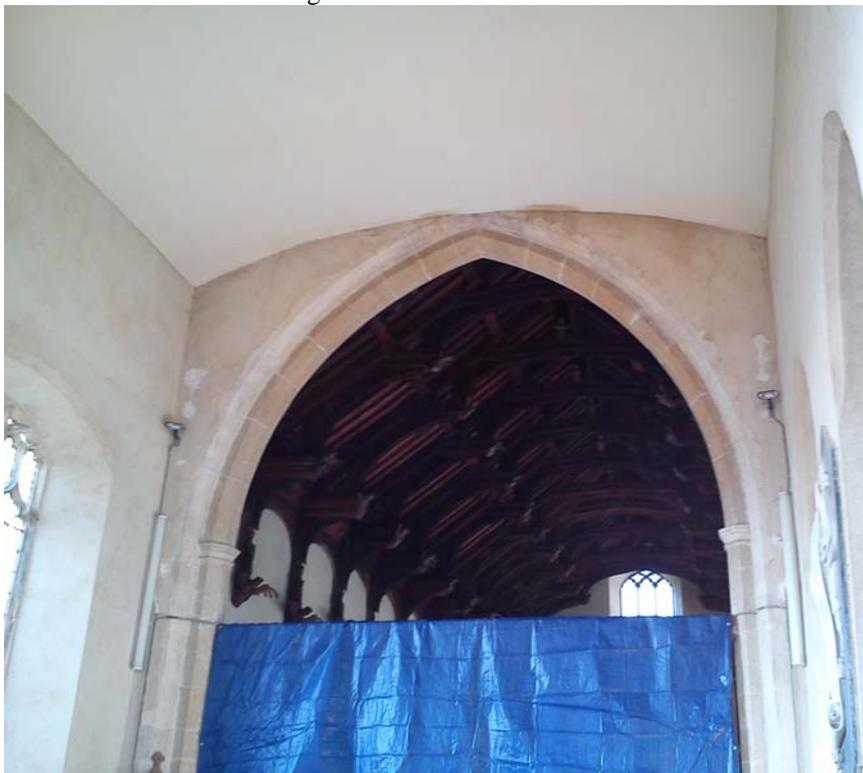
Fig. 20. Chancel arch and chancel ceiling

The chancel arch itself appears to belong to the 14th-century phase (Fig.20). The original 1504 hammer beam roof to the chancel was replaced with the present roof and ceiling of

circa 1780. The pitch of the roof was reduced by heightening the side walls. The plaster ceiling forms a shallow segmental barrel vault (Fig. 20).

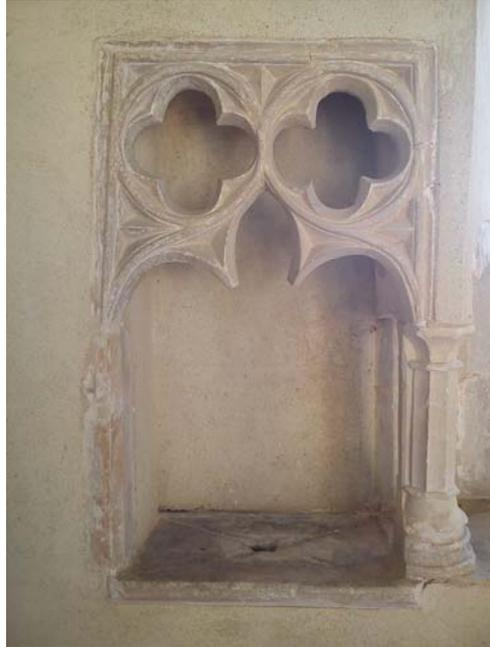
Fig.21. Piscina

There is a fine angle piscina to the south (Fig.21). It consists of a pair of quatrefoils in the spandrels of a an ogee arch. The right hand section is a modern reinstatement.

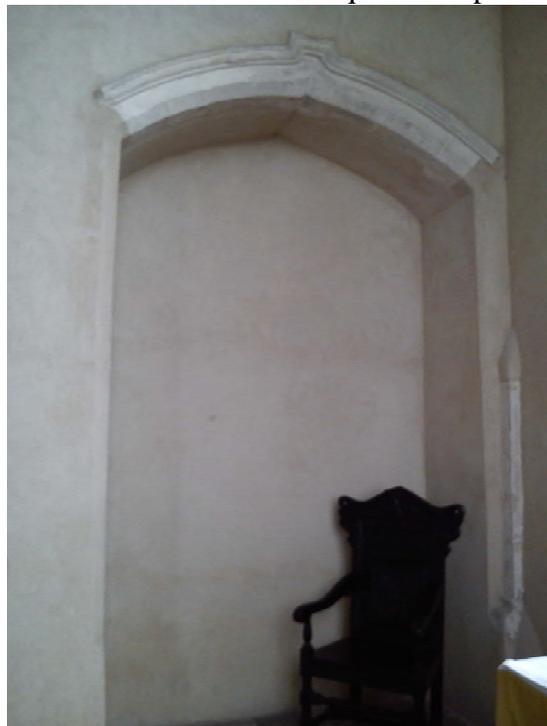
Fig, 21. Easter sepulchre?

There is large part-blocked archway at the east end of the north wall (Fig. 21). There is no sign of it in the present vestry. The most likely purpose for this was for an Easter Sepulchre although the lack of a tomb in the recess leaves the question open.

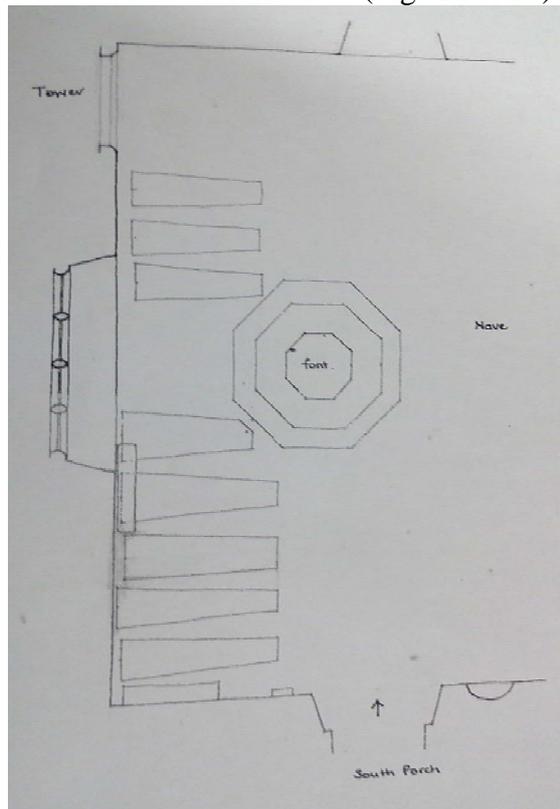
Fig 22. Plan of west end of nave (Ruth Blackman)

At the west end of the nave is a row of eight medieval stone tomb slabs. A ninth of the same sort is in a tomb recess on the south side of the nave (Figs 22 & 23).

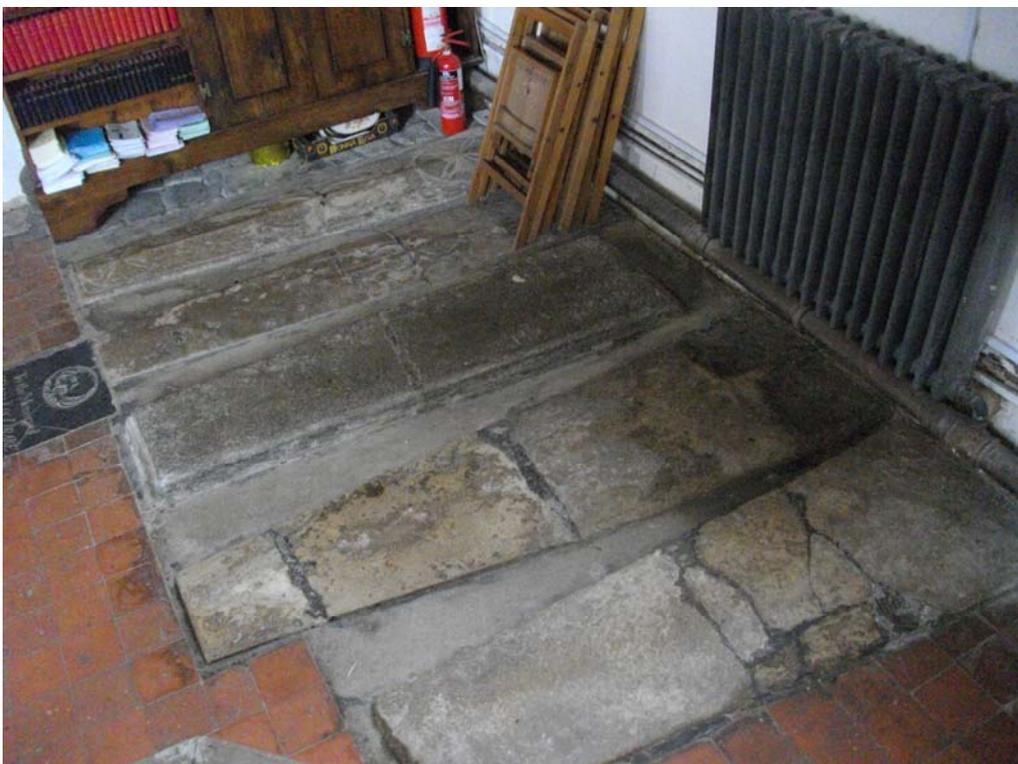
Fig 23. View of five tomb covers form north

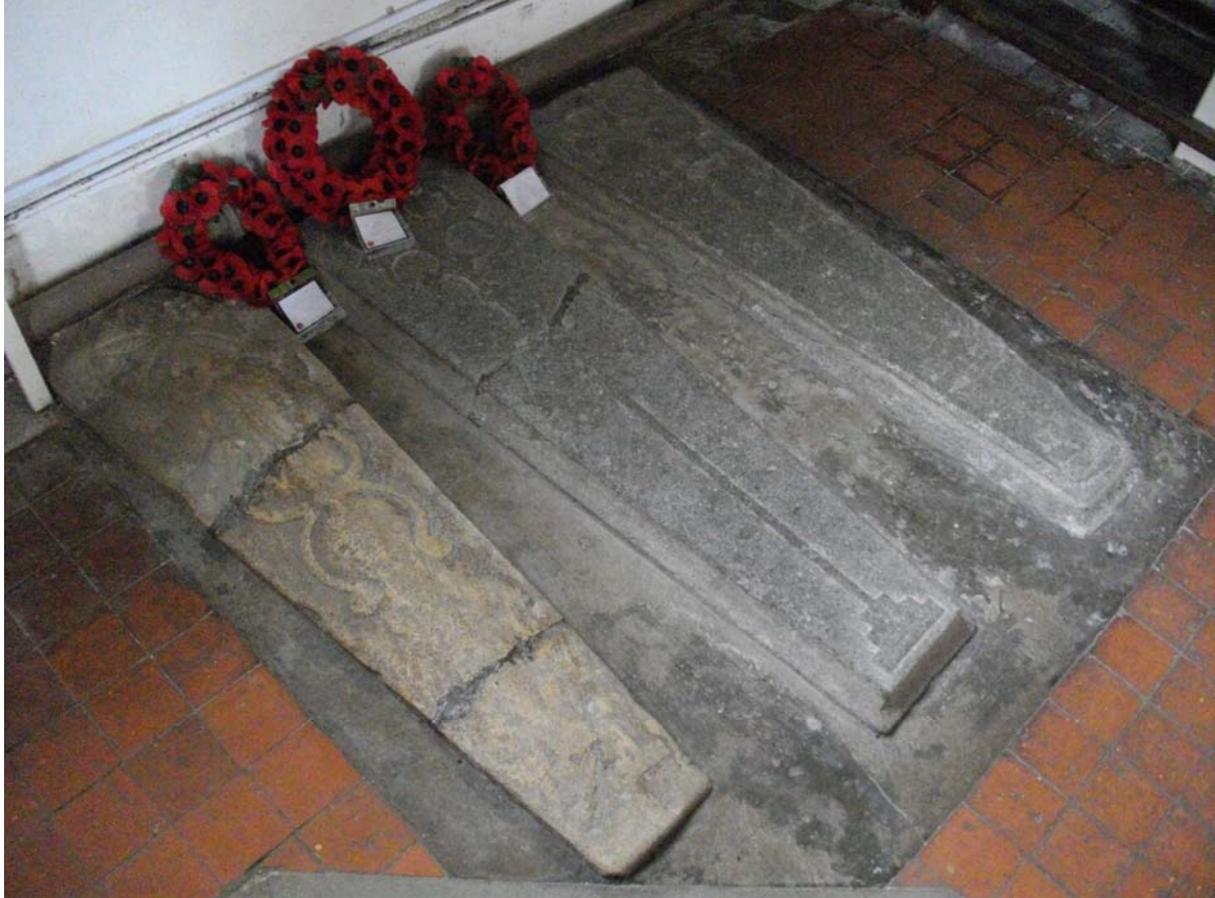
Fig. 24. Two covers with cusped crosses and one with alisées patée cross and flanking arabesque. The slabs are clearly not in their original positions and George Gilbert Scott's plan plots the lay out of the covers which were distributed randomly about the church but presumably over actual graves (Fig. 25). One of his proposals is to leave them in situ and replace the pews but,

These are decorated with either cusped cross, shaft and stepped base or alisées patée crosses also with shafts and in two examples with flanking arabesques (Fig.24). Some of the slabs are made of Purbeck stone or similar and some are very worn suggesting that formerly they may have been outside or in places of frequent foot fall. They are raised above ground level rendering the space unusable and the slabs themselves at risk of being damaged.

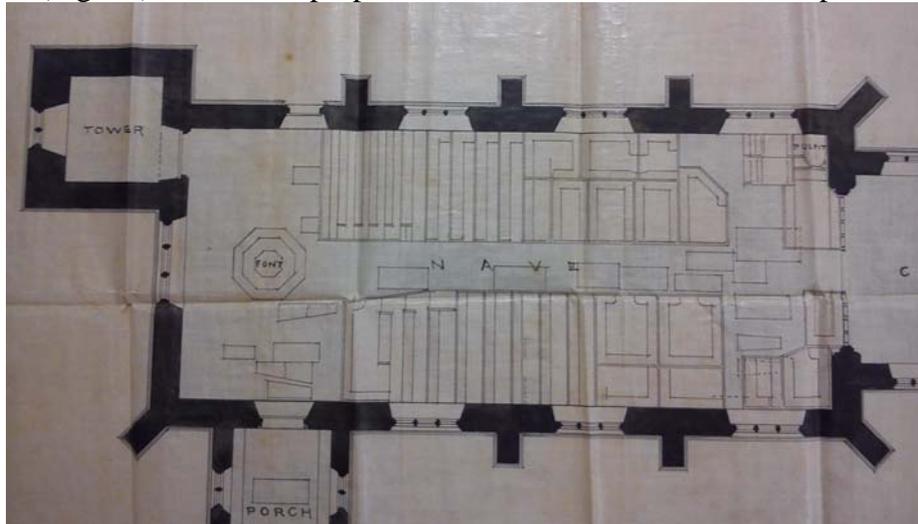
Fig. 25. Scott's plan of existing arrangements in 1881 (PD 265/21)

The major restoration took place during the 1880s under the direction of George Gilbert Scott (PD265/20 & 21). His specification for the neglected and damaged church survives and he undertook its repair which involved rebuilding the buttresses, repairing and re-leading the nave roof, cementing and tiling the floor, the replacement of the box pews and benches with 30 new oak pews (Fig. 29), new doors and other works (Figs 25-27). This restoration was responsible for the re-introduction of the angels at the wall posts' feet.

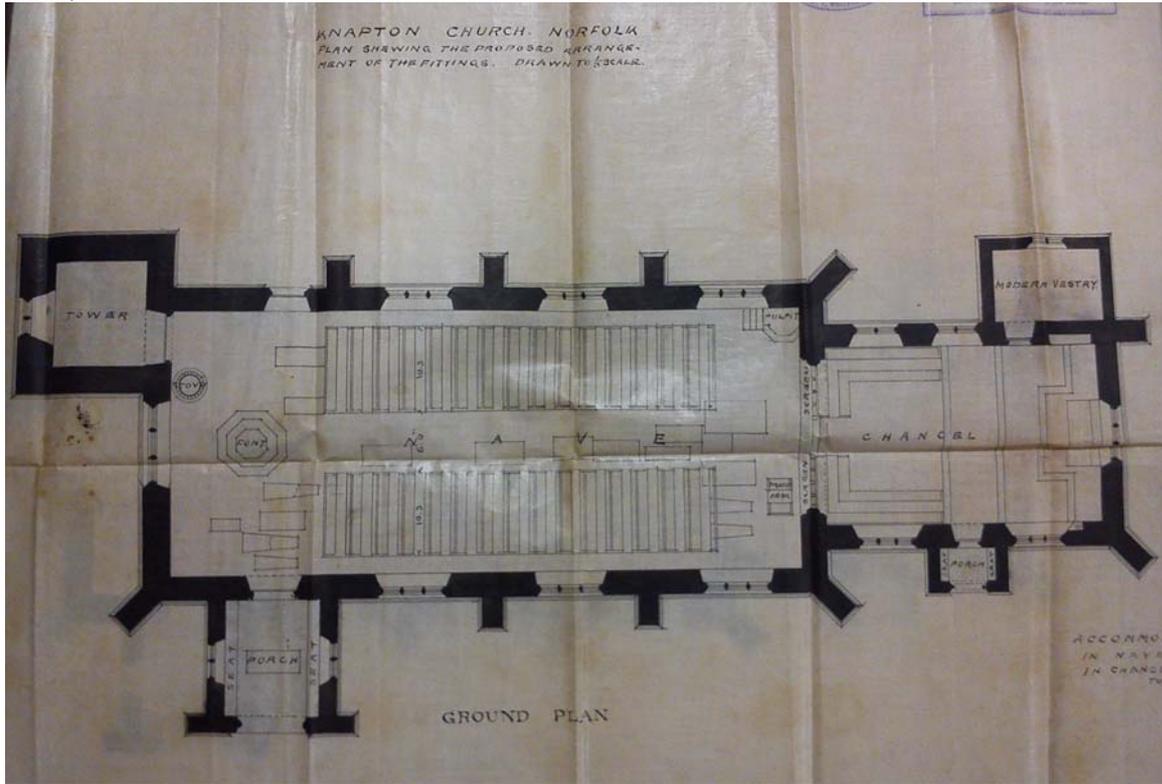
Fig 26. Proposed 1(PD 265/21)

since he cemented and tiled the floor it seems likely that the slabs were moved then (Figs 26 & 27).

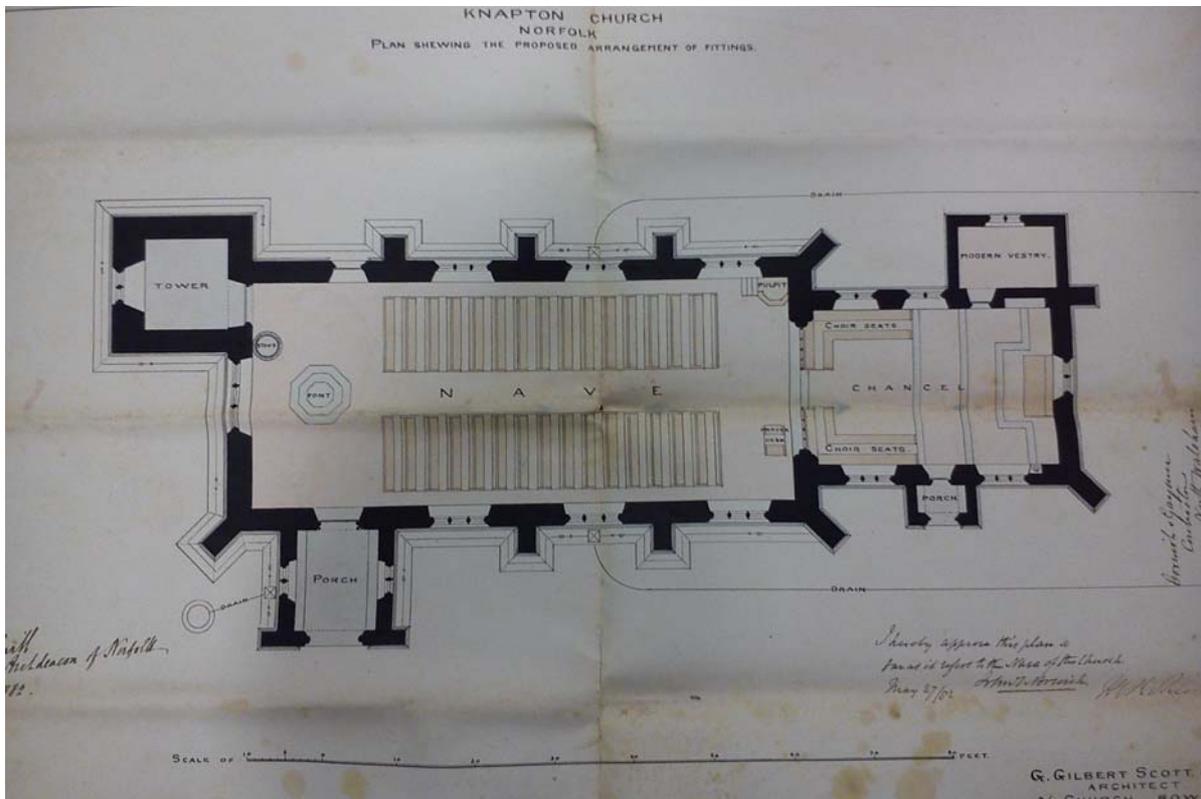
Fig. 27. The final approved plan (PD 265/21)

The final approved plan shows no grave covers at all. In the event the Tournai marble slabs down the central aisle have been neatly re-arranged (Fig.28). Bryant records in 1900 (Bryant 1900) six coffin lids at the south west corner of the nave, 4 at south east corner of chancel and two with crosses under the south east nave window. According to this it was not until later that the present arrangement was arrived at. But Bryant's information was second hand and it is certain that the main changes were made under Scott. The seven narrow slabs at the west end along with one of the tapered slabs at the south east are now lined up against the west walls and the one remaining tapered slab was probably moved into the grave niche on the south wall. Of Bryant's 4 other slabs there is no sign.

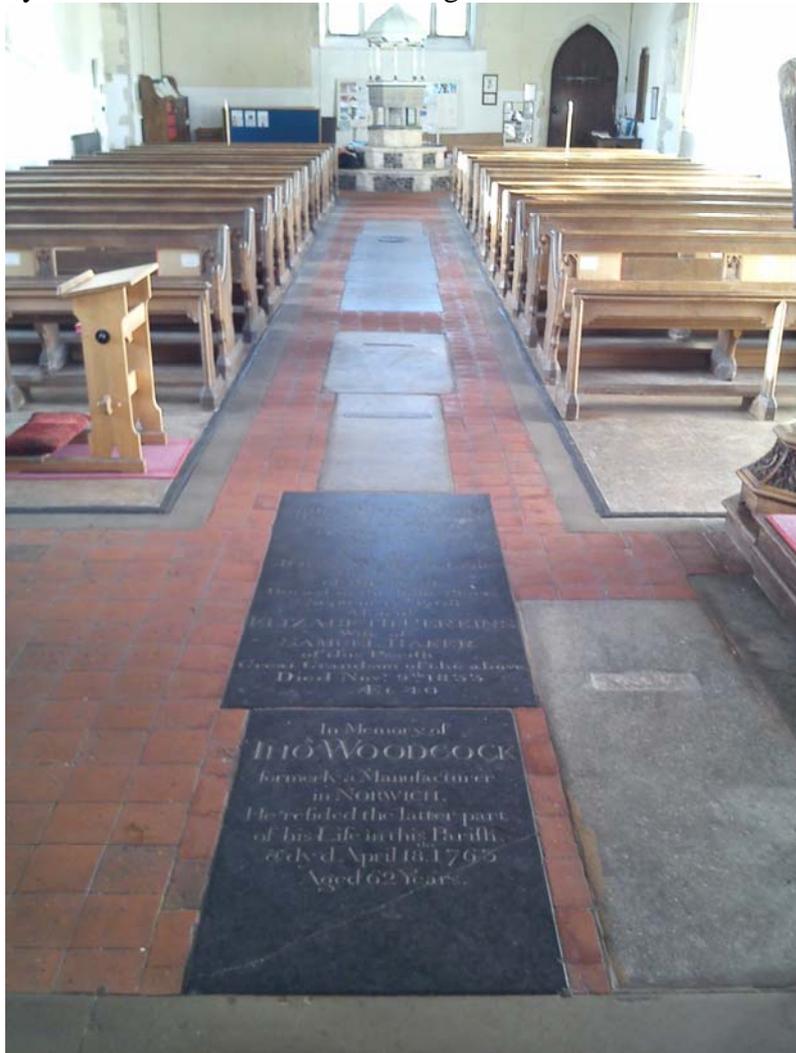
Fig. 28. View of nave floor looking west.
