The Church

SS Peter & Paul

KNAPTON

Conservation-Based Research and Analysis Report

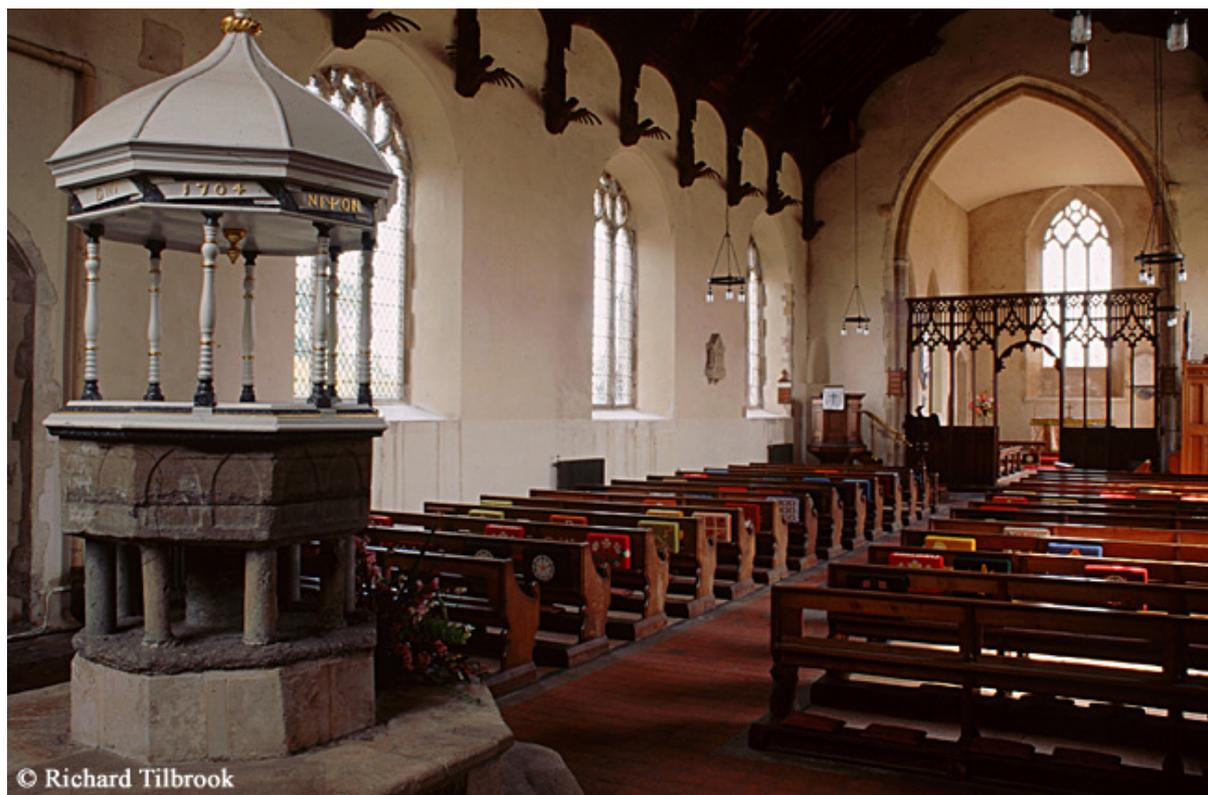
Fig. 29. General view of nave with font in foreground.

The font, with its steps and cover, is an important feature at the west end of the church at its traditional position opposite the doors (Fig. 29). The polygonal bowl is of Purbeck 'marble' with typical shallow arcading. The rather weak cover has a cupola with a Greek Inscription.
